## Property Condition Report (PCR)

For the Project:  
**123 E 4th Street**  
**New York, NY**  
**KOW Job 2020-000**

Inspection Date:  
**9/25/2020**

Report Date:  
**9/30/2020**

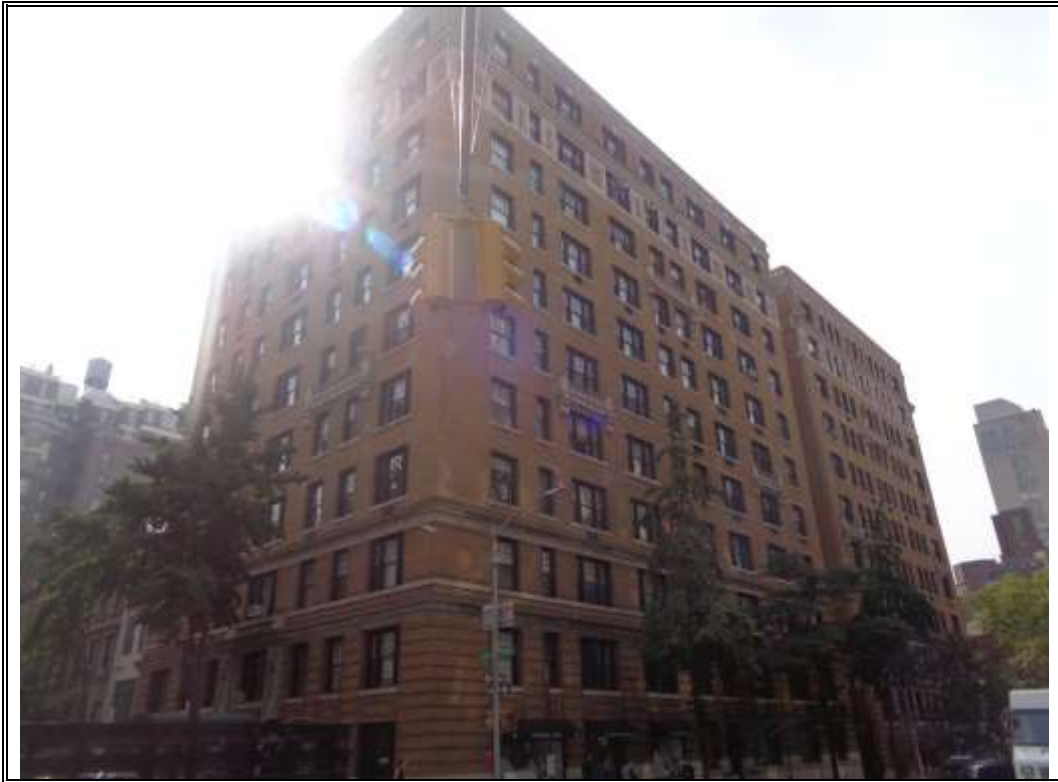
Photo 1 – View of 40 East 83<sup>rd</sup> Street.

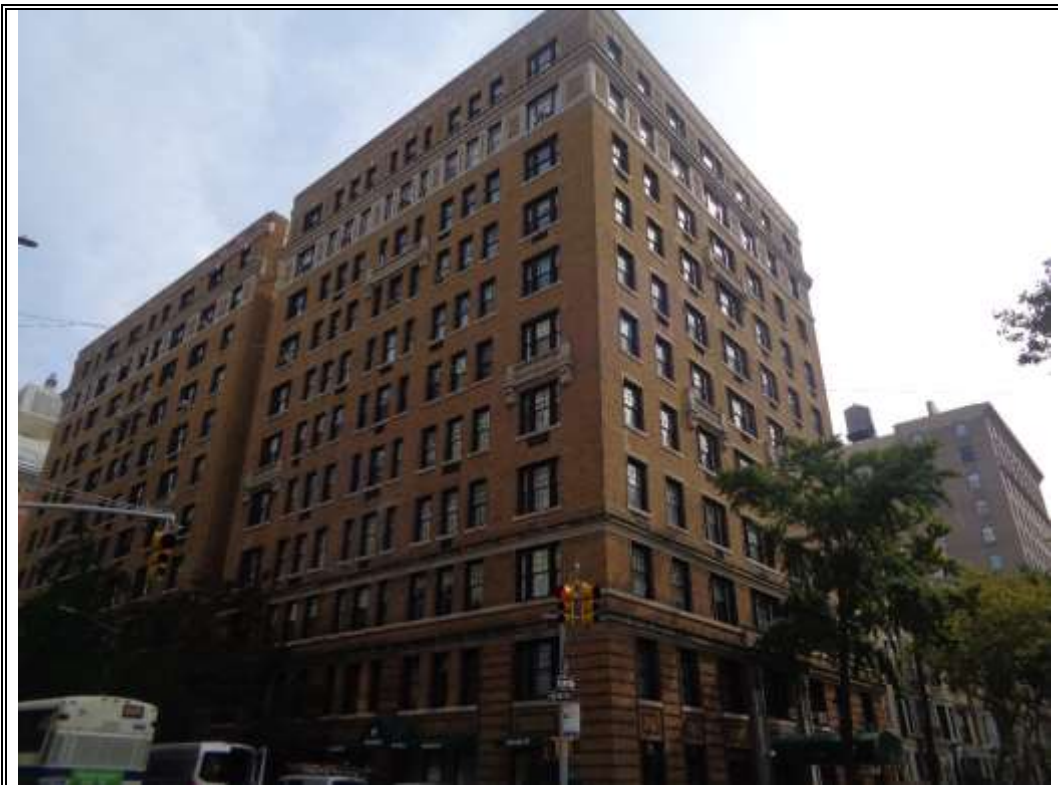
Photo 2 – View of 45 East 82<sup>nd</sup> Street.

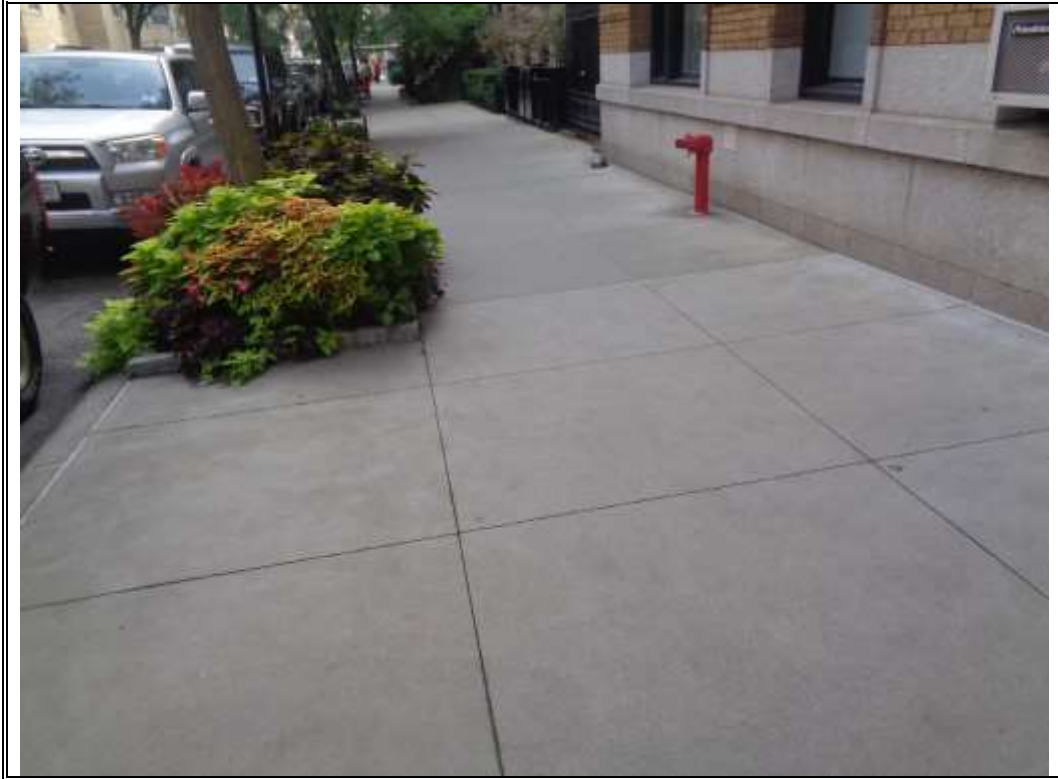
Photo 3 – View of typical flatwork condition.

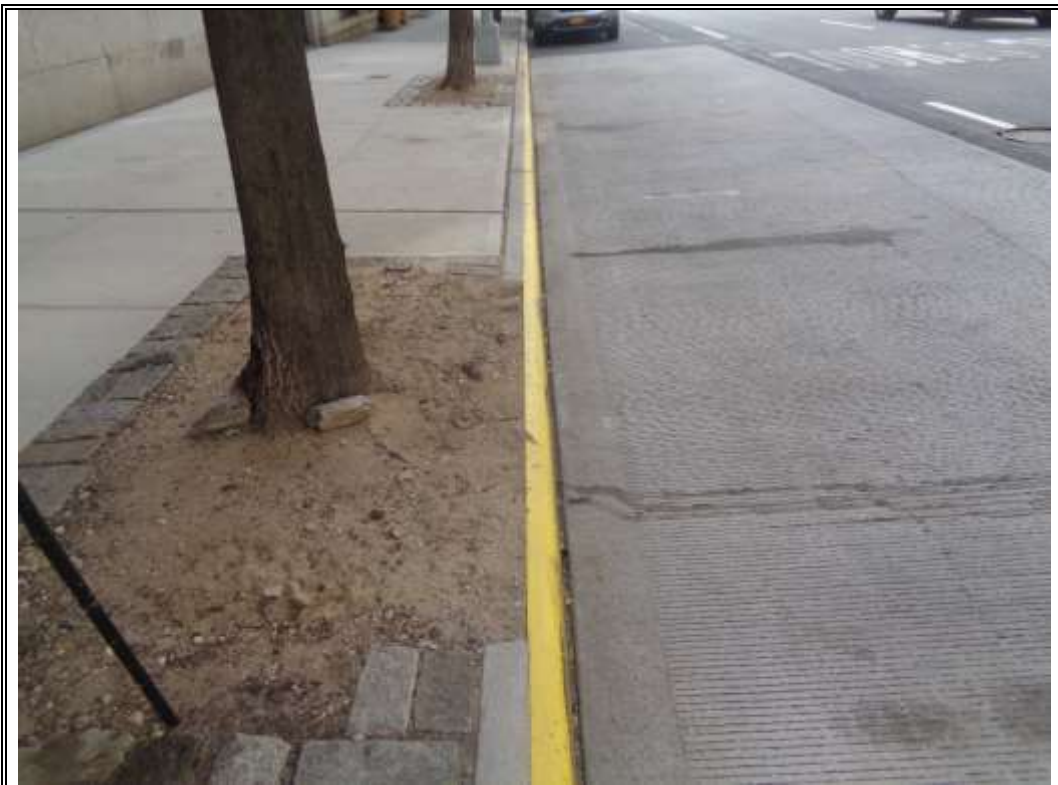
Photo 4 – View of a typical curbing.

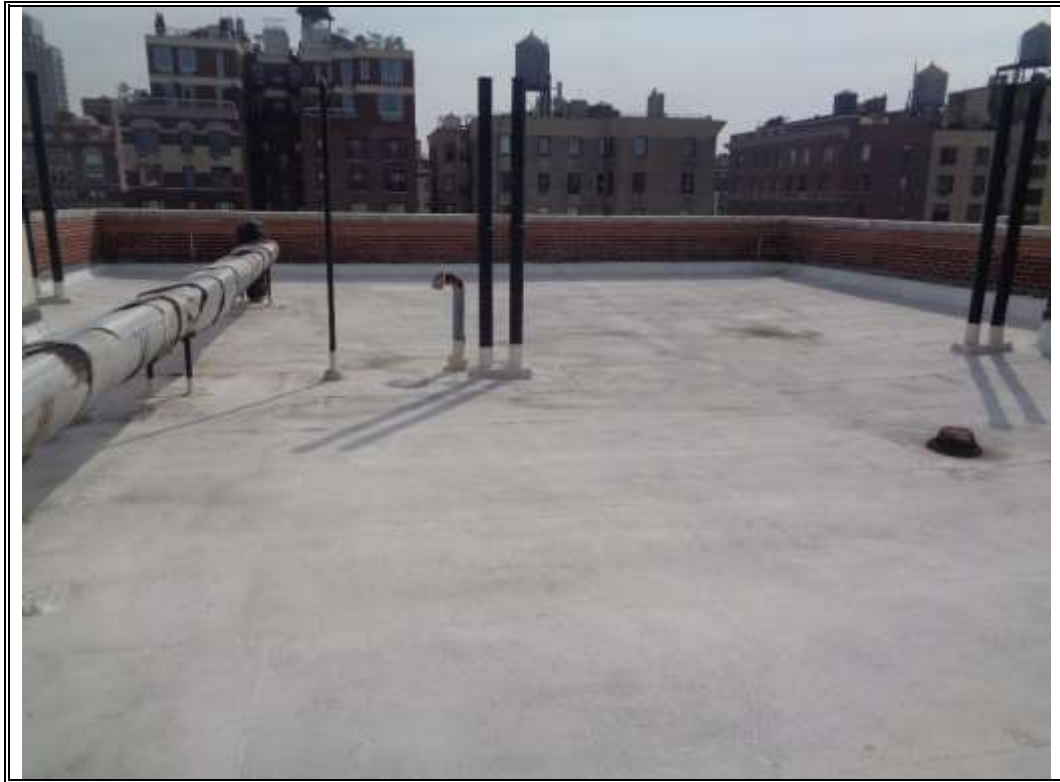
Photo 5 – View of the roof at 40 East 83<sup>rd</sup> Street.

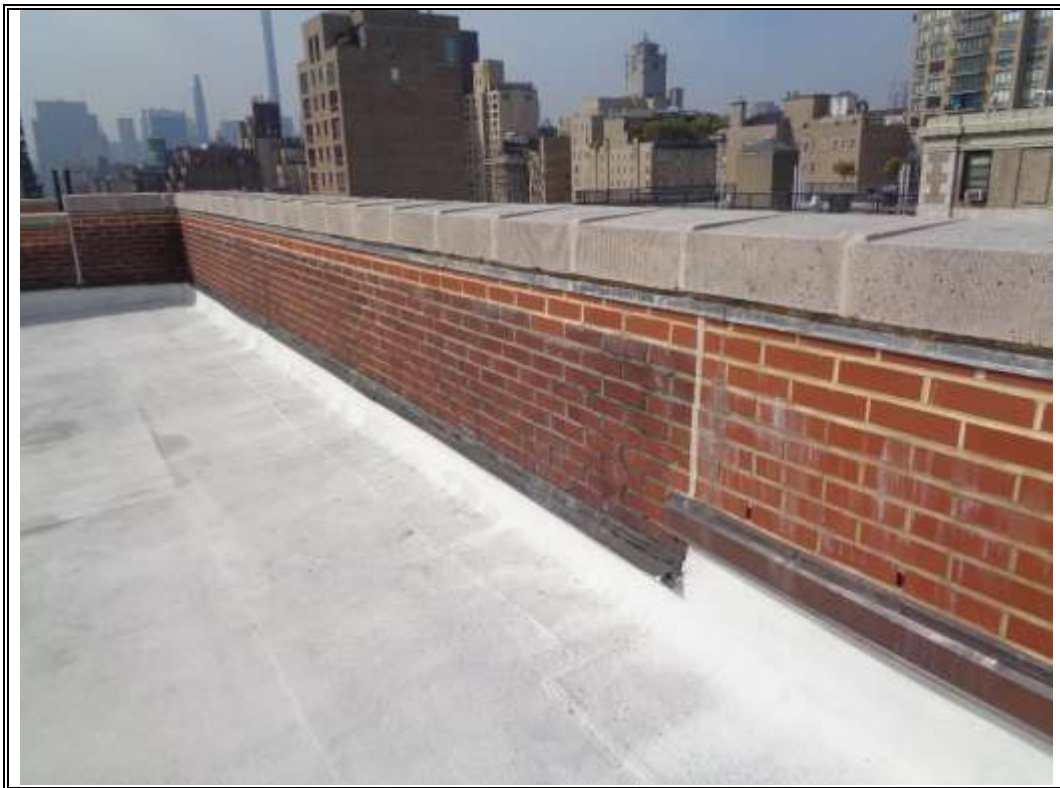
Photo 6 – View of recently repaired/ built parapet wall at 40 East 83<sup>rd</sup> Street.

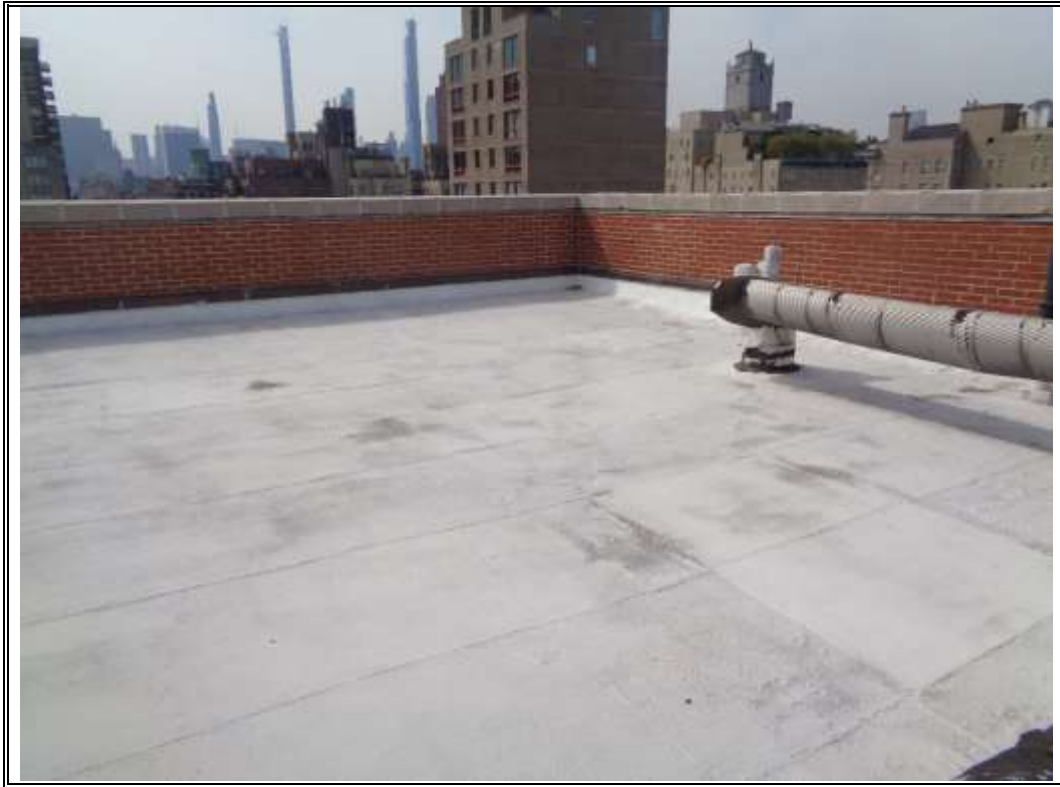
Photo 7 – View of the roof at 45 East 82<sup>nd</sup> Street.

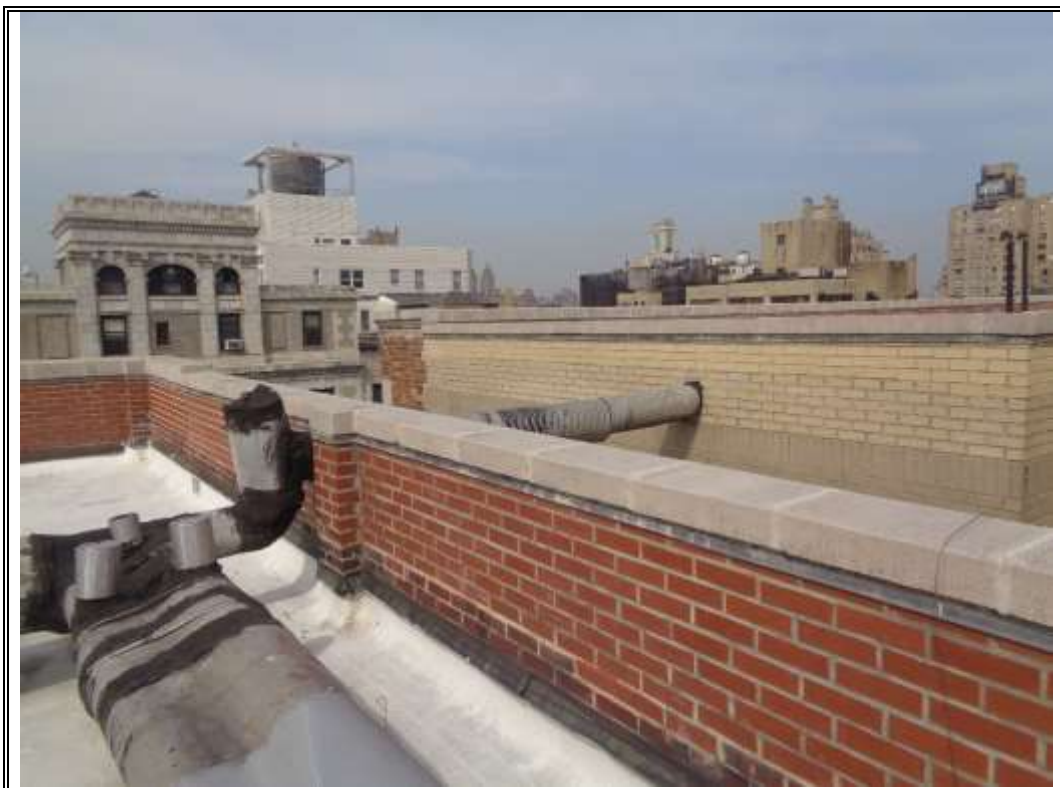
Photo 8 – View of the parapet wall at 45 East 82<sup>nd</sup> Street.

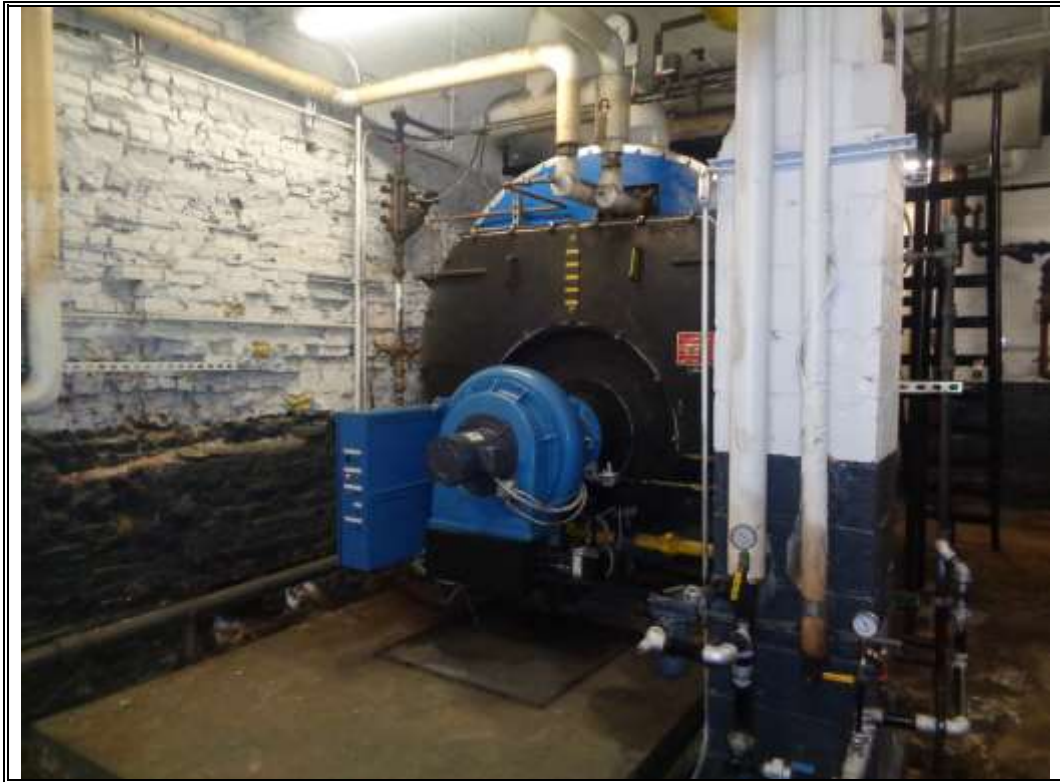
Photo 9 – Overall view of the boiler located in 40 East 83<sup>rd</sup> Street.

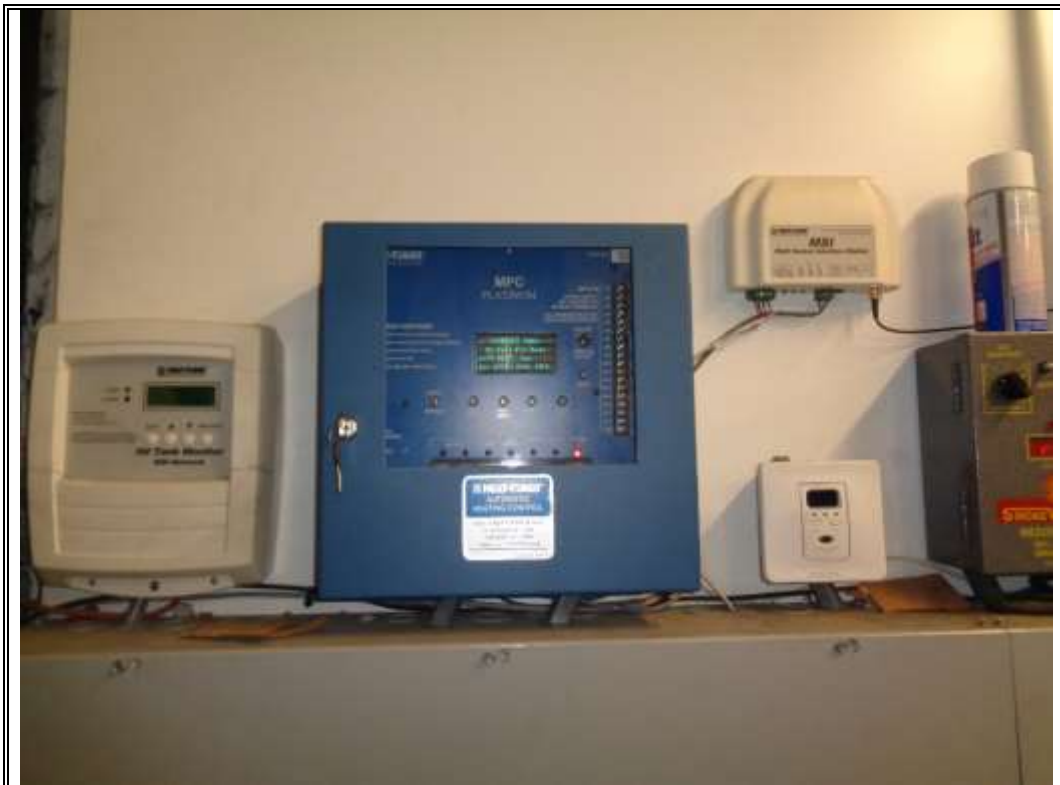
Photo 10 – View of the boiler controls.

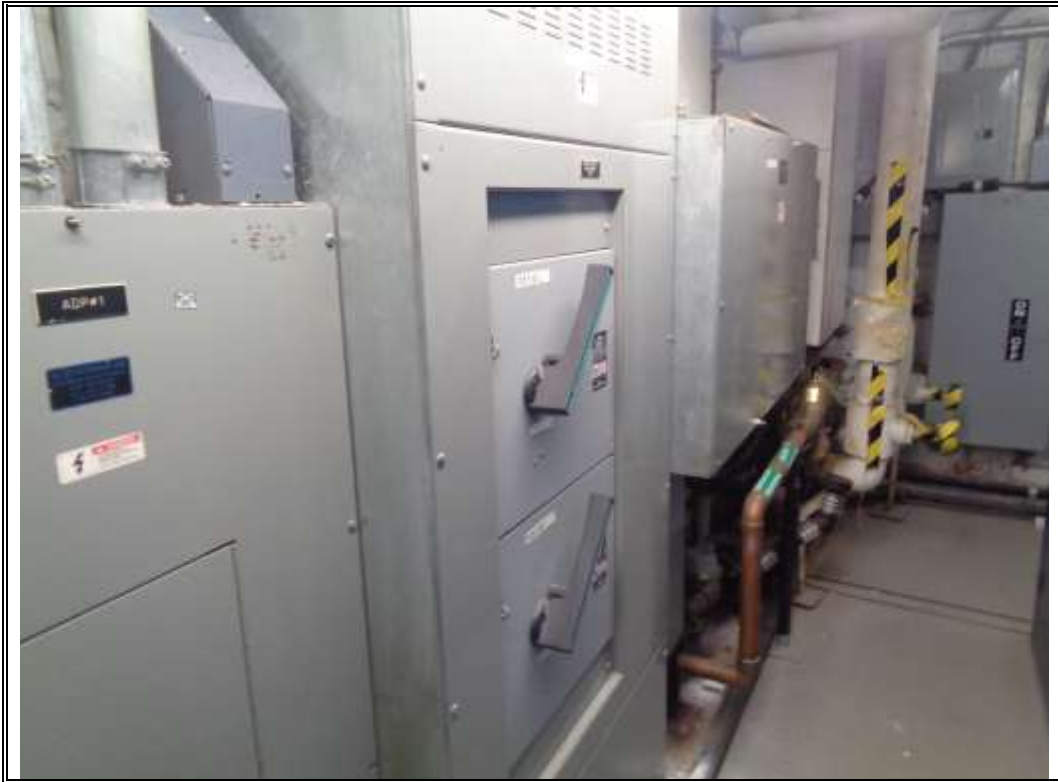
Photo 11 – View of electrical switch gear.

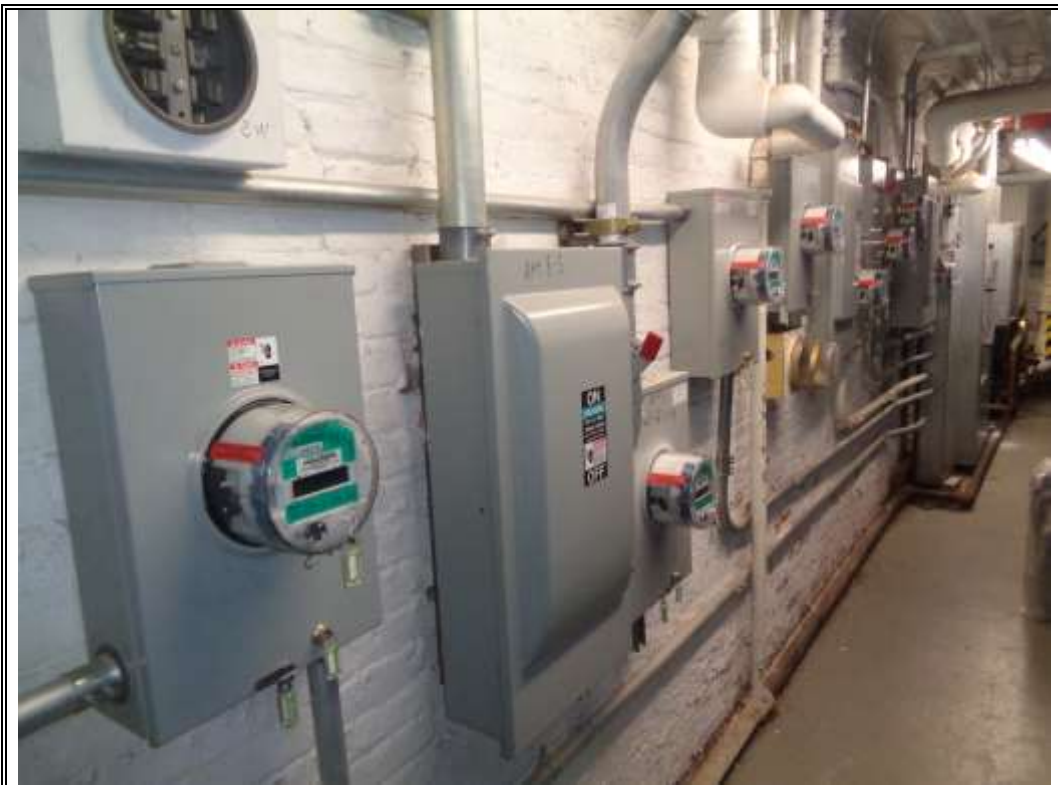
Photo 12 – View of electrical meters at the cellar.

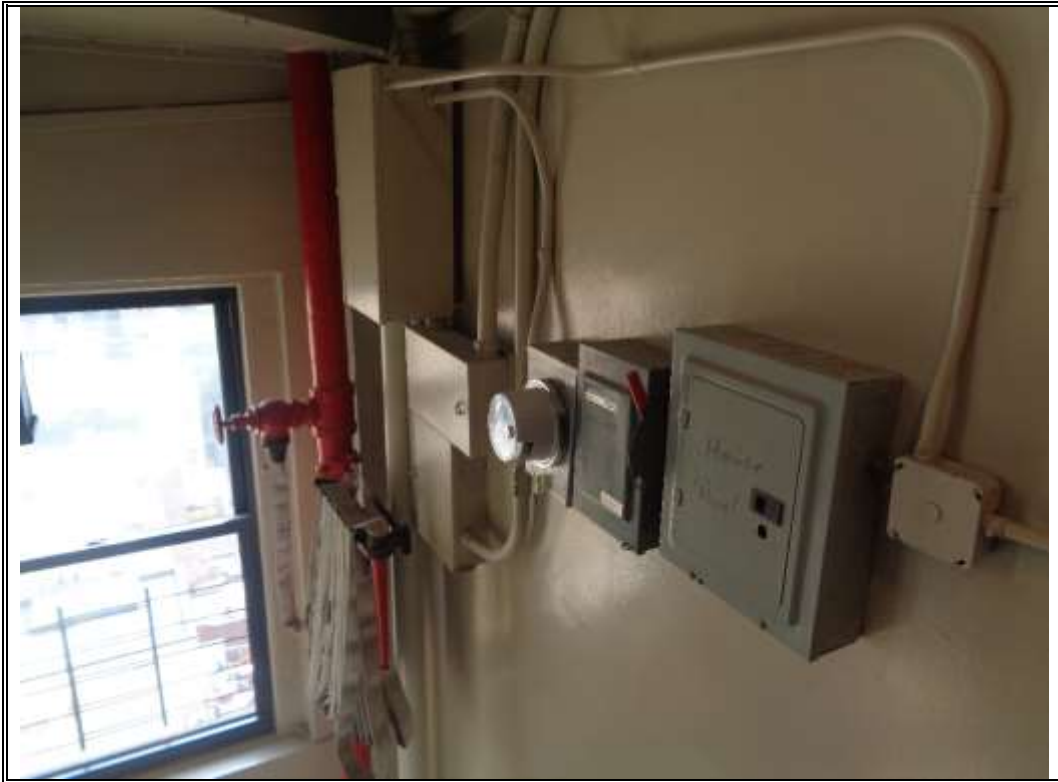
Photo 13 – View of electrical meter at the back stairs.

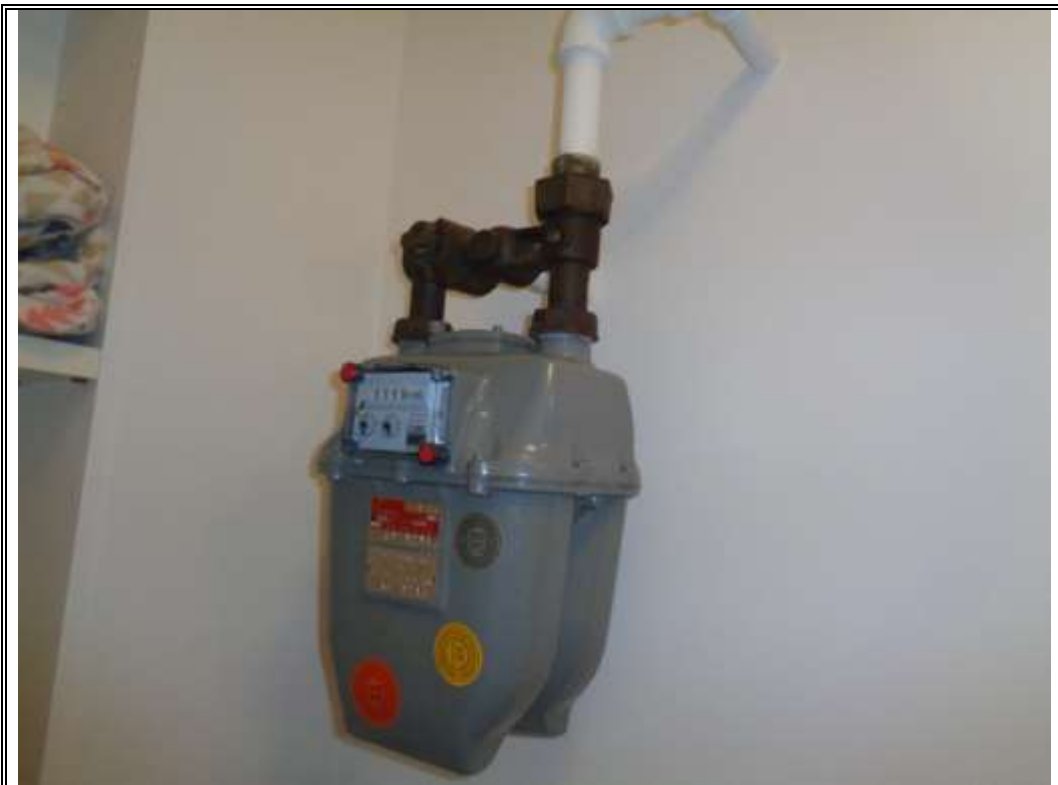
Photo 14 – View of a typical tenant gas meter.

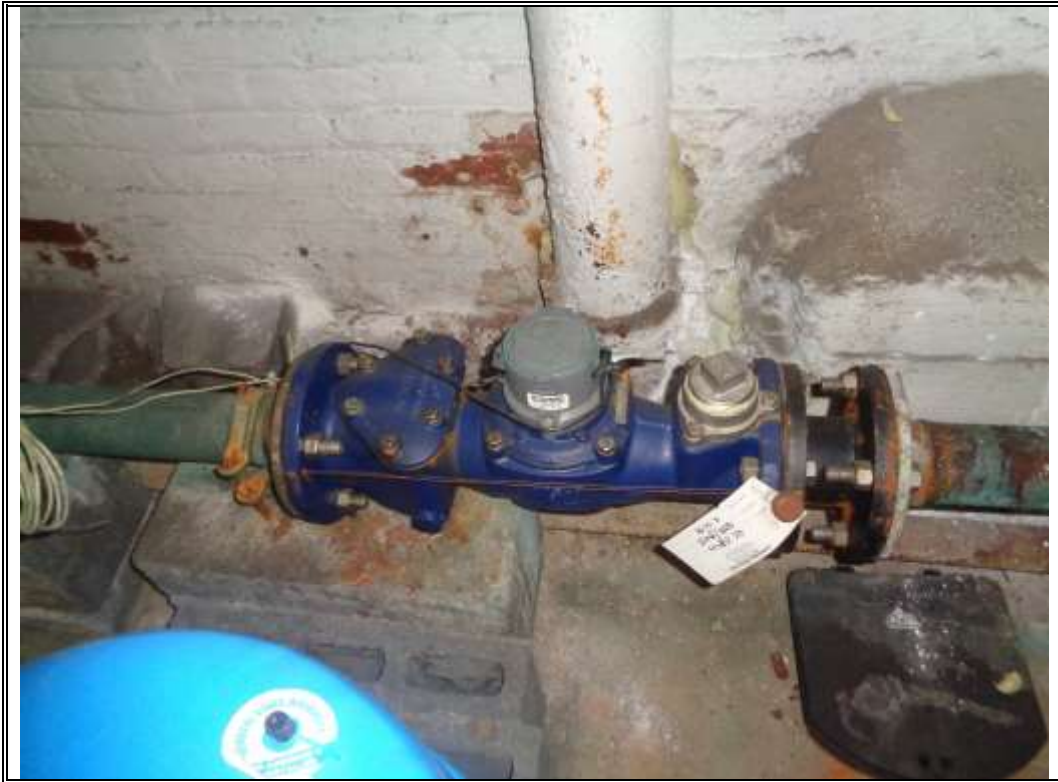
Photo 15 – View of the water meter located in 45 East 82<sup>nd</sup> Street.

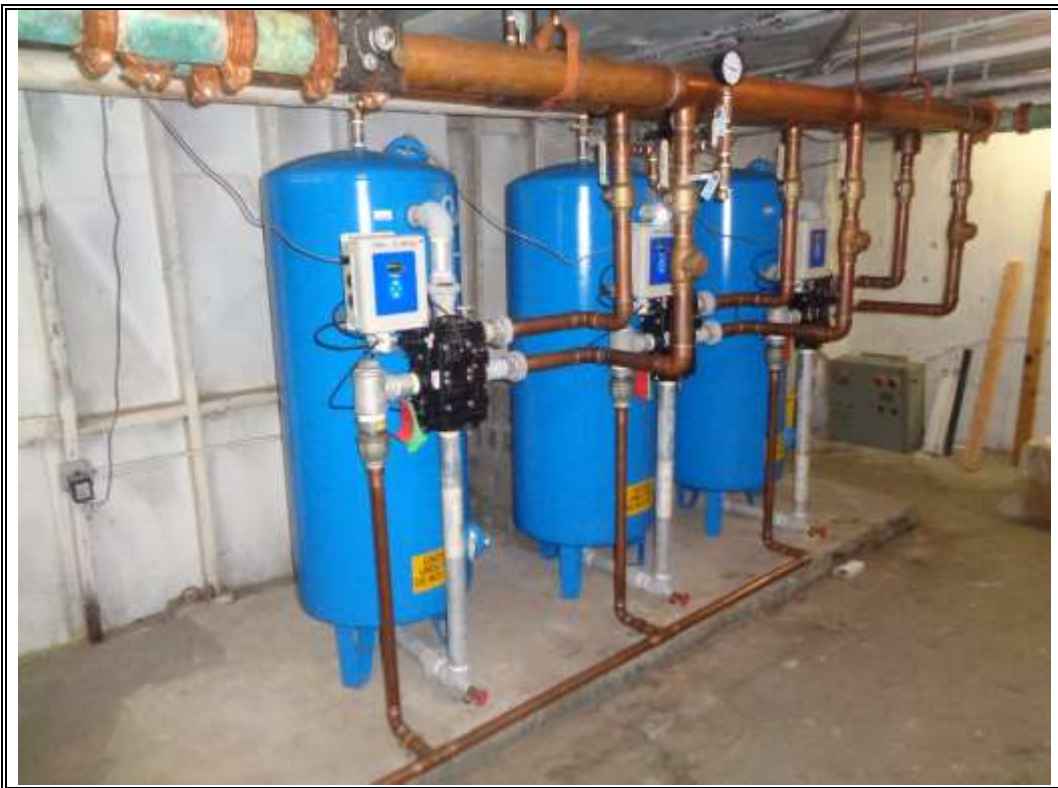
Photo 16 – View of the water pumps.

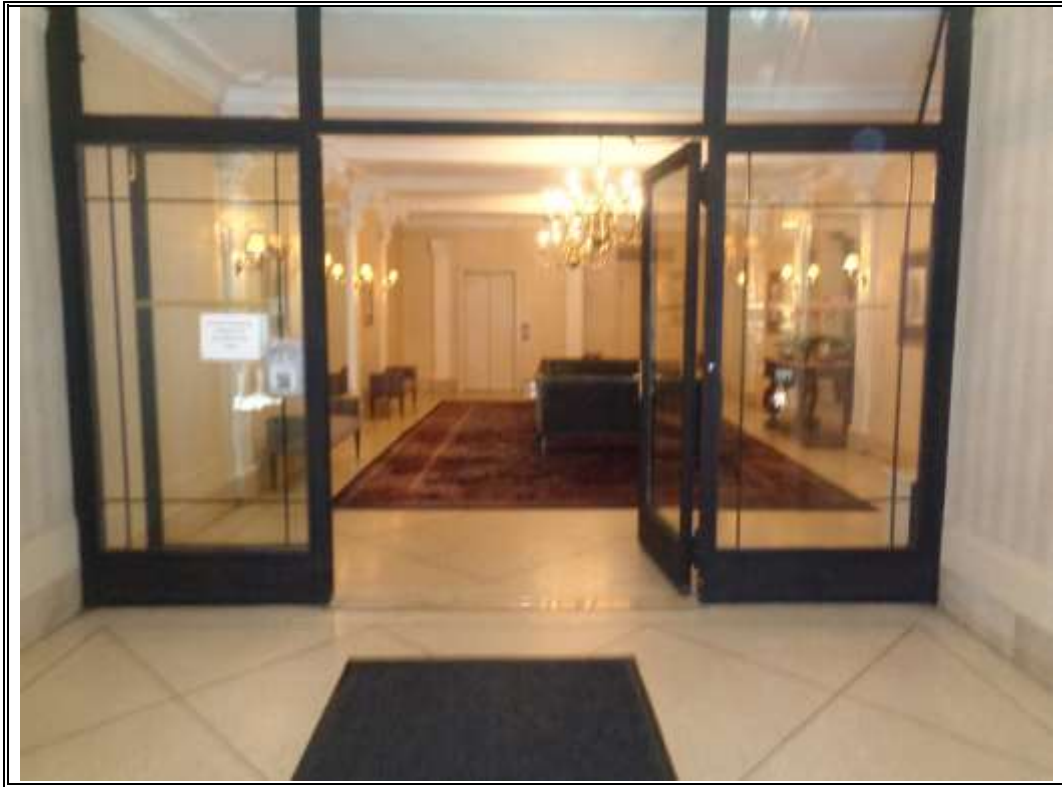
Photo 17 – View of the main entry at 45 East 82<sup>nd</sup> Street.

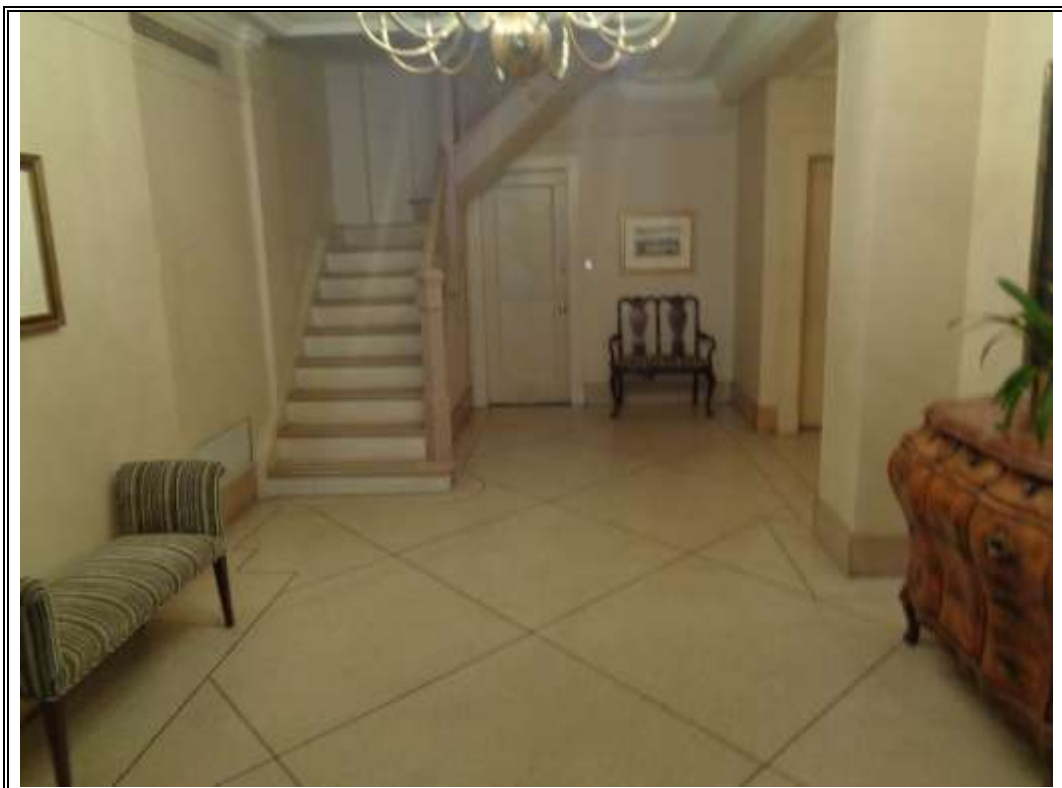
Photo 18 – View of the lobby at 40 East 83<sup>rd</sup> Street.

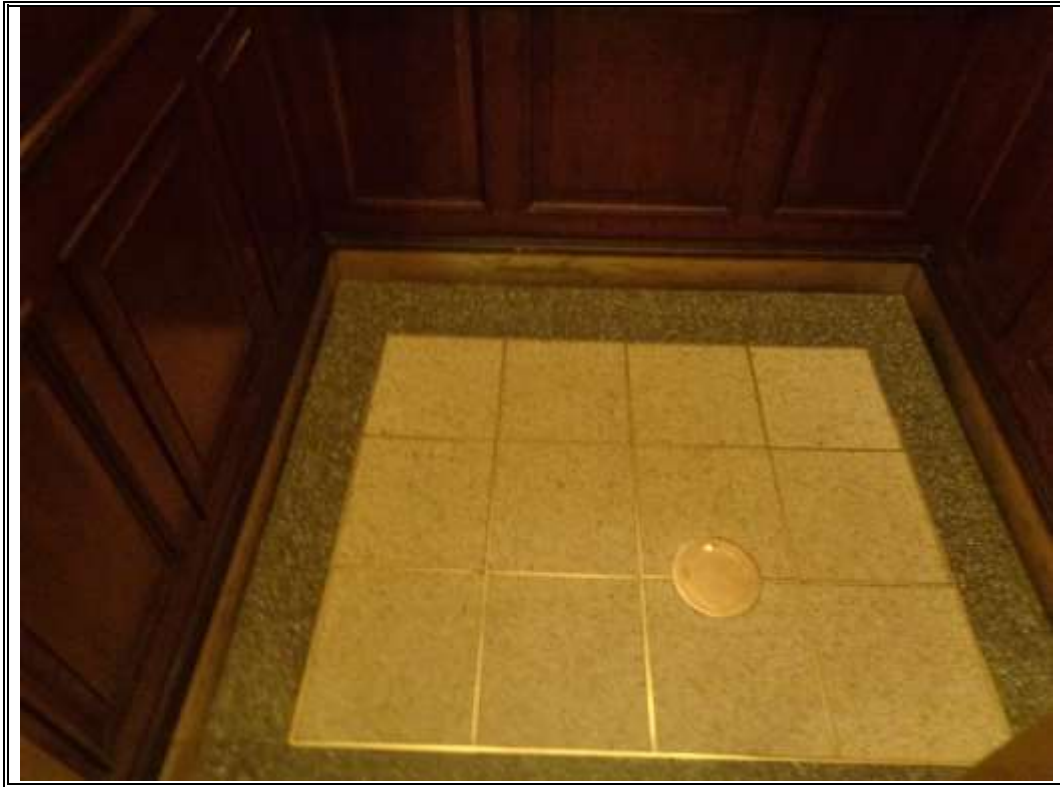
Photo 19 – View of typical elevator finishes.

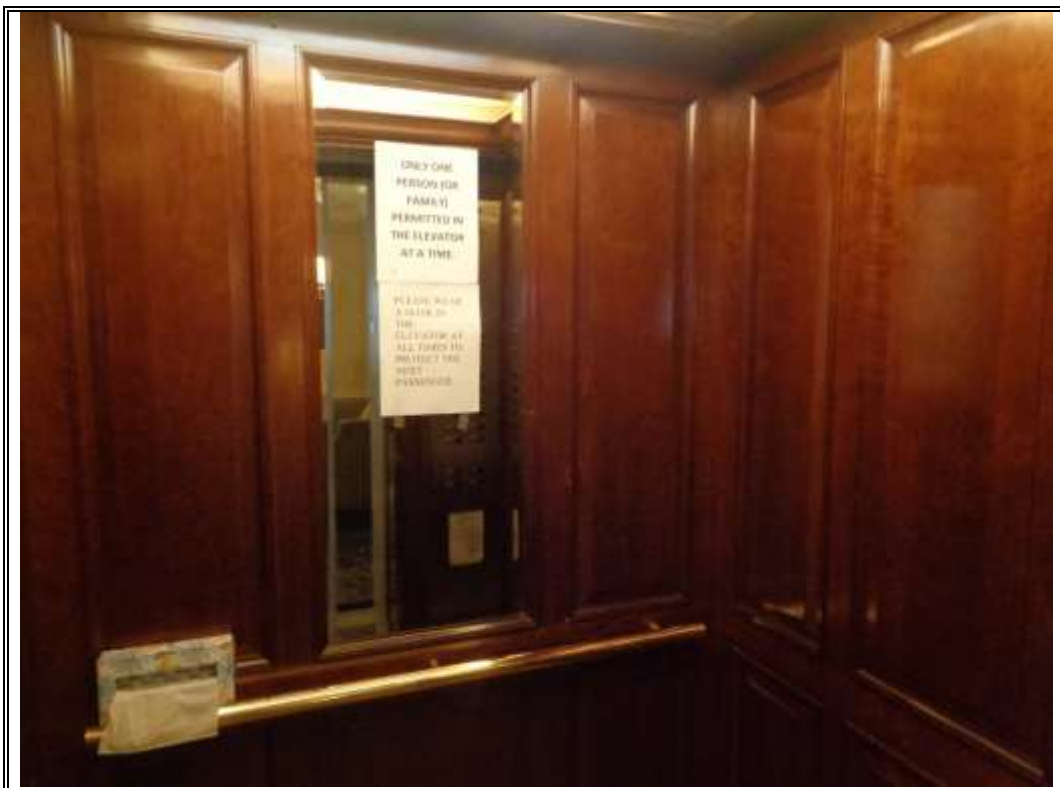
Photo 20 – View of typical elevator finishes.

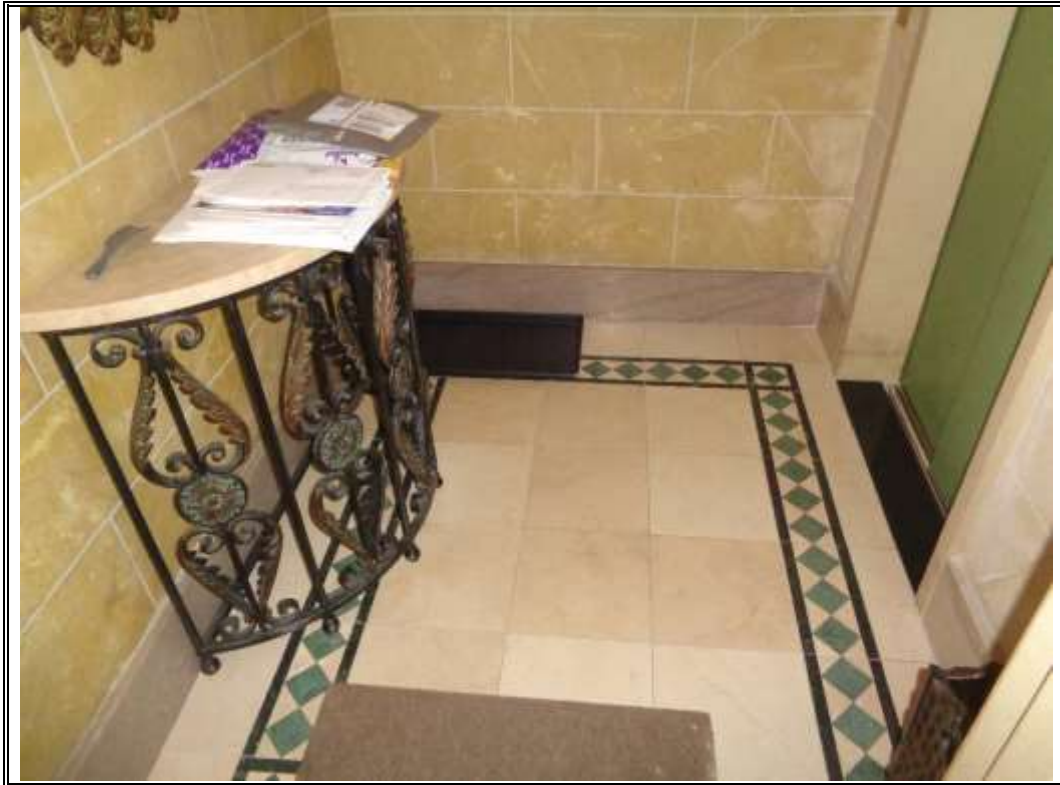
Photo 21 – View of a tenant-maintained elevator lobby.

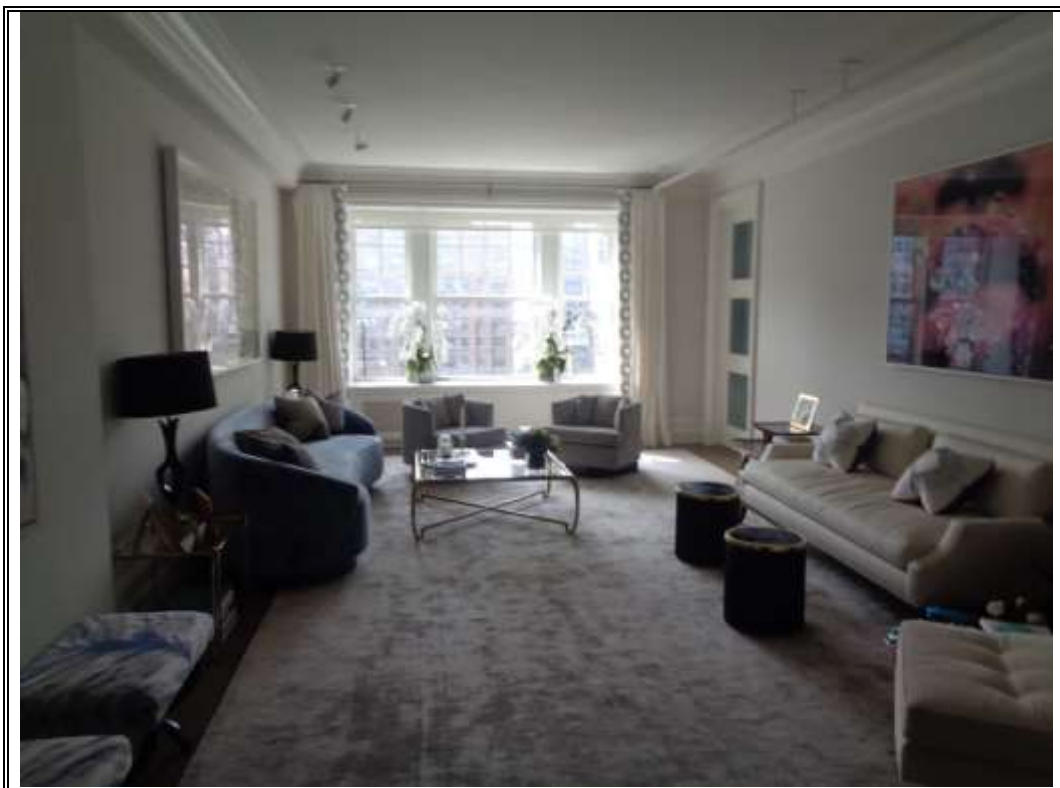
Photo 22 – View of a living room.

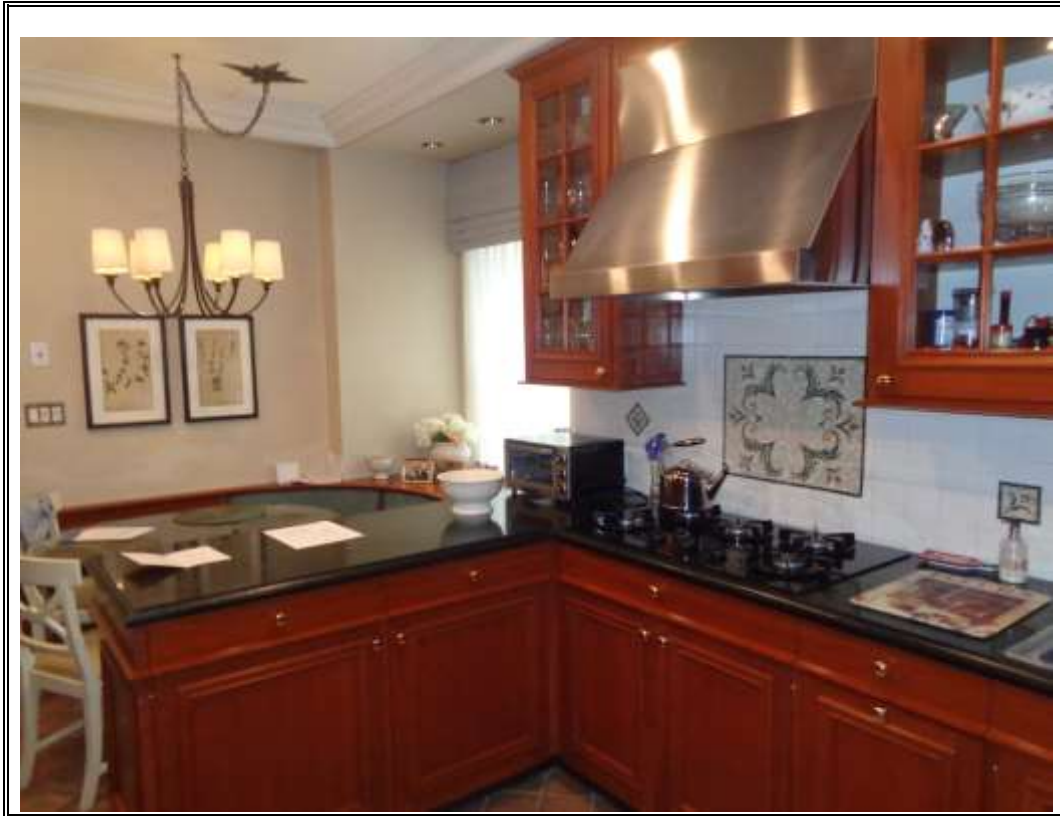
Photo 23 – View of a unit kitchen.

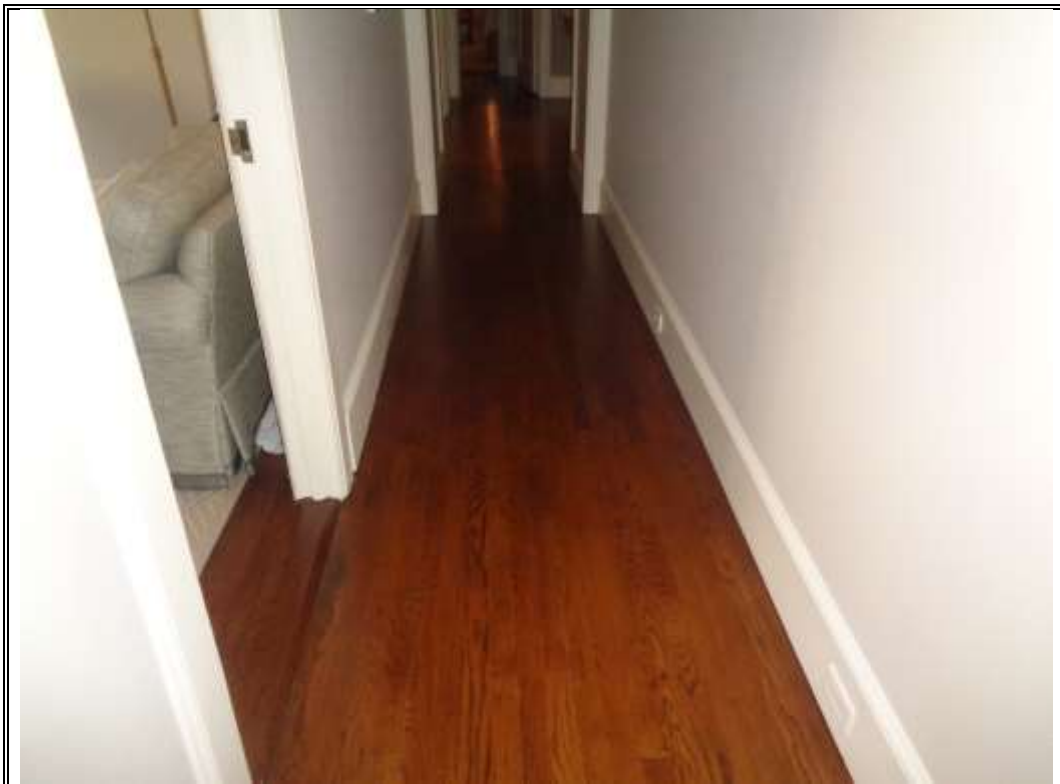
Photo 24 – View of a hallway.

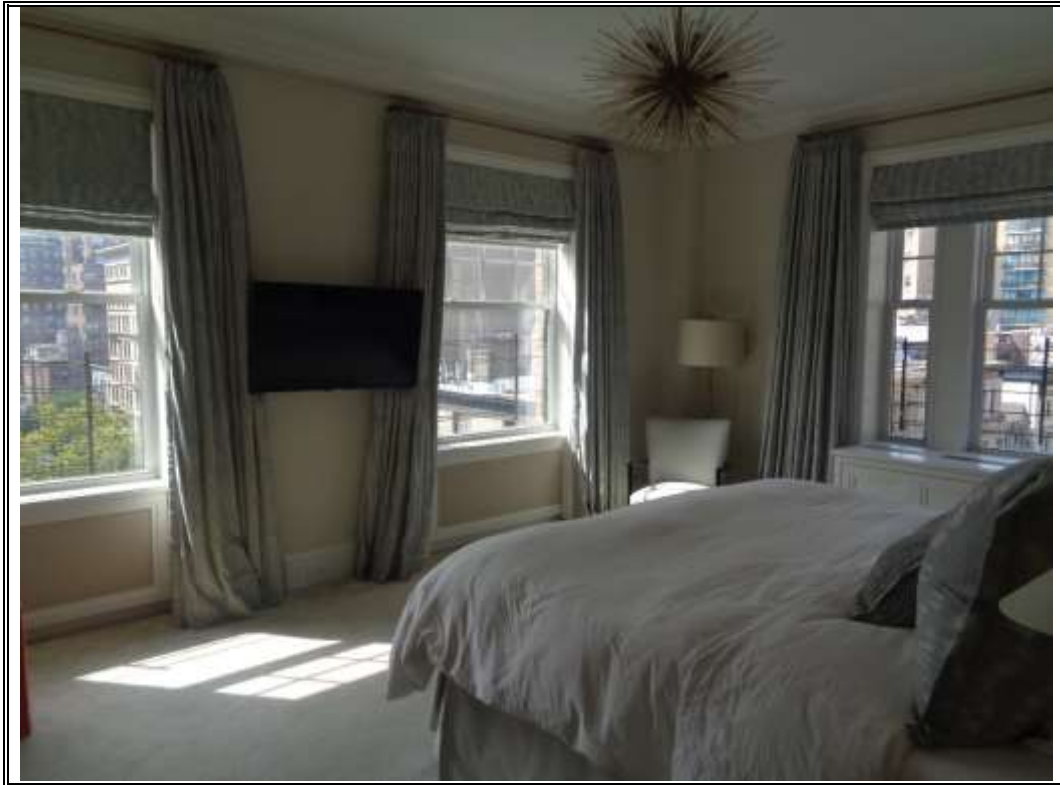
Photo 25 – View of a unit bedroom.

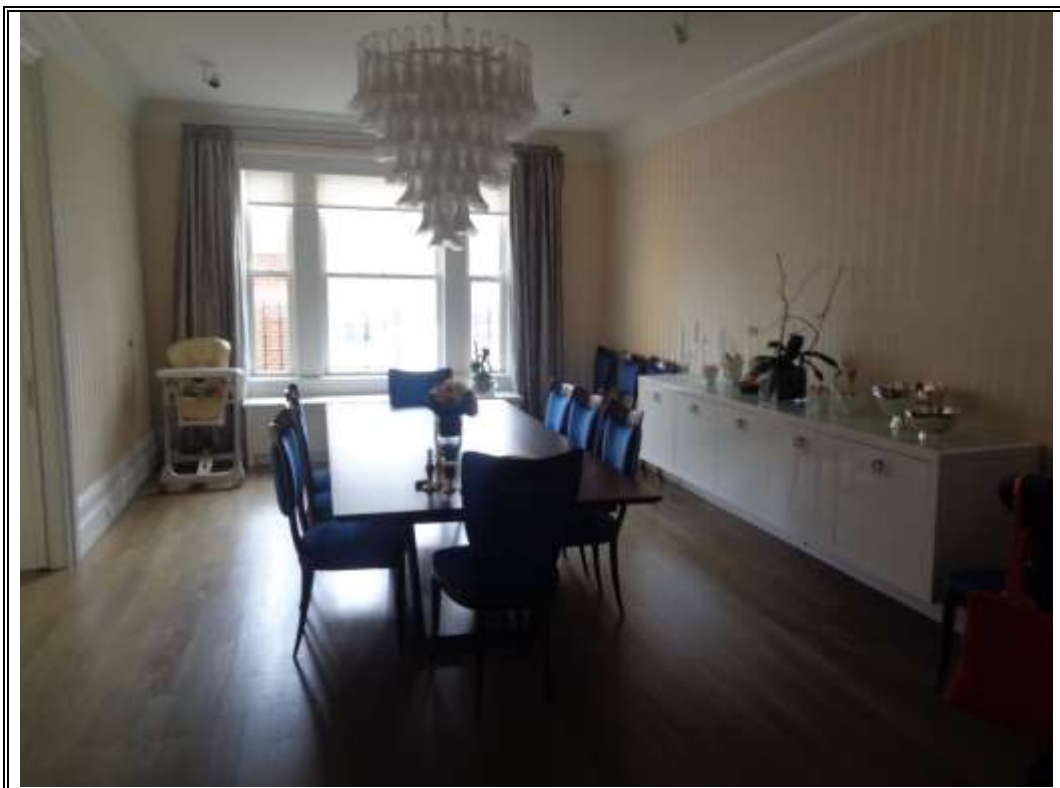
Photo 26 – View of a dining room.

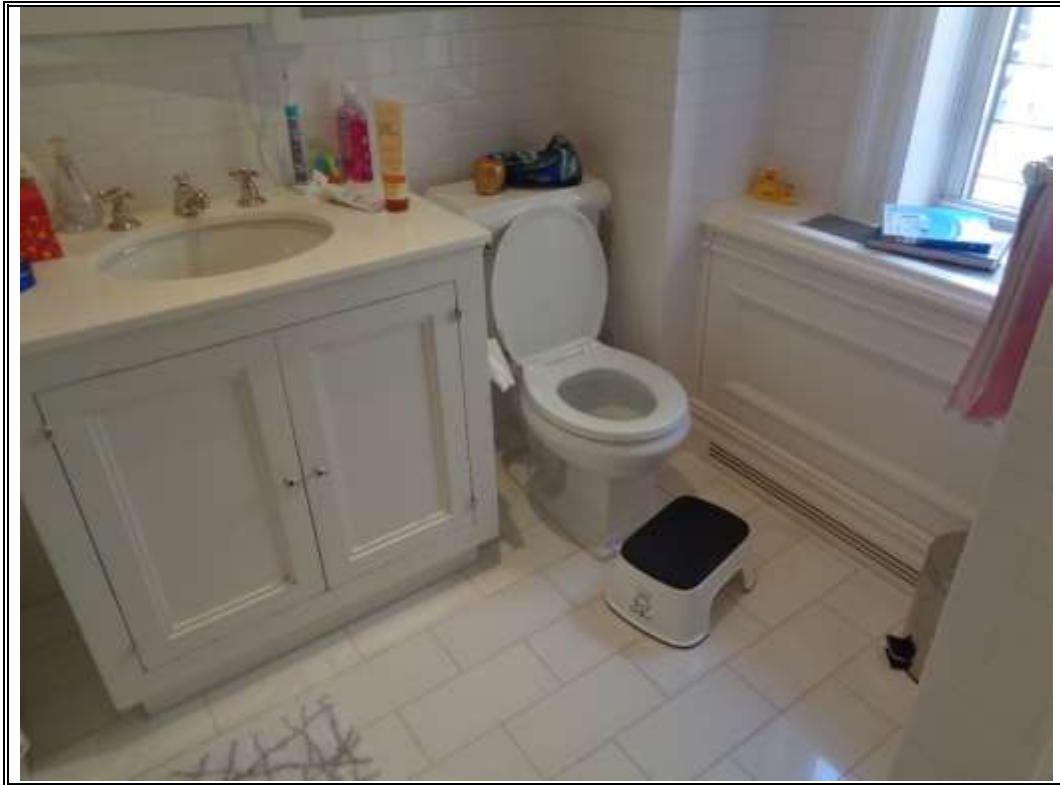
Photo 27 – View of a unit bathroom.
