## Property Condition Report (PCR)

For the Project:  
**123 E 4th Street**  
**New York, NY**  
**KOW Job 2020-000**

Inspection Date:  
**9/25/2020**

Report Date:  
**9/30/2020**

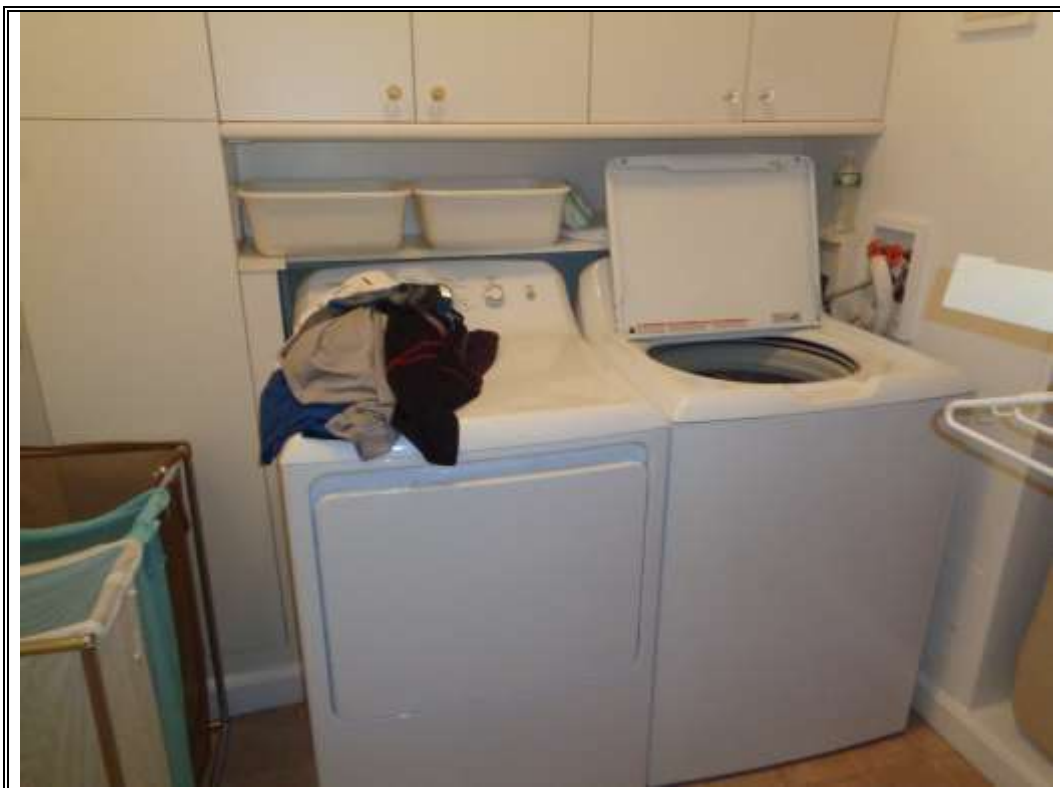
Photo 28 – View of a unit's laundry area.
