# Budget Review

**Lori Place  
123 Main Street  
Los Angeles, California 91604**

# Budget Review Report

**Project:**  
Lori Place

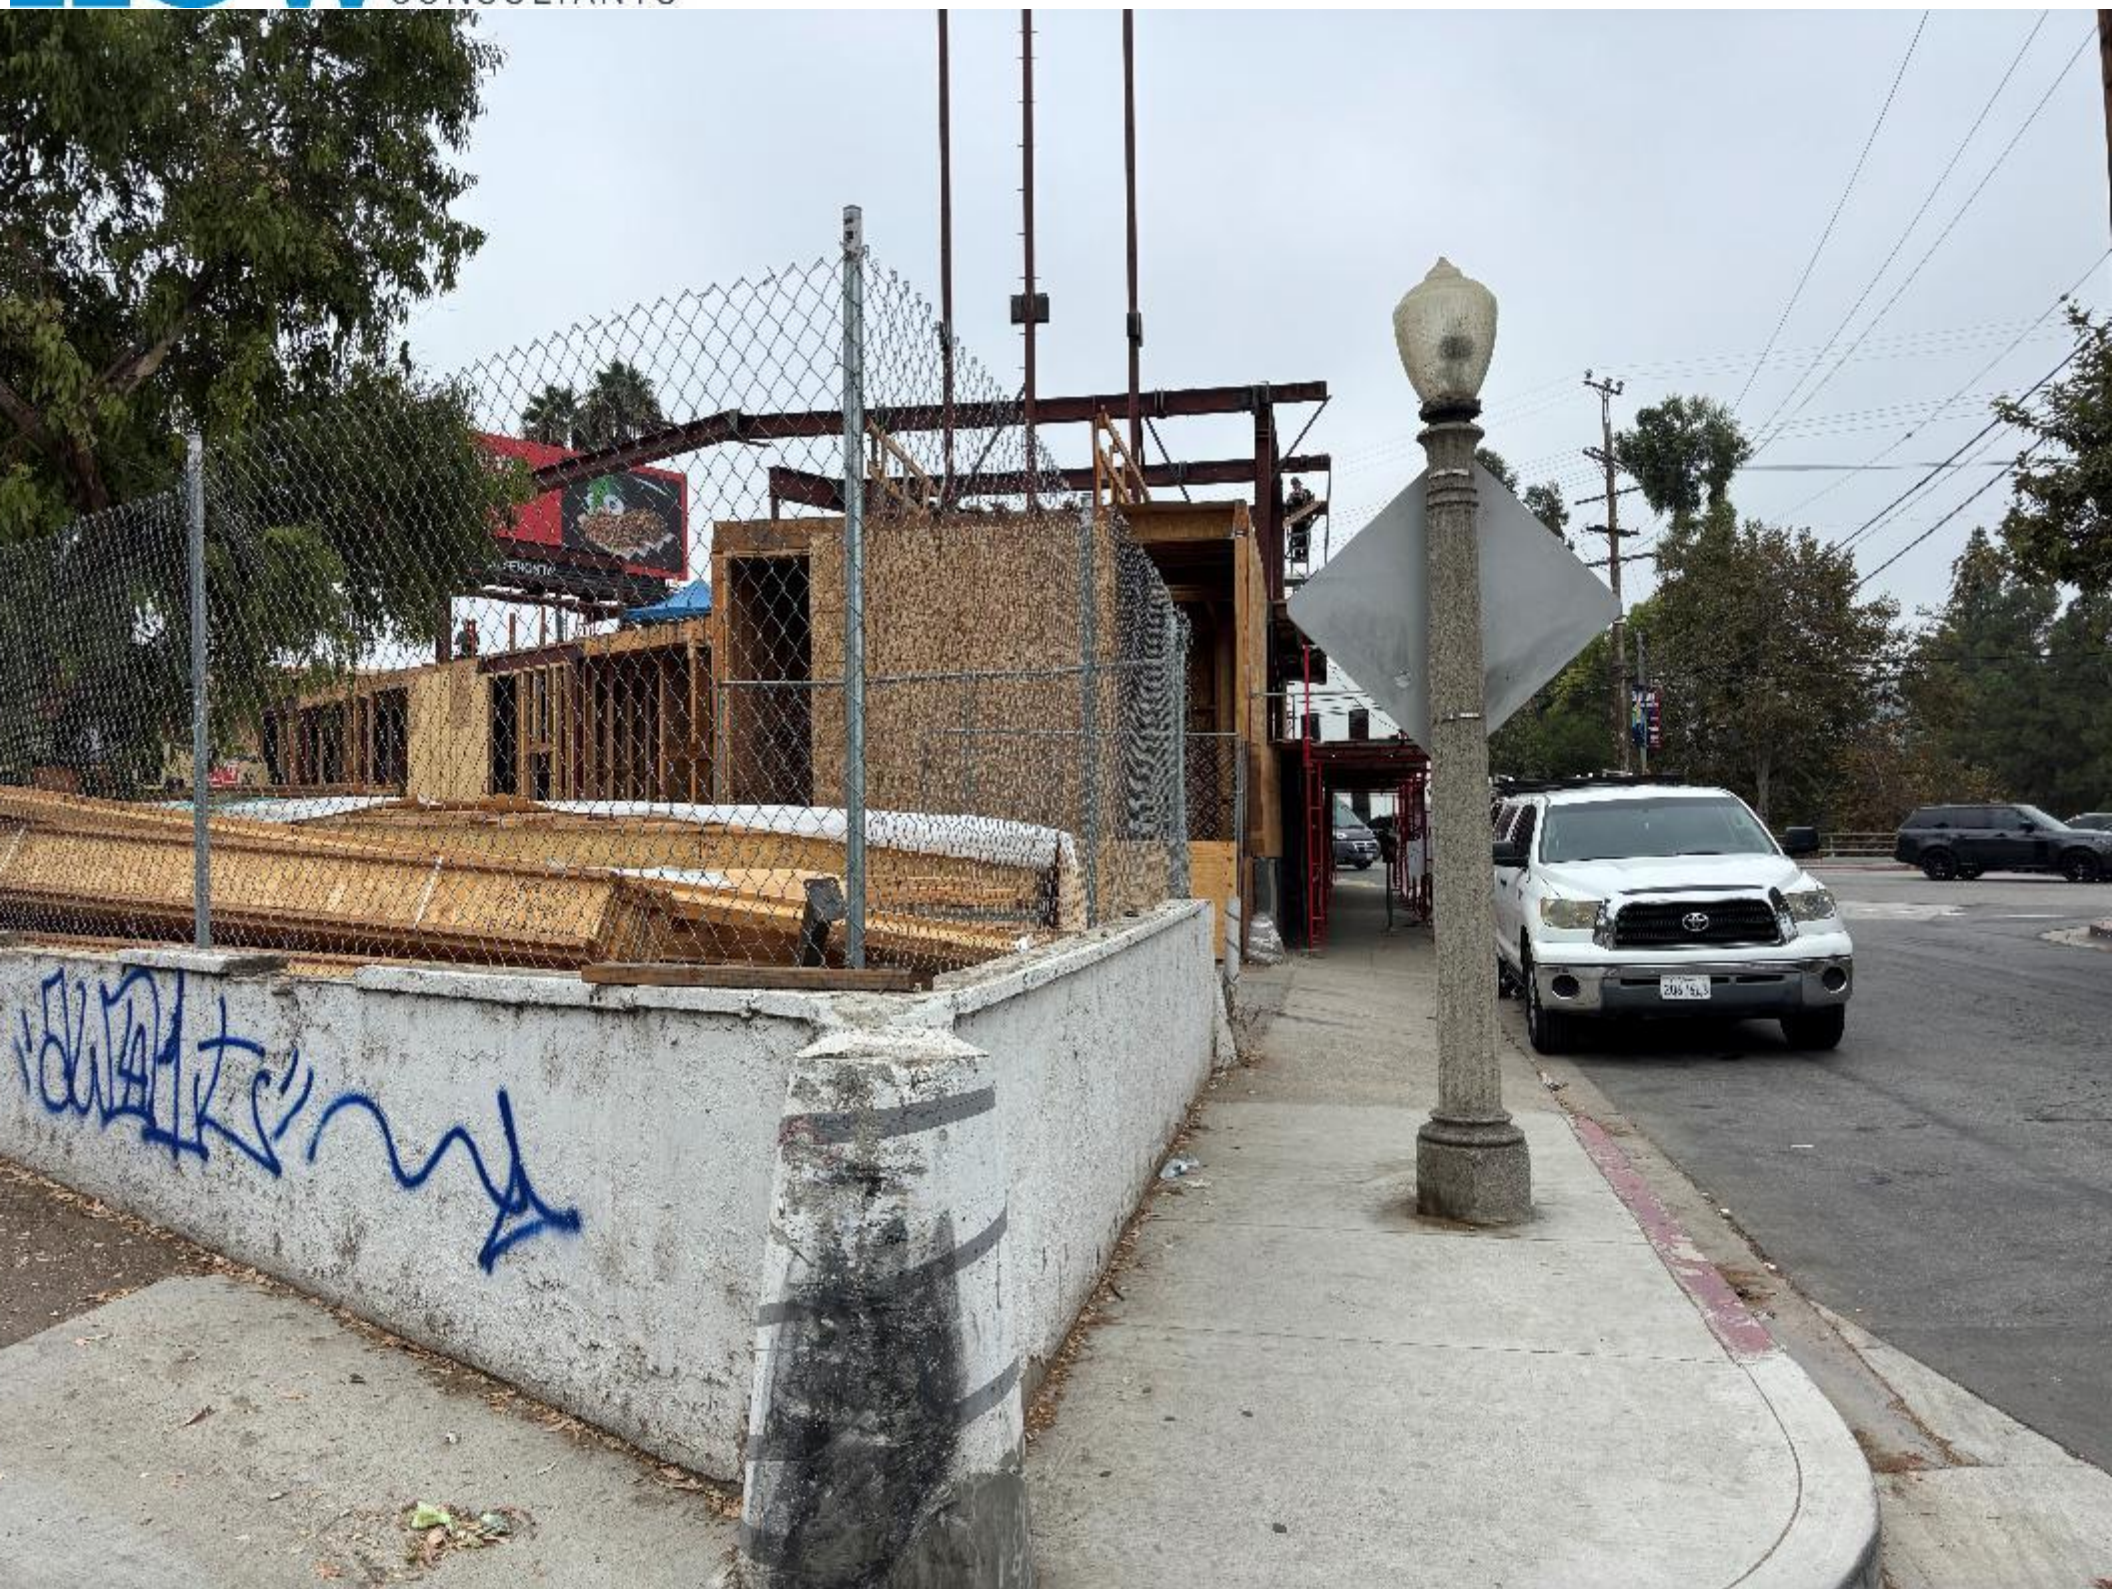
**Photo 2**

View of the back side of the site looking southwest..

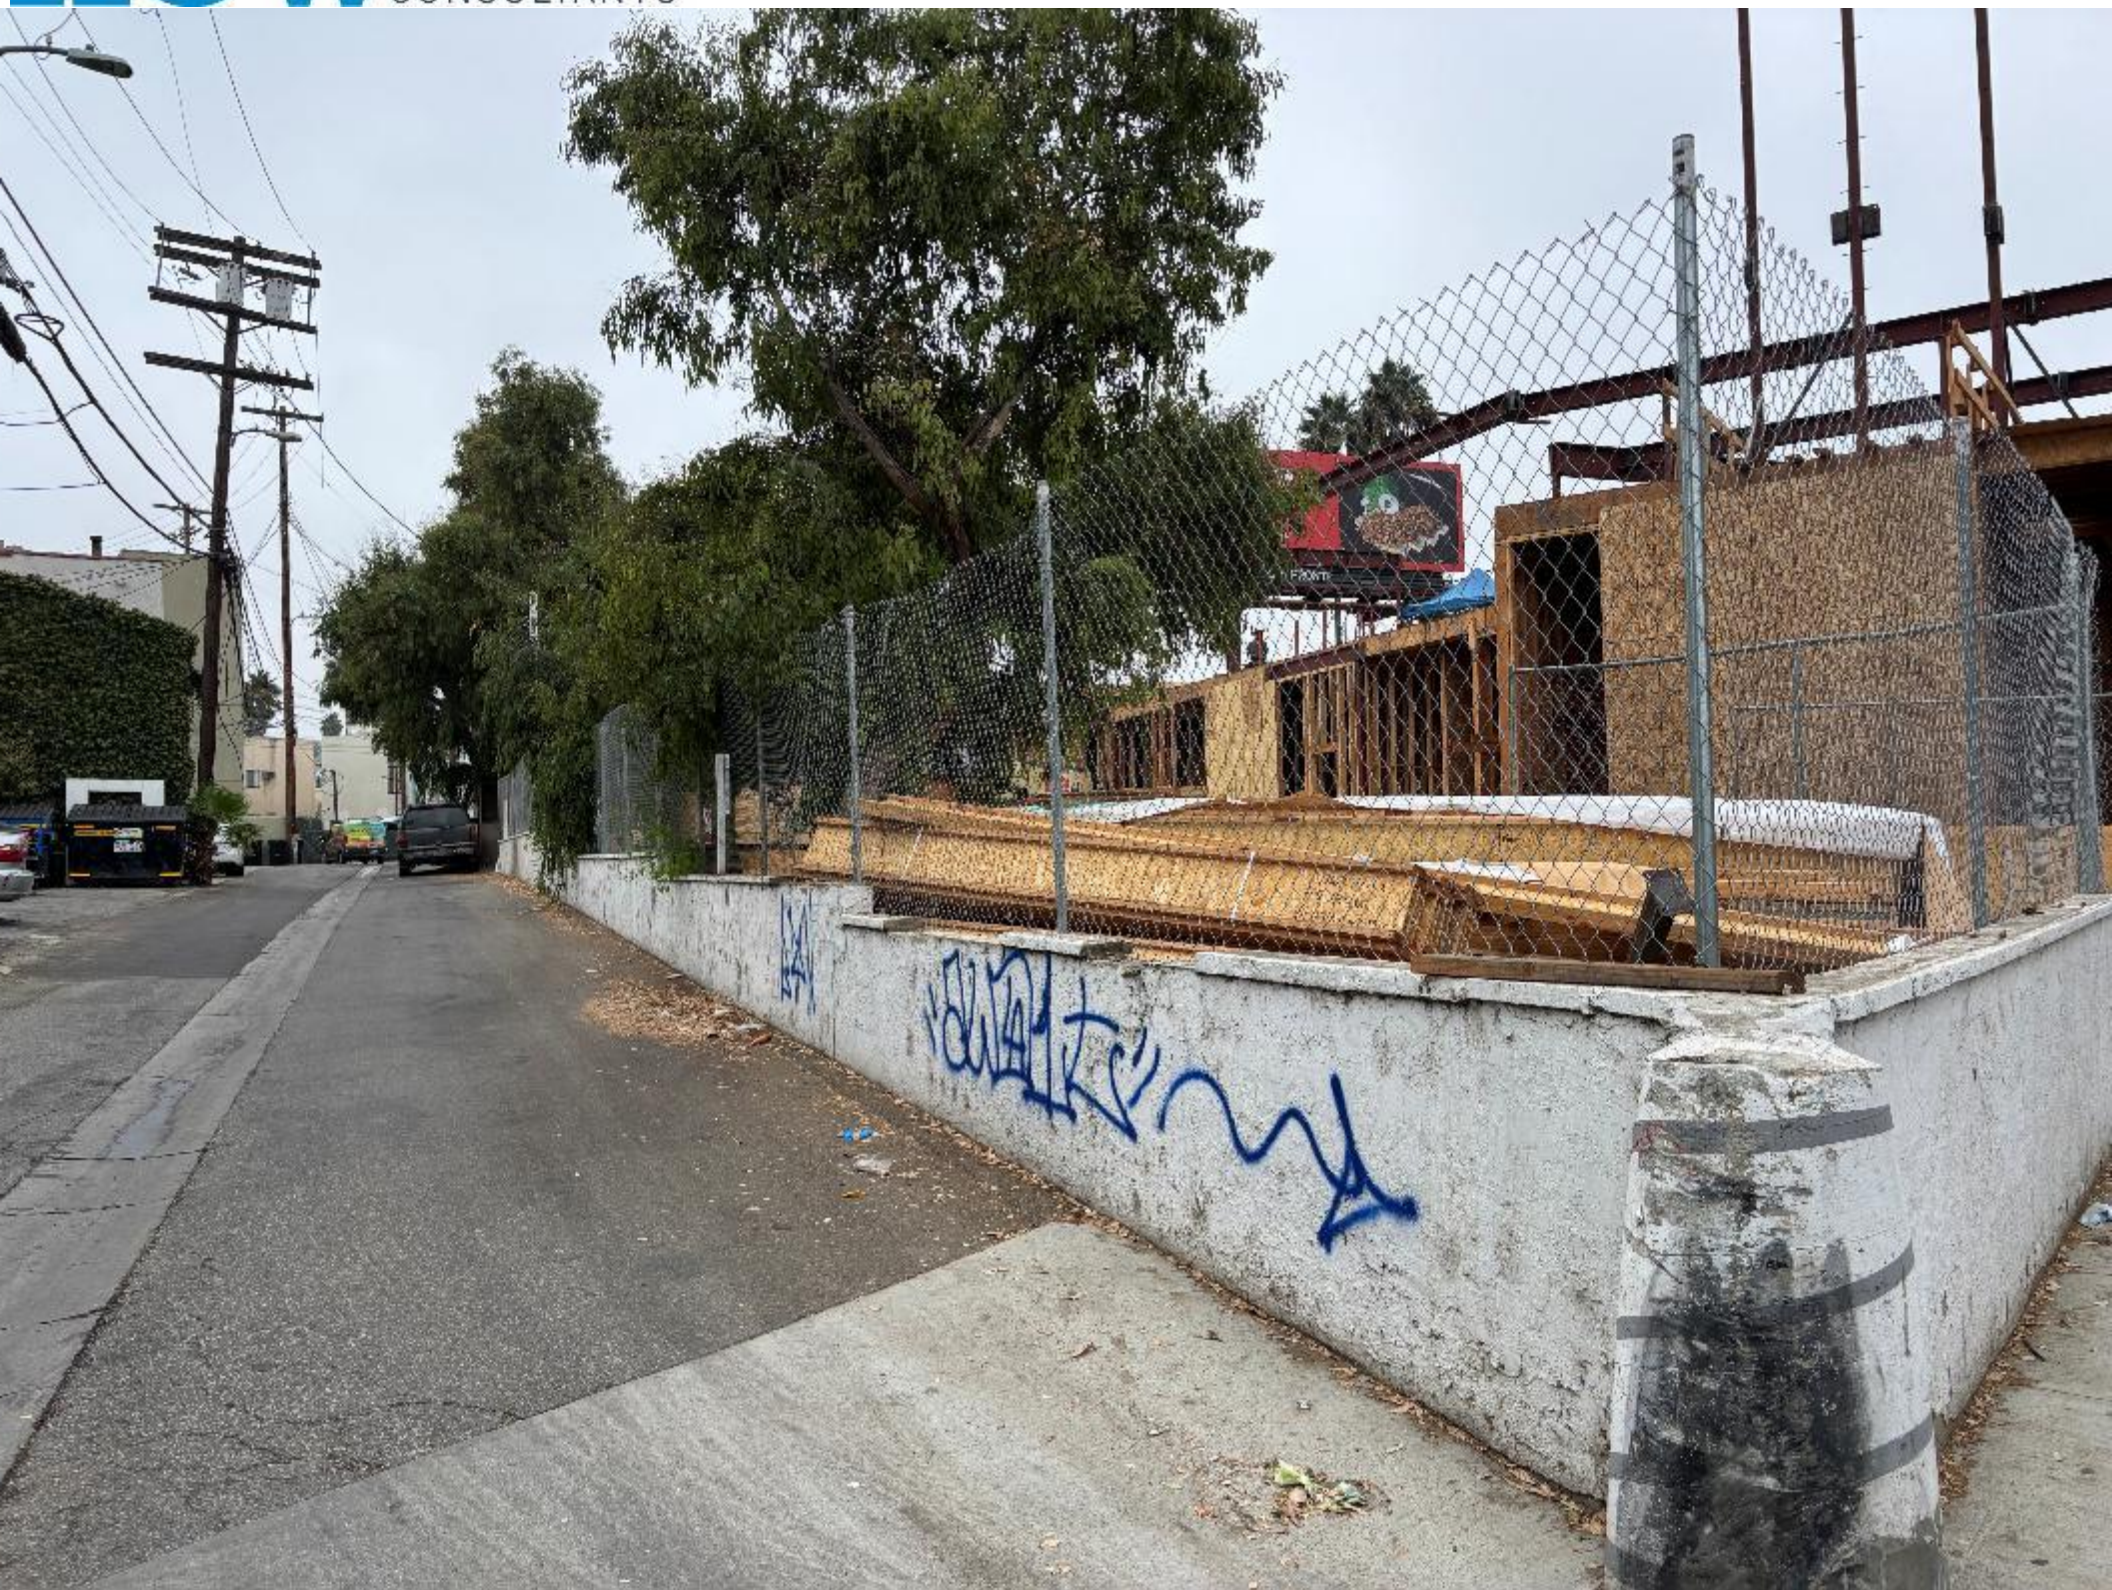
**Photo 3**

View of the back side of the site facing southeast along the alley.

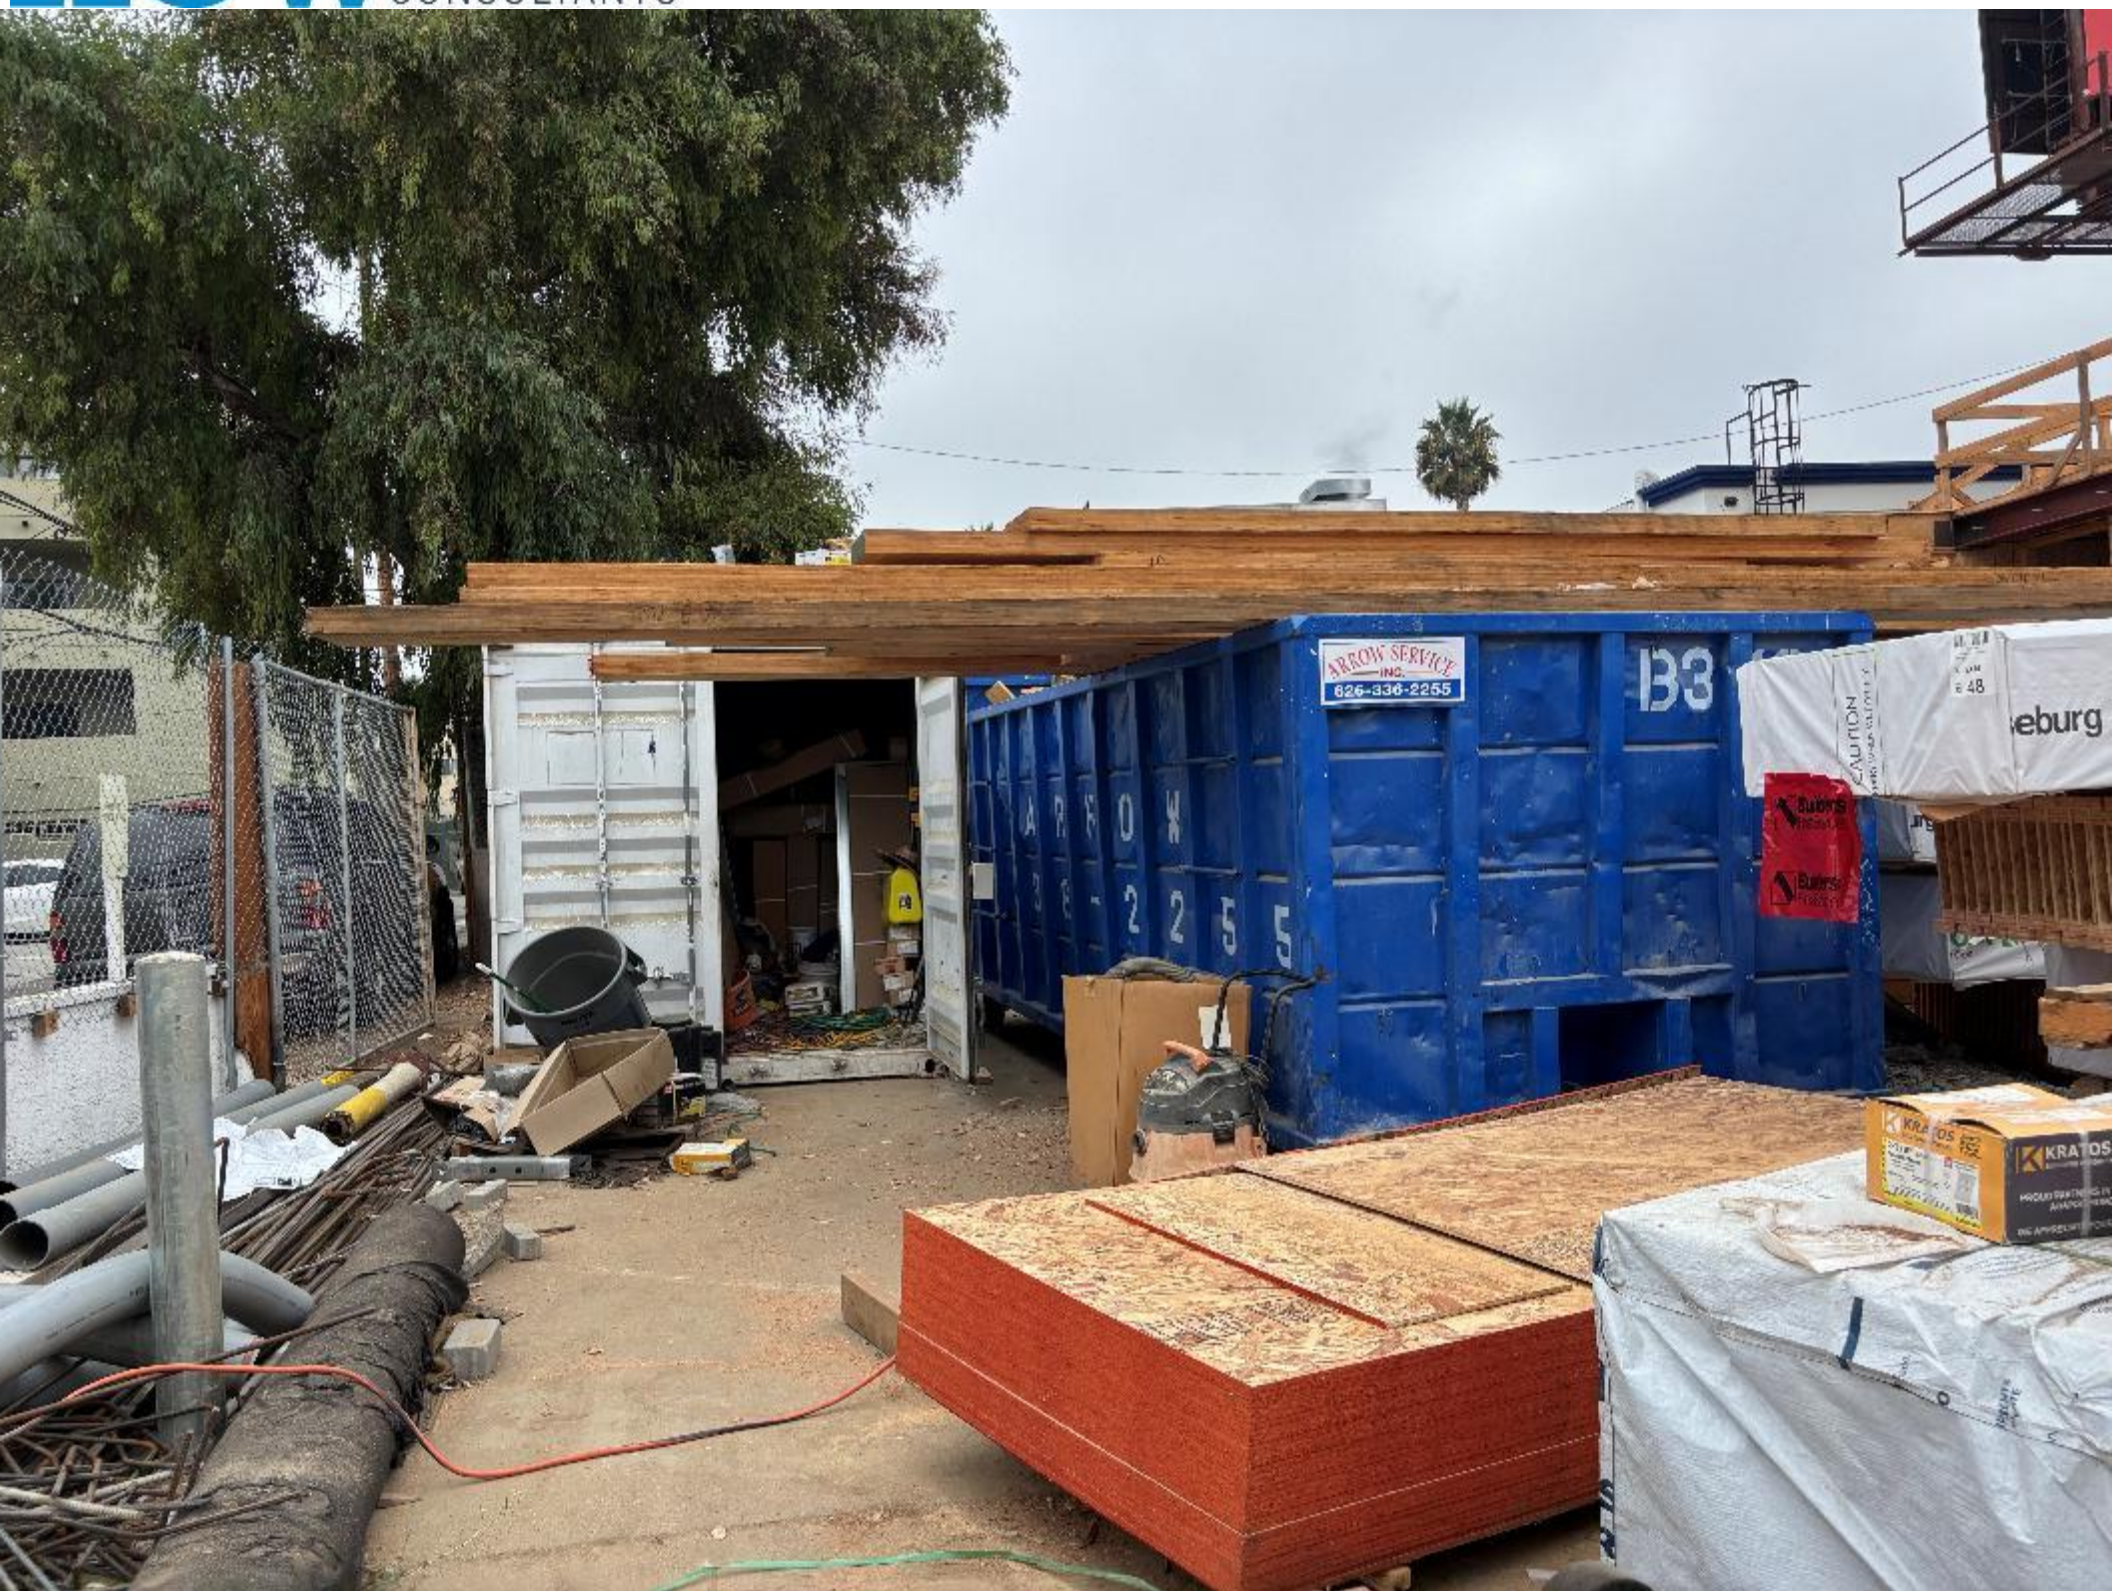
**Photo 4**

Dumpster, Storage container and framing materials on site at rear parking lot of the property.

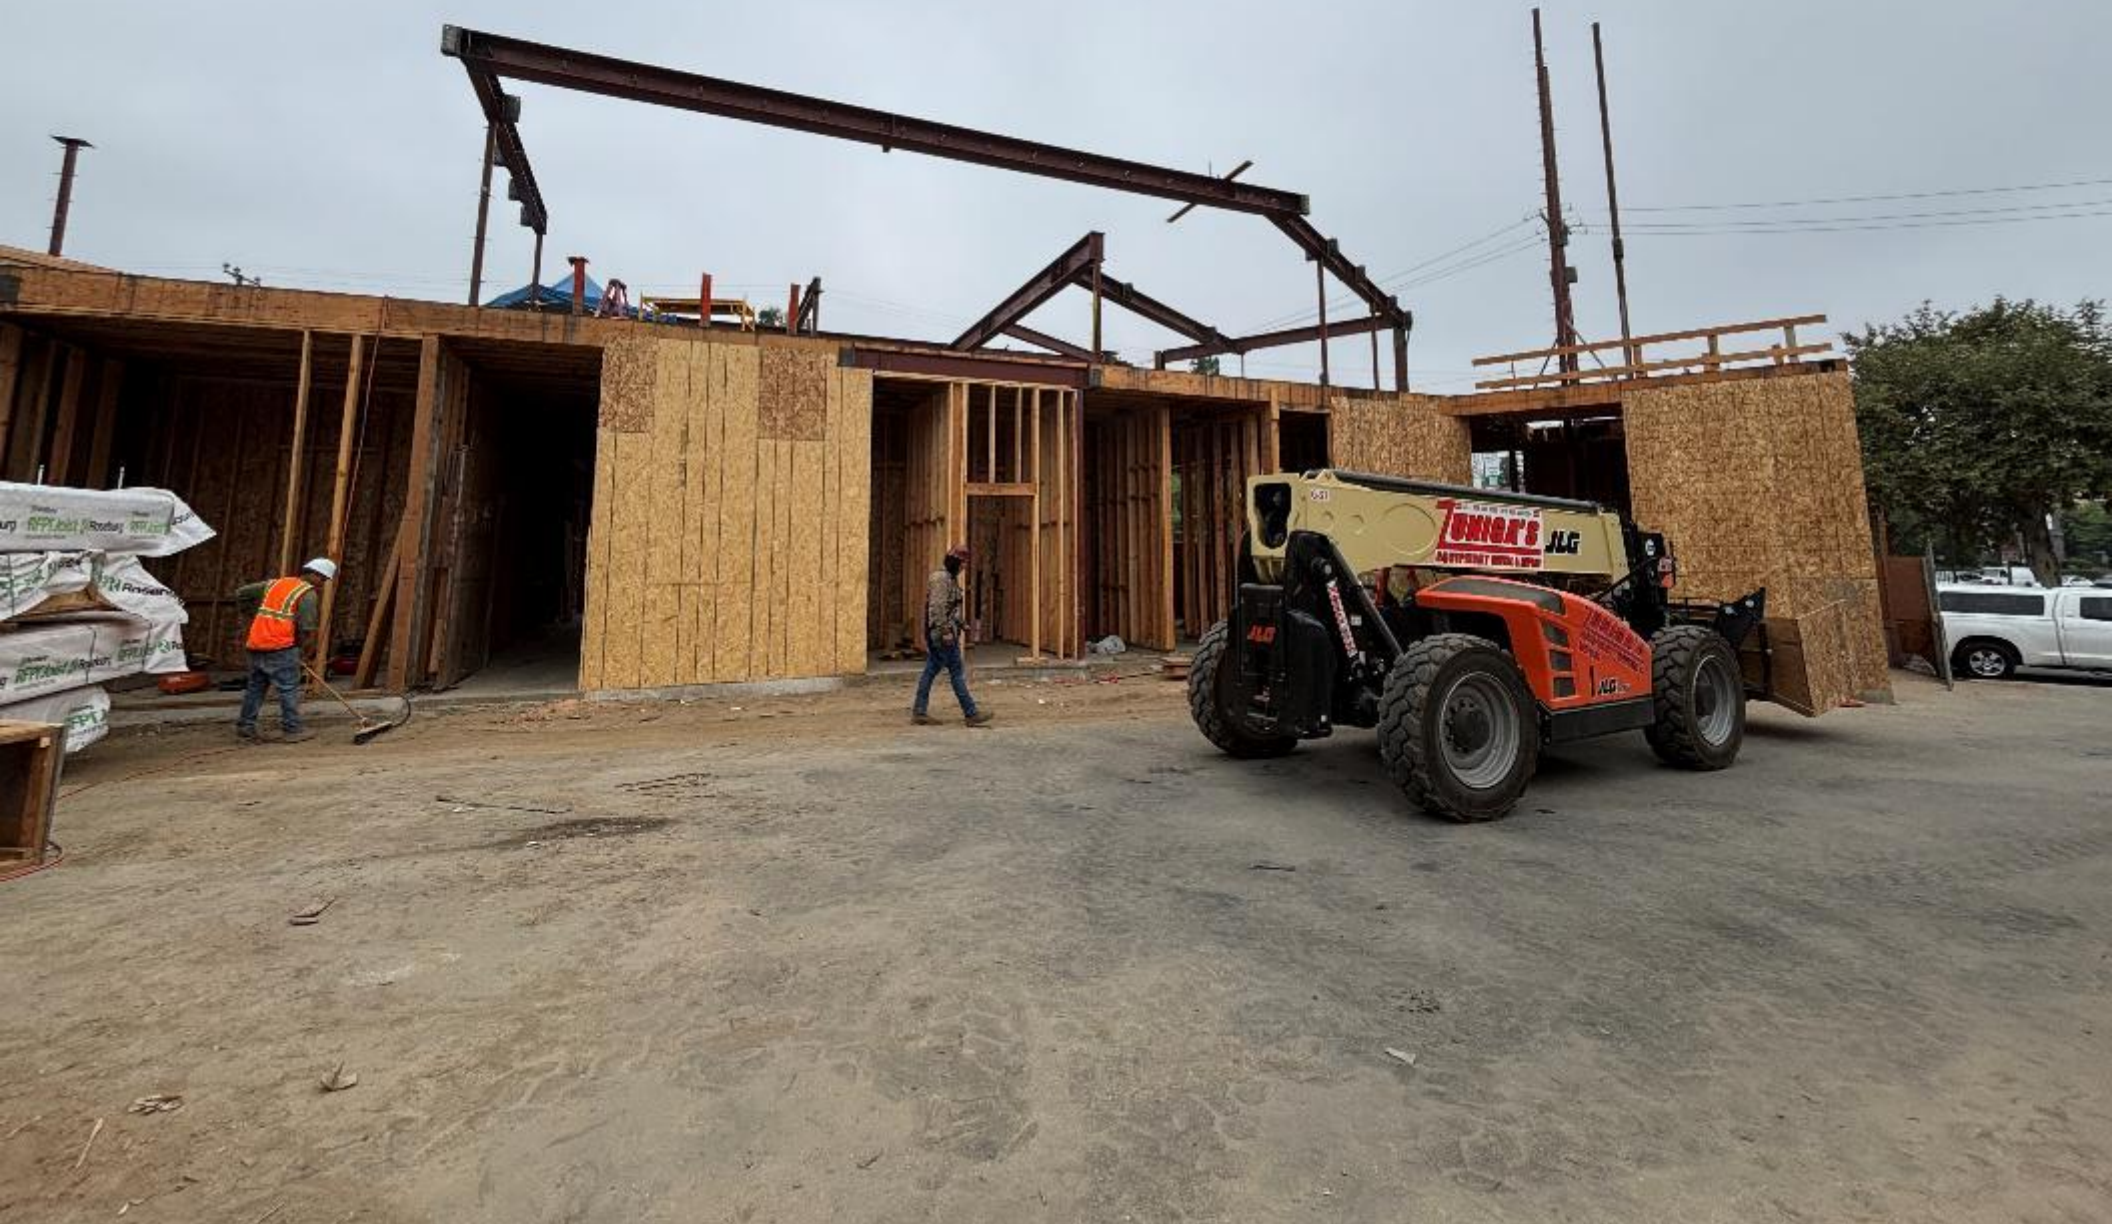
**Photo 5**

Site view from the rear parking lot facing southwest. Framing advanced at the first floor, structural steel advancing.

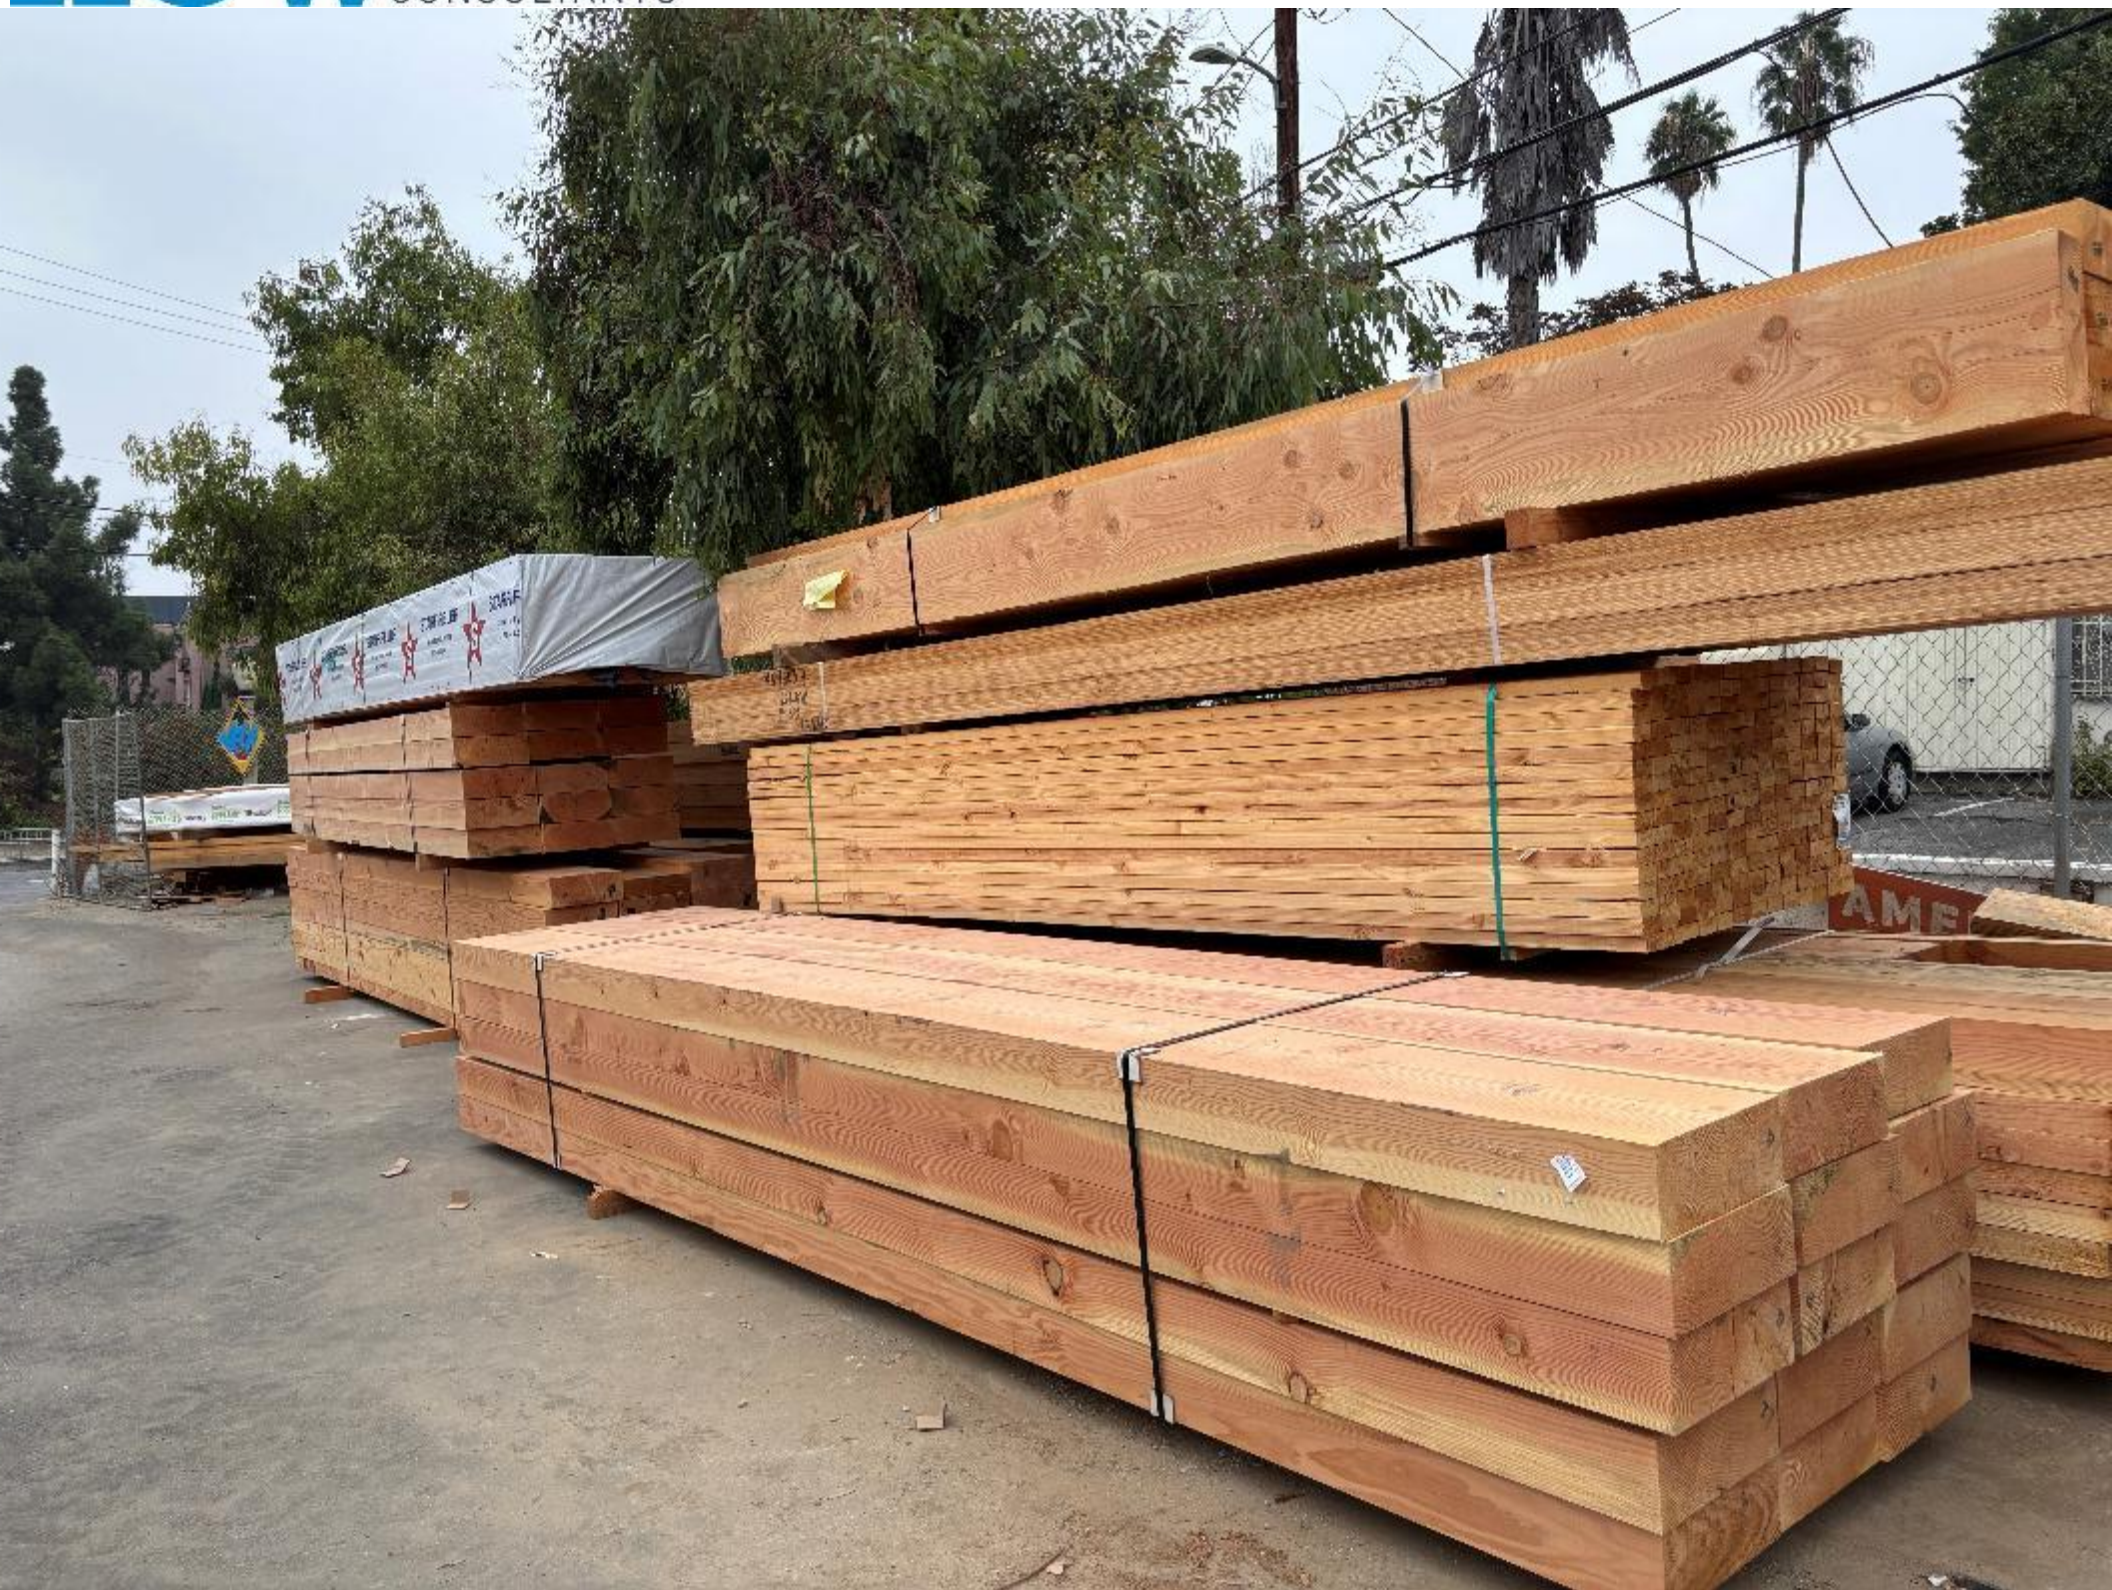
**Photo 6**

Additional framing materials staged for installation.

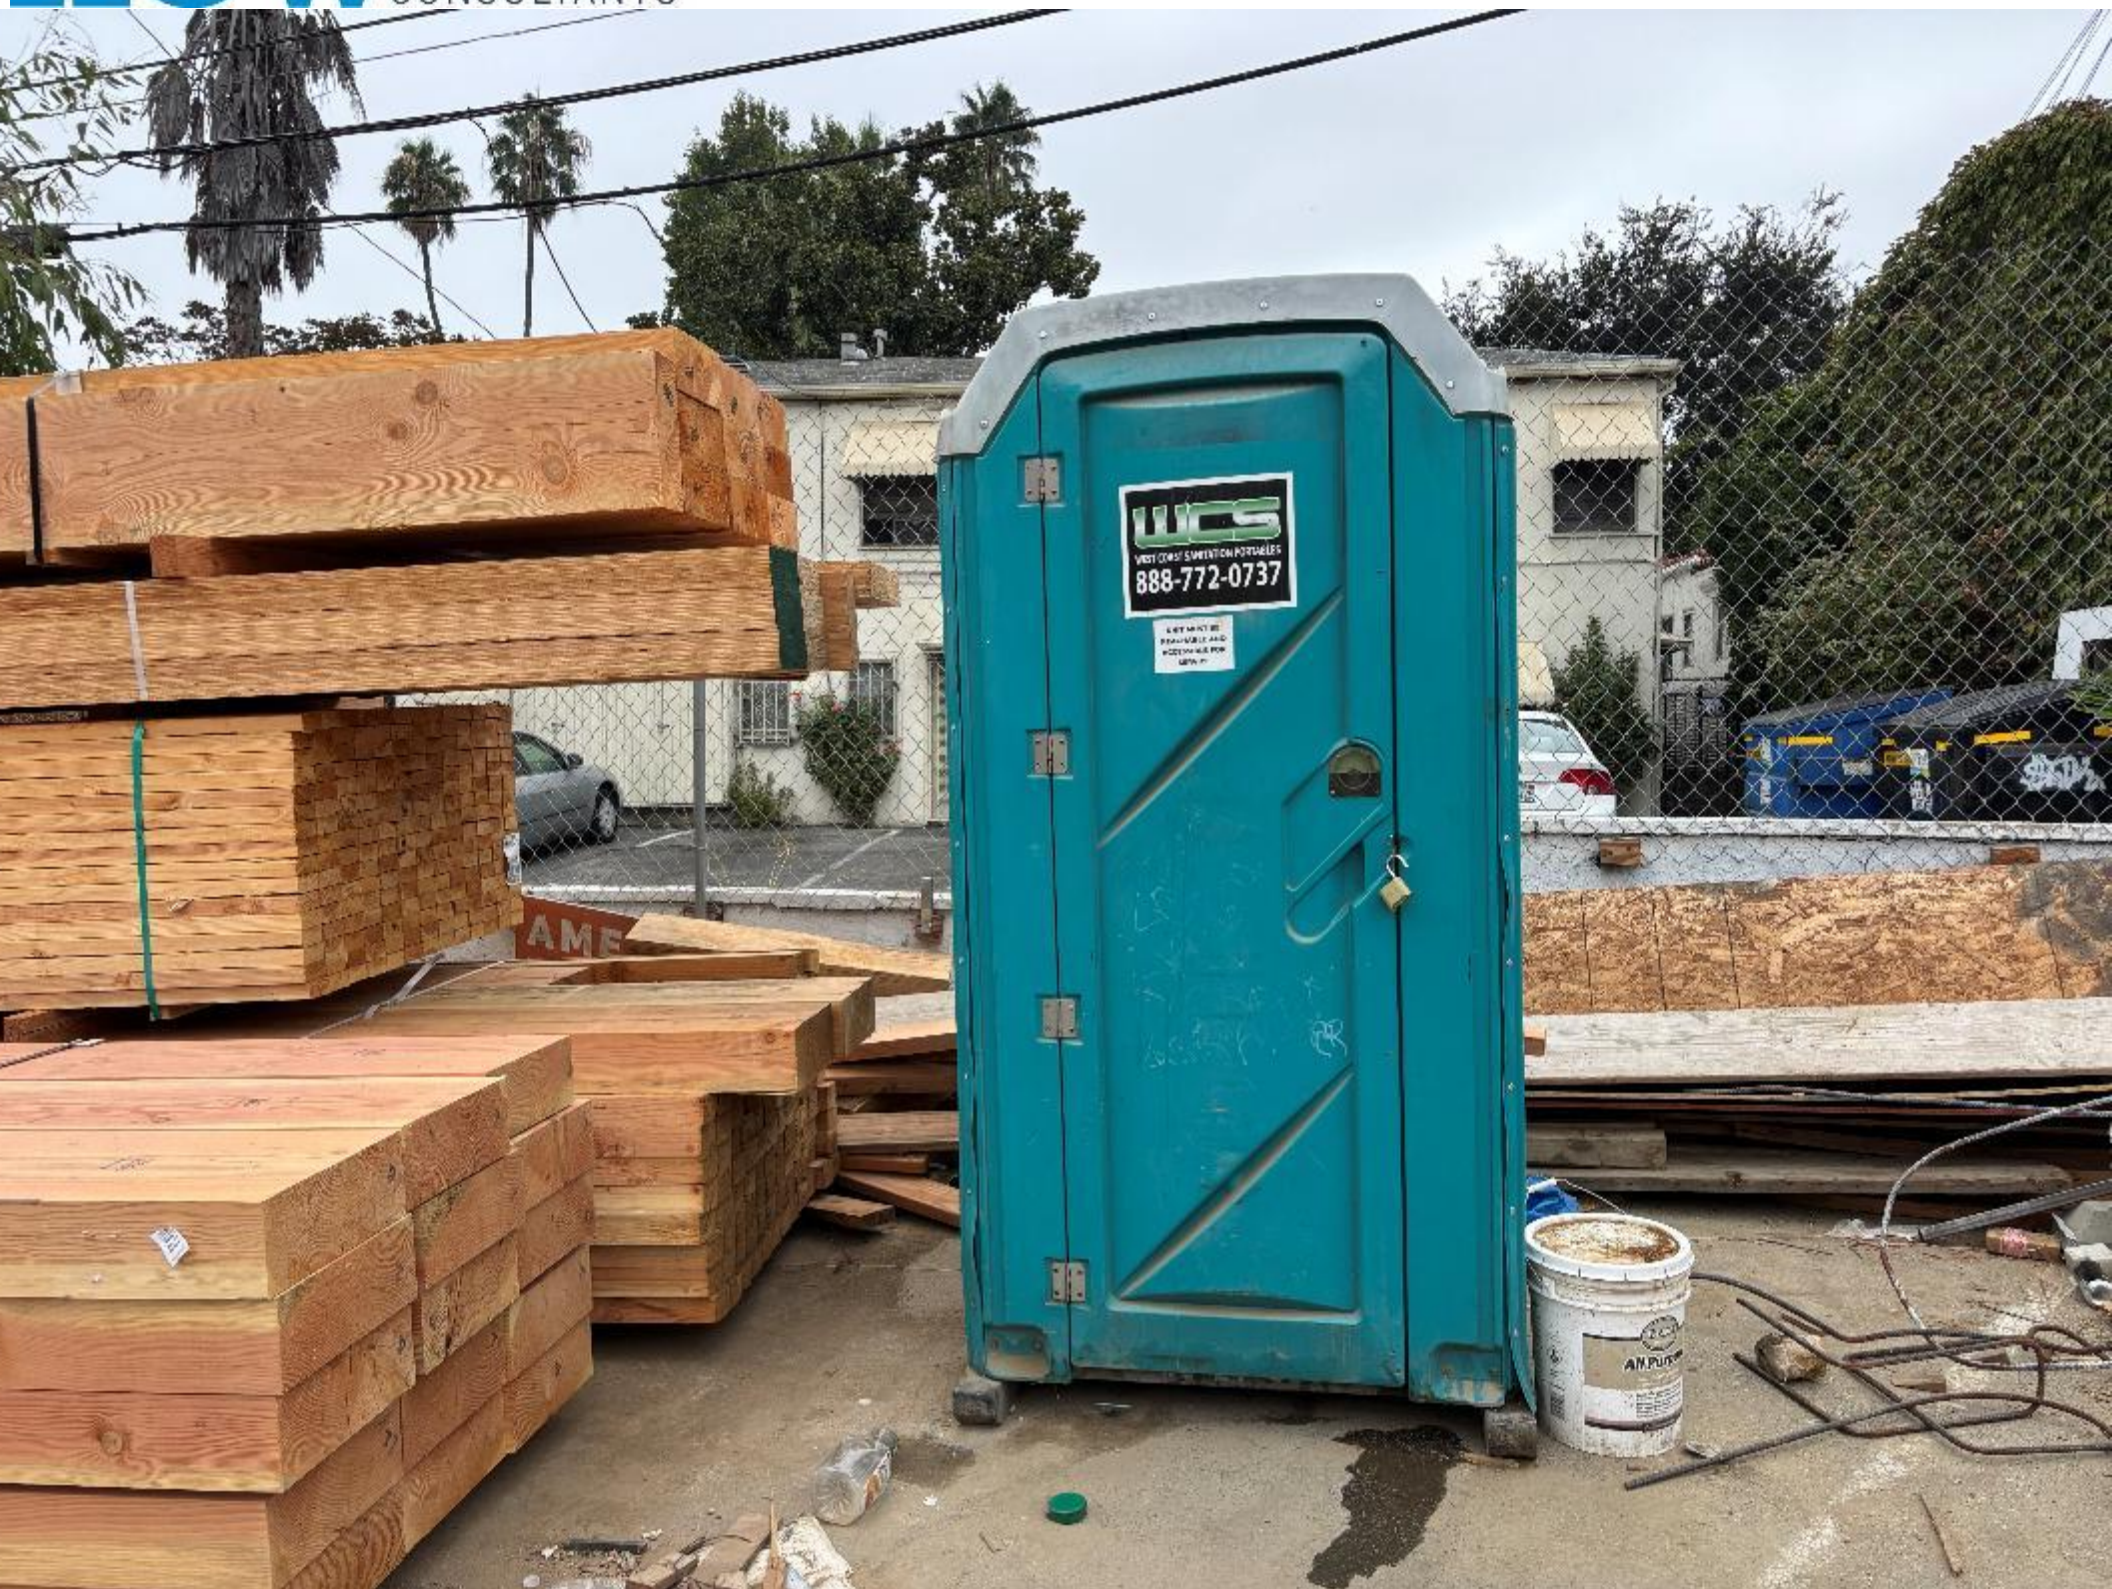
**Photo 7**

Portable toilet (with built-in hygiene station) on site.

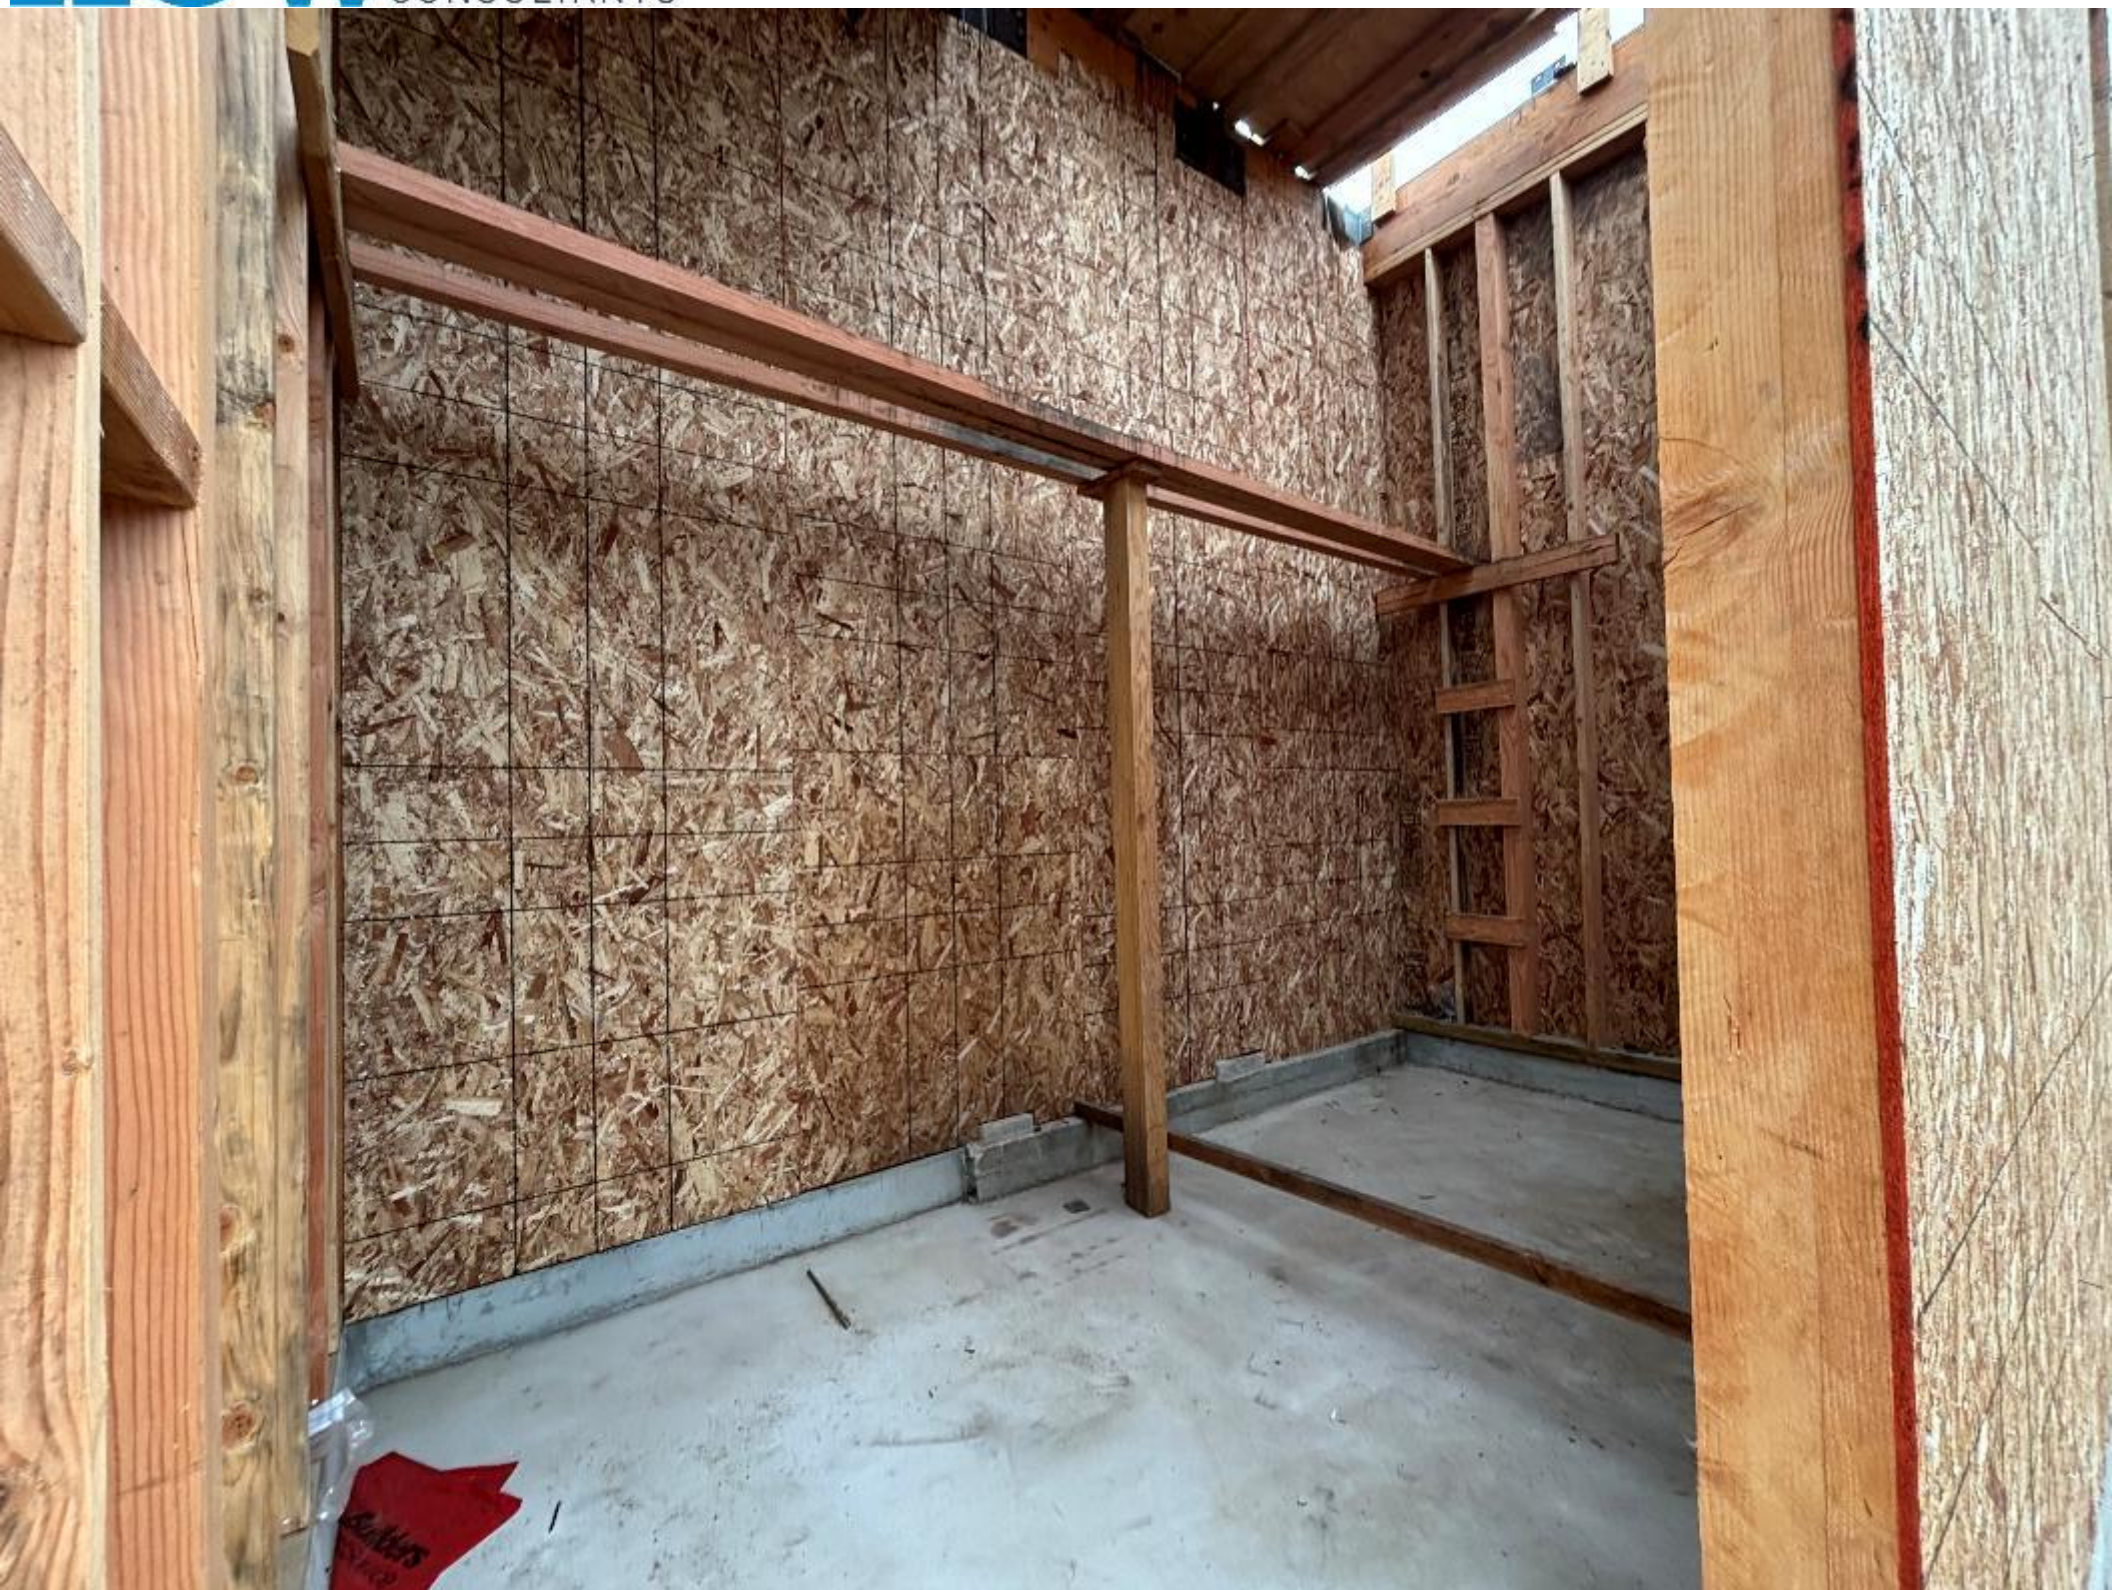
**Photo 8**

North stairwell 1 awaiting construction of stairs.
