# Budget Review

**Lori Place  
123 Main Street  
Los Angeles, California 91604**

# Budget Review Report

**Project:**  
Lori Place

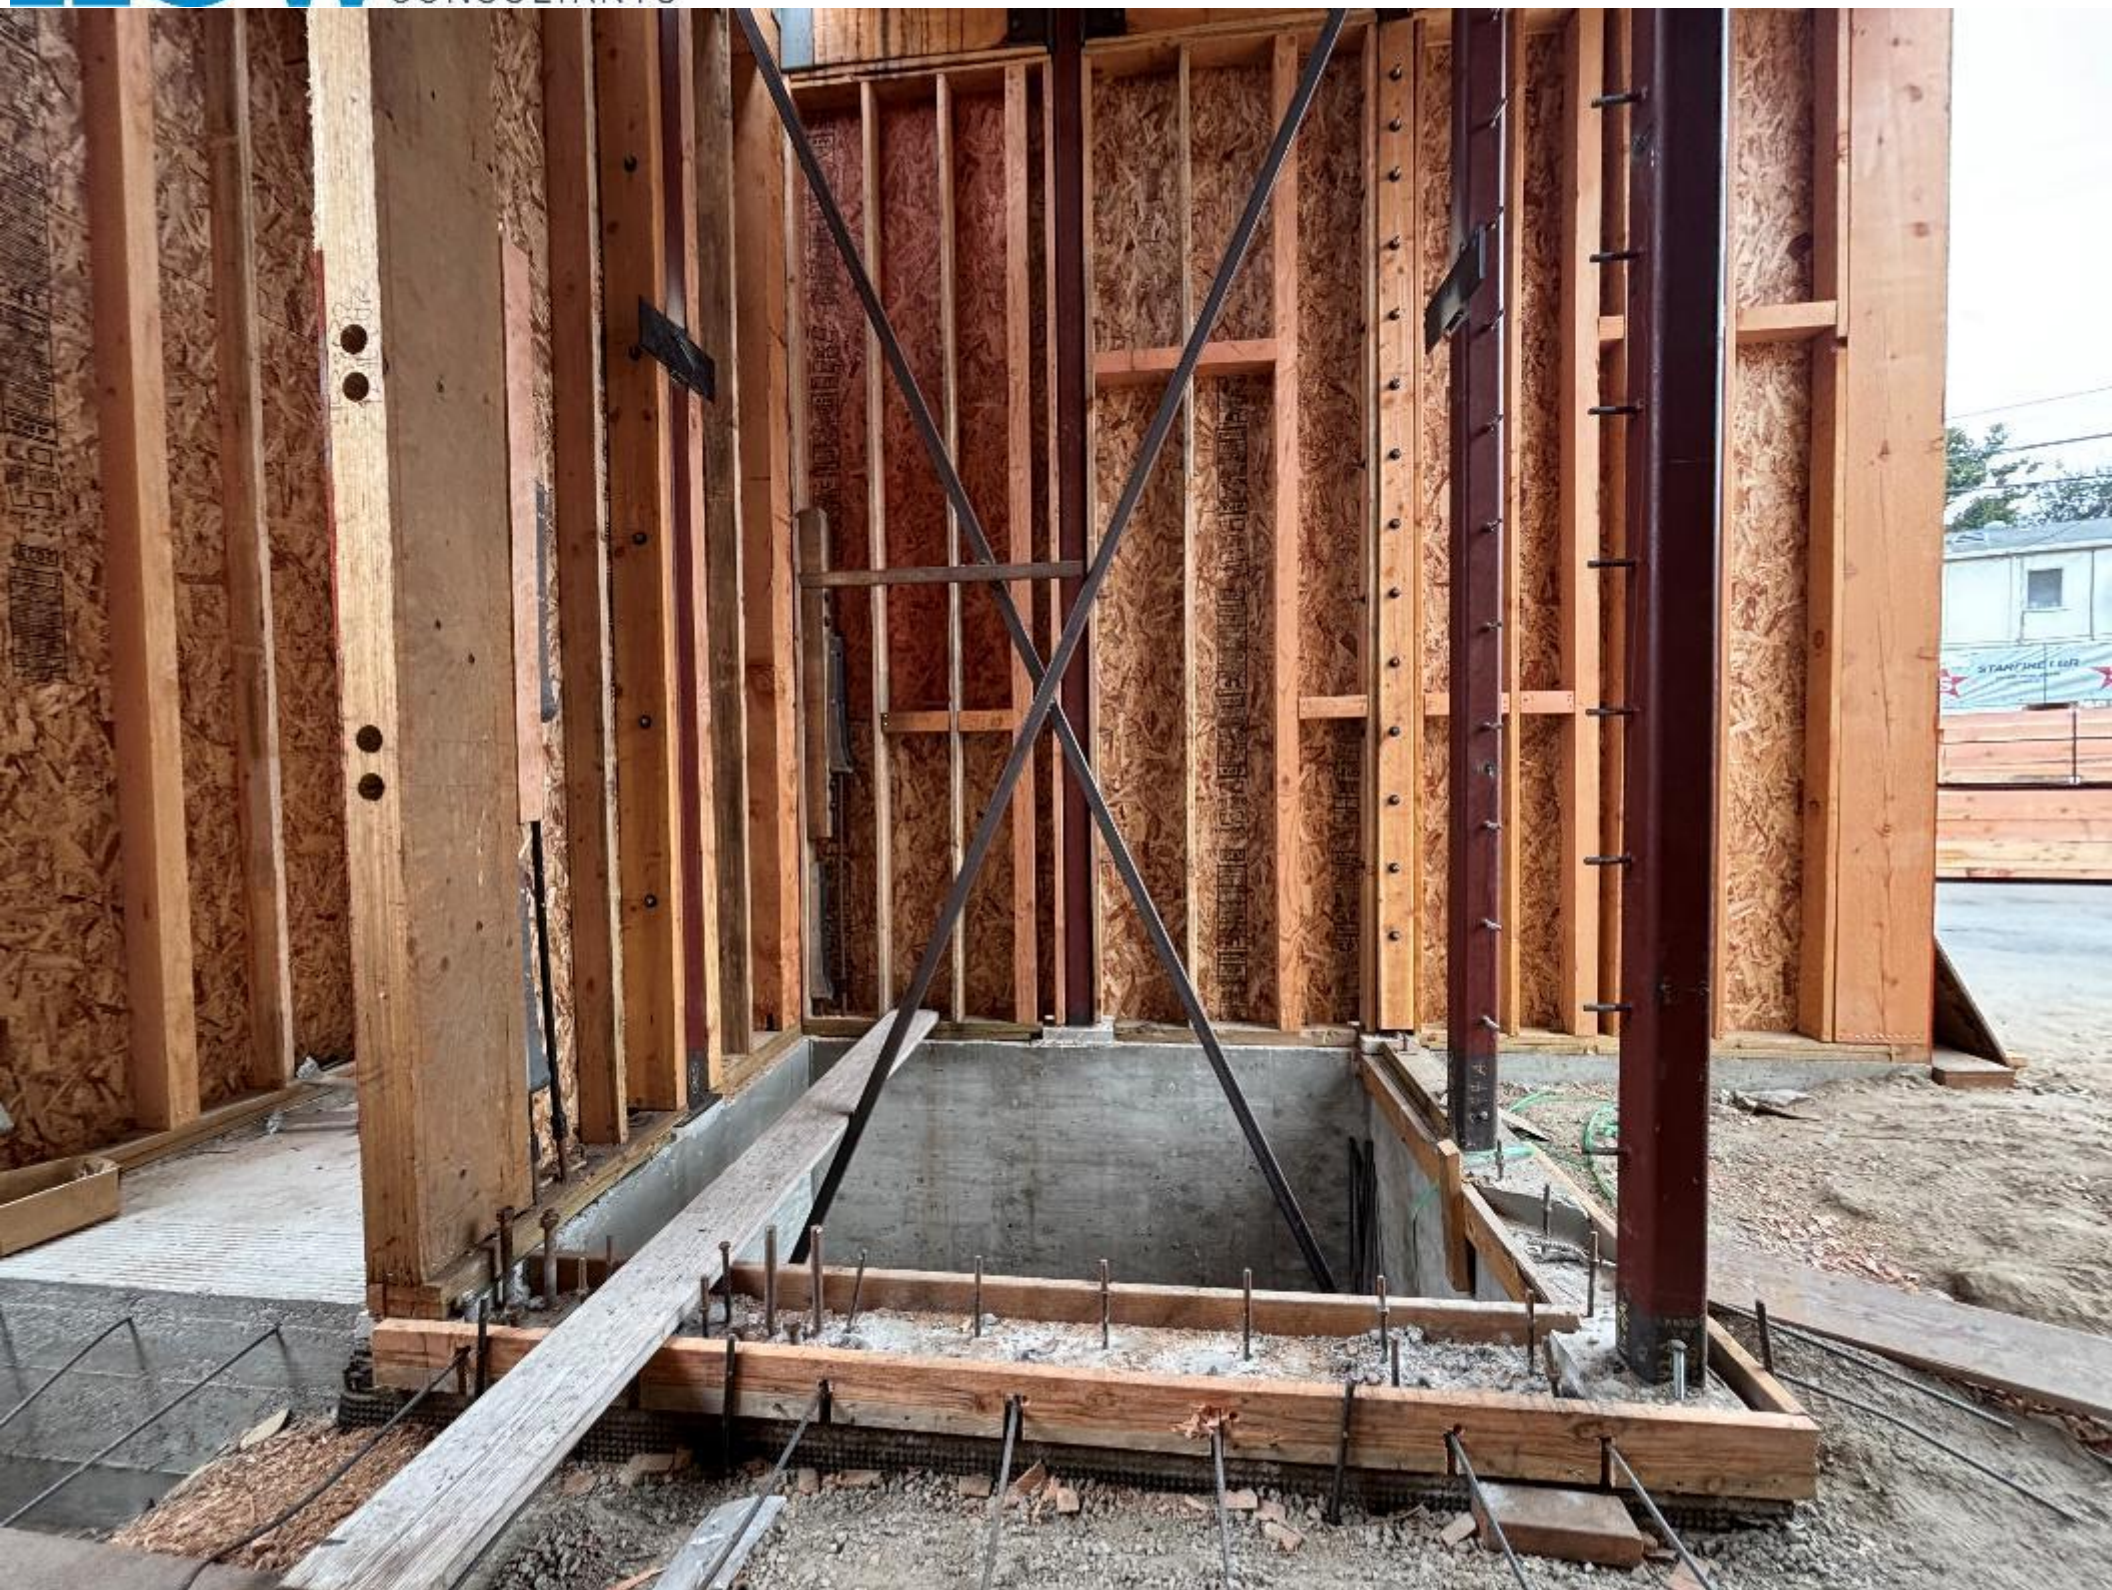
**Photo 9**

Elevator shaft area. Rails, Jambs, and platform reported to be installed the third week of October.

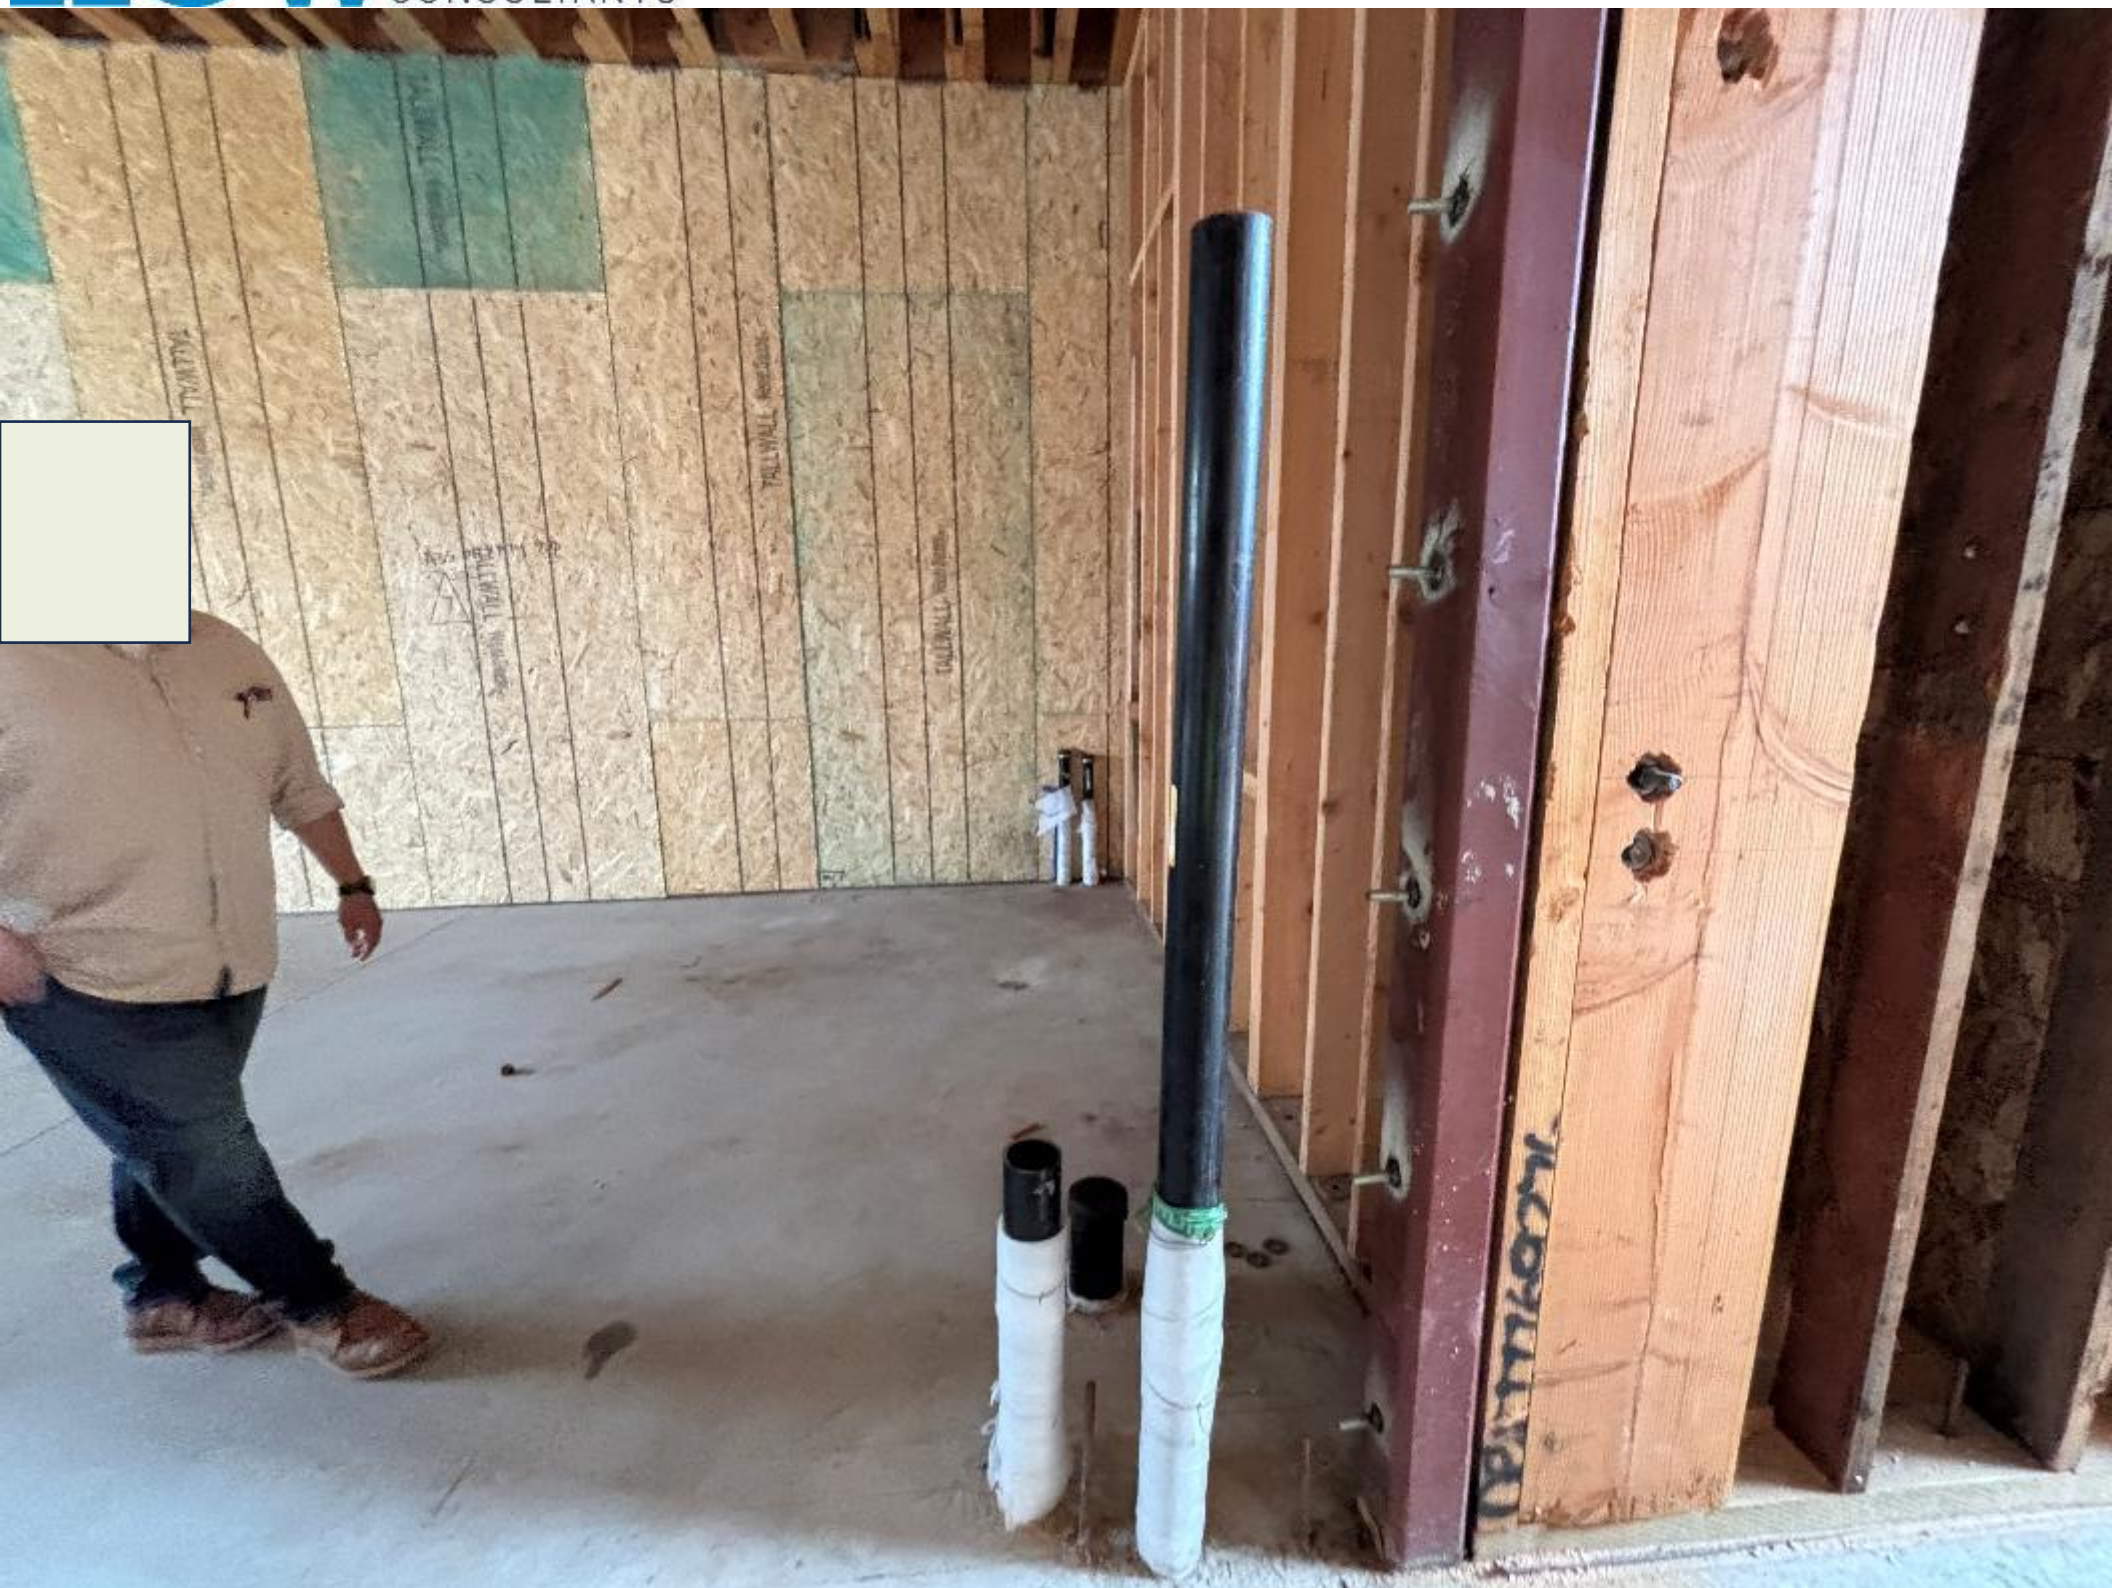
**Photo 19**  
Restaurant 4 facing storefront.

- The area of the first floor behind restaurants 4 & 5 shown on the plans is currently built as an indoor space indicating that a plan change has been made at this area.

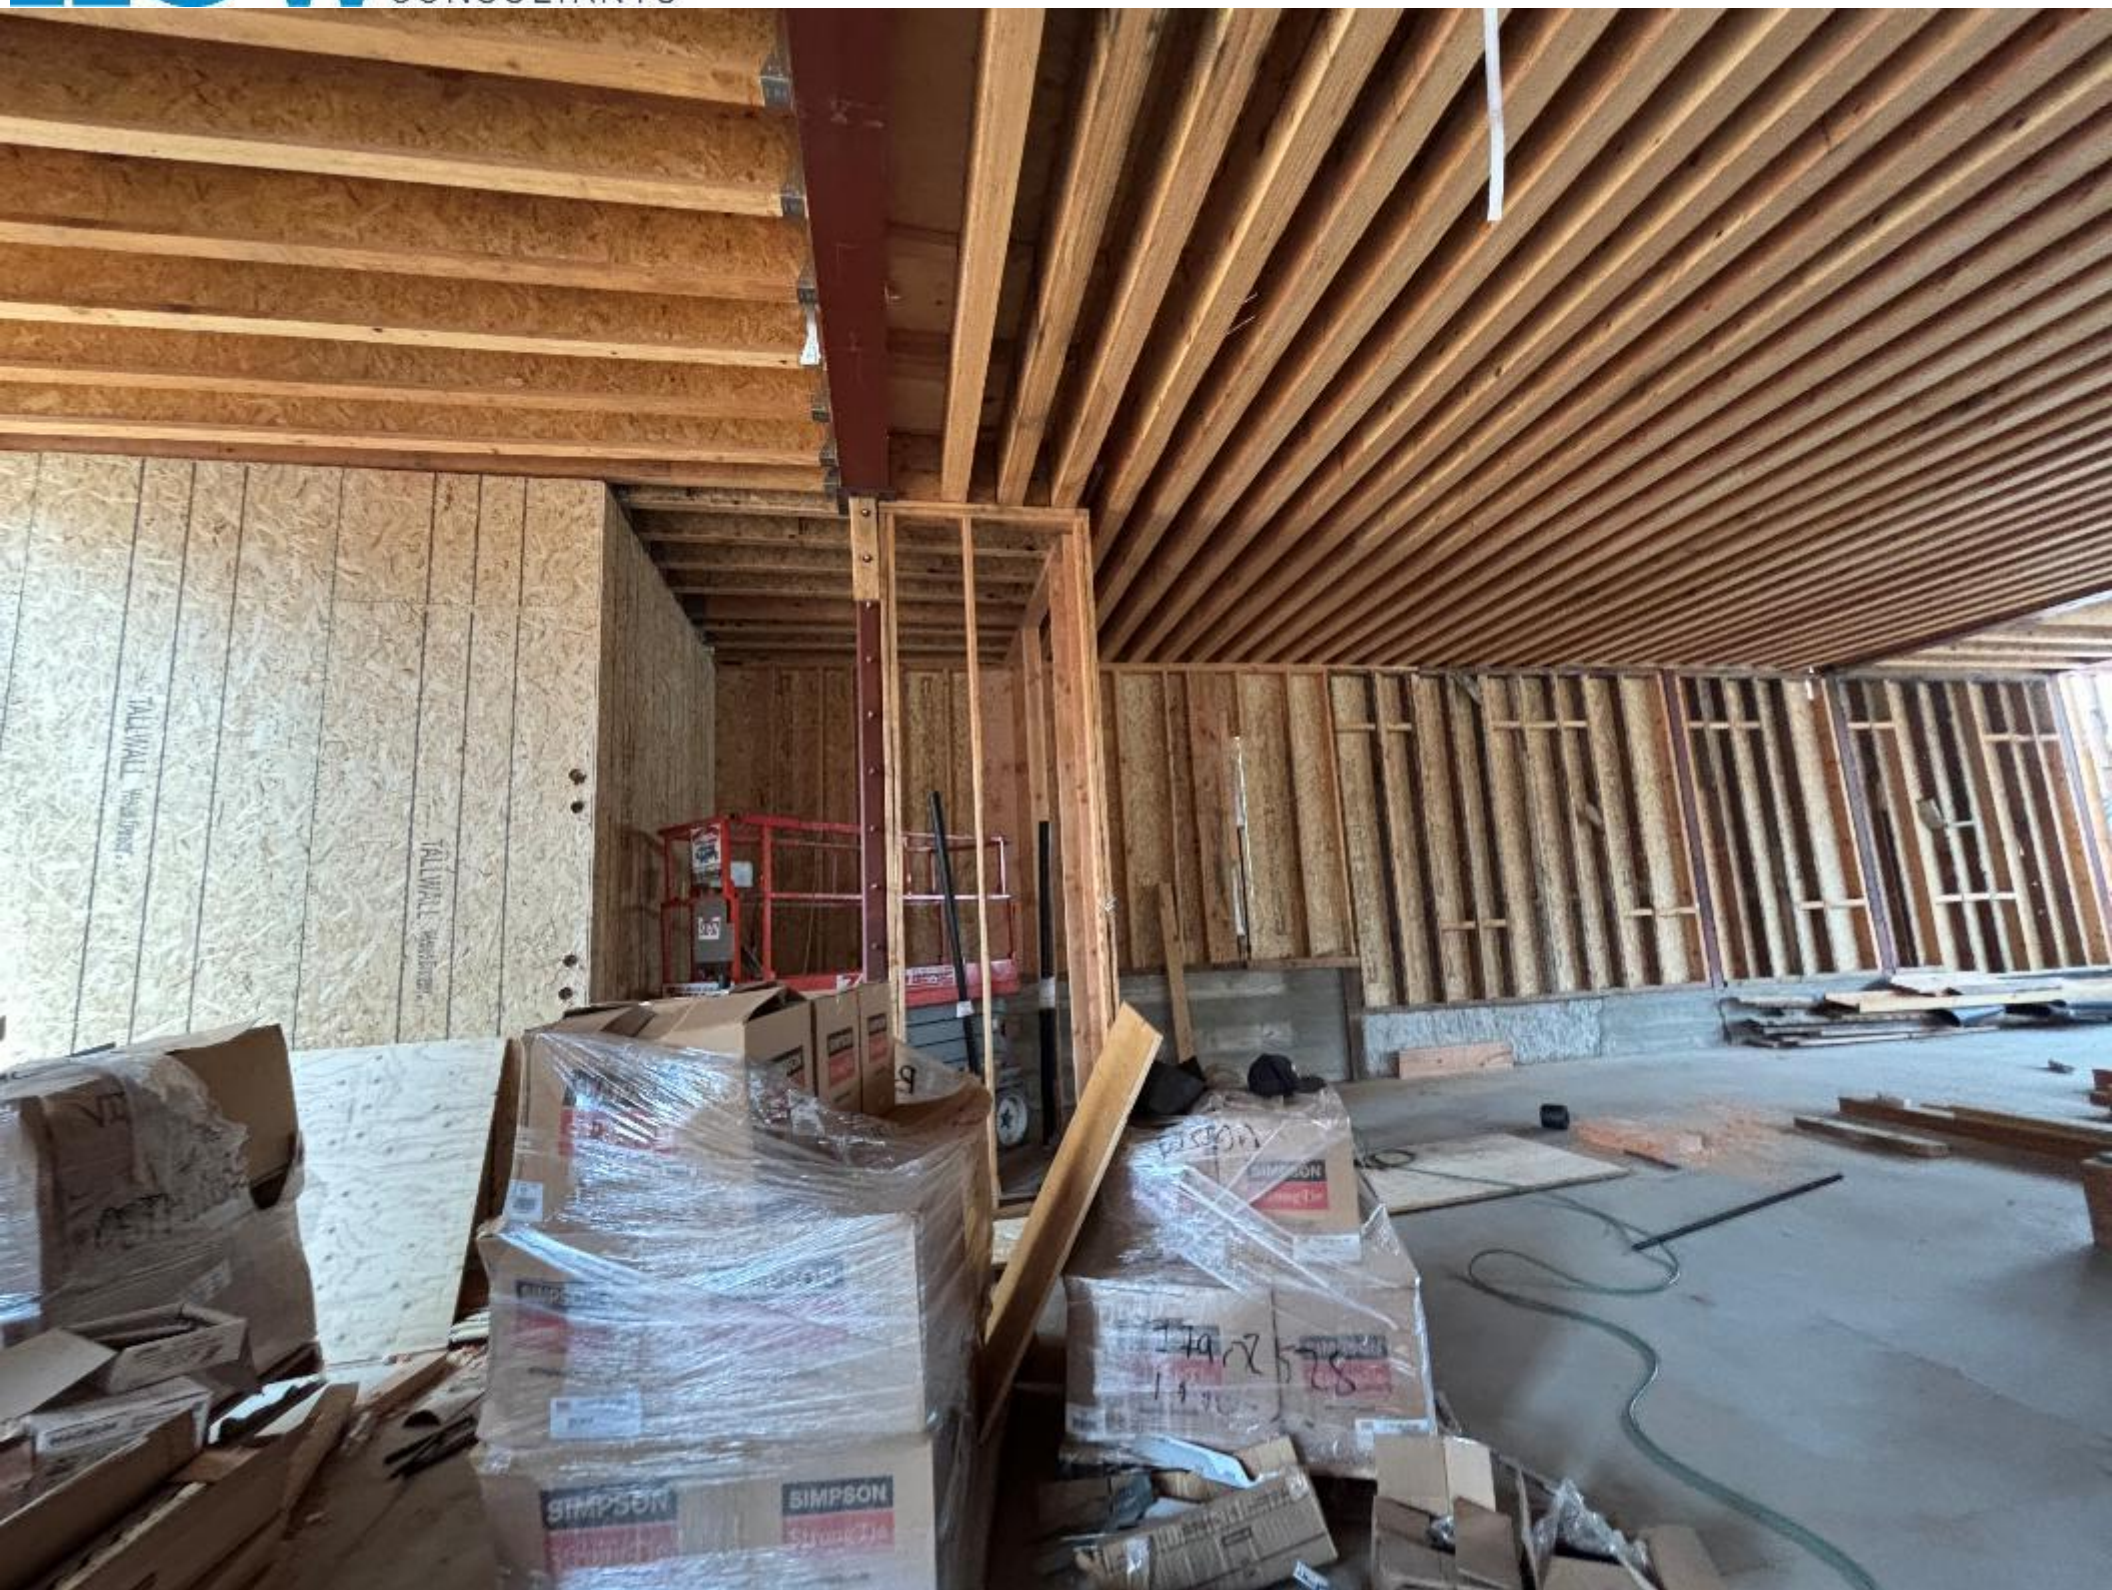
**Photo 22**

Restaurant 5 restroom area (where the scissor lift is located). Framing hardware staged.

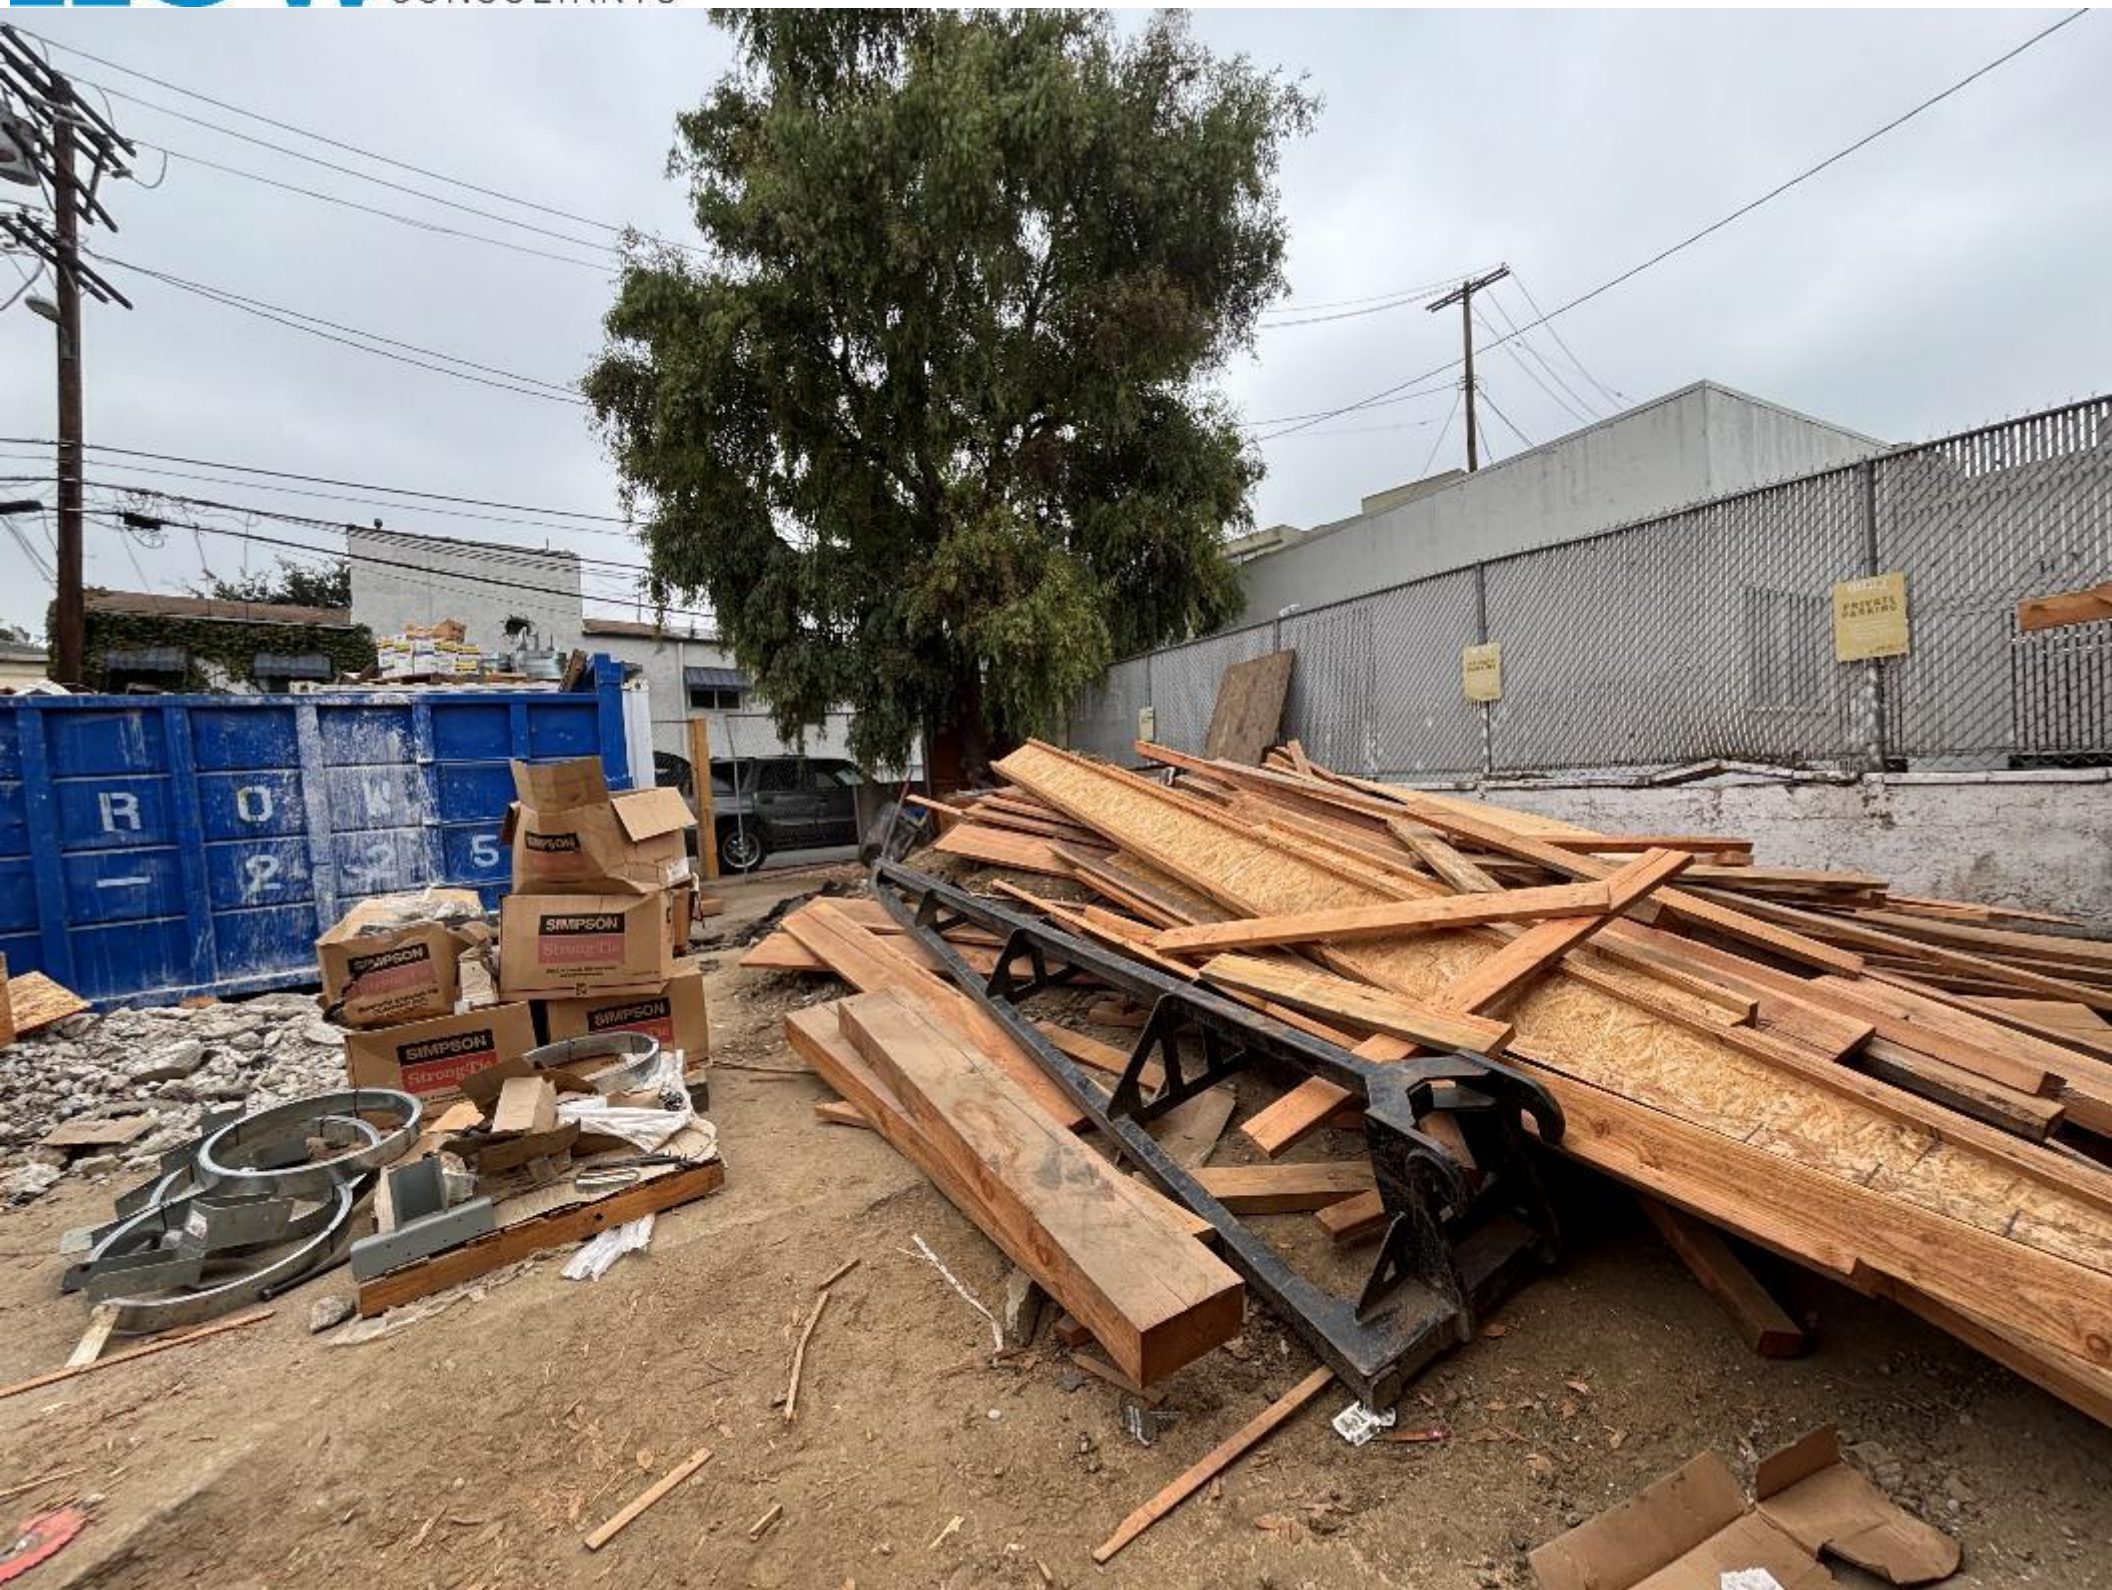
**Photo 23**

Area at the right will be the future LID Planter #2.

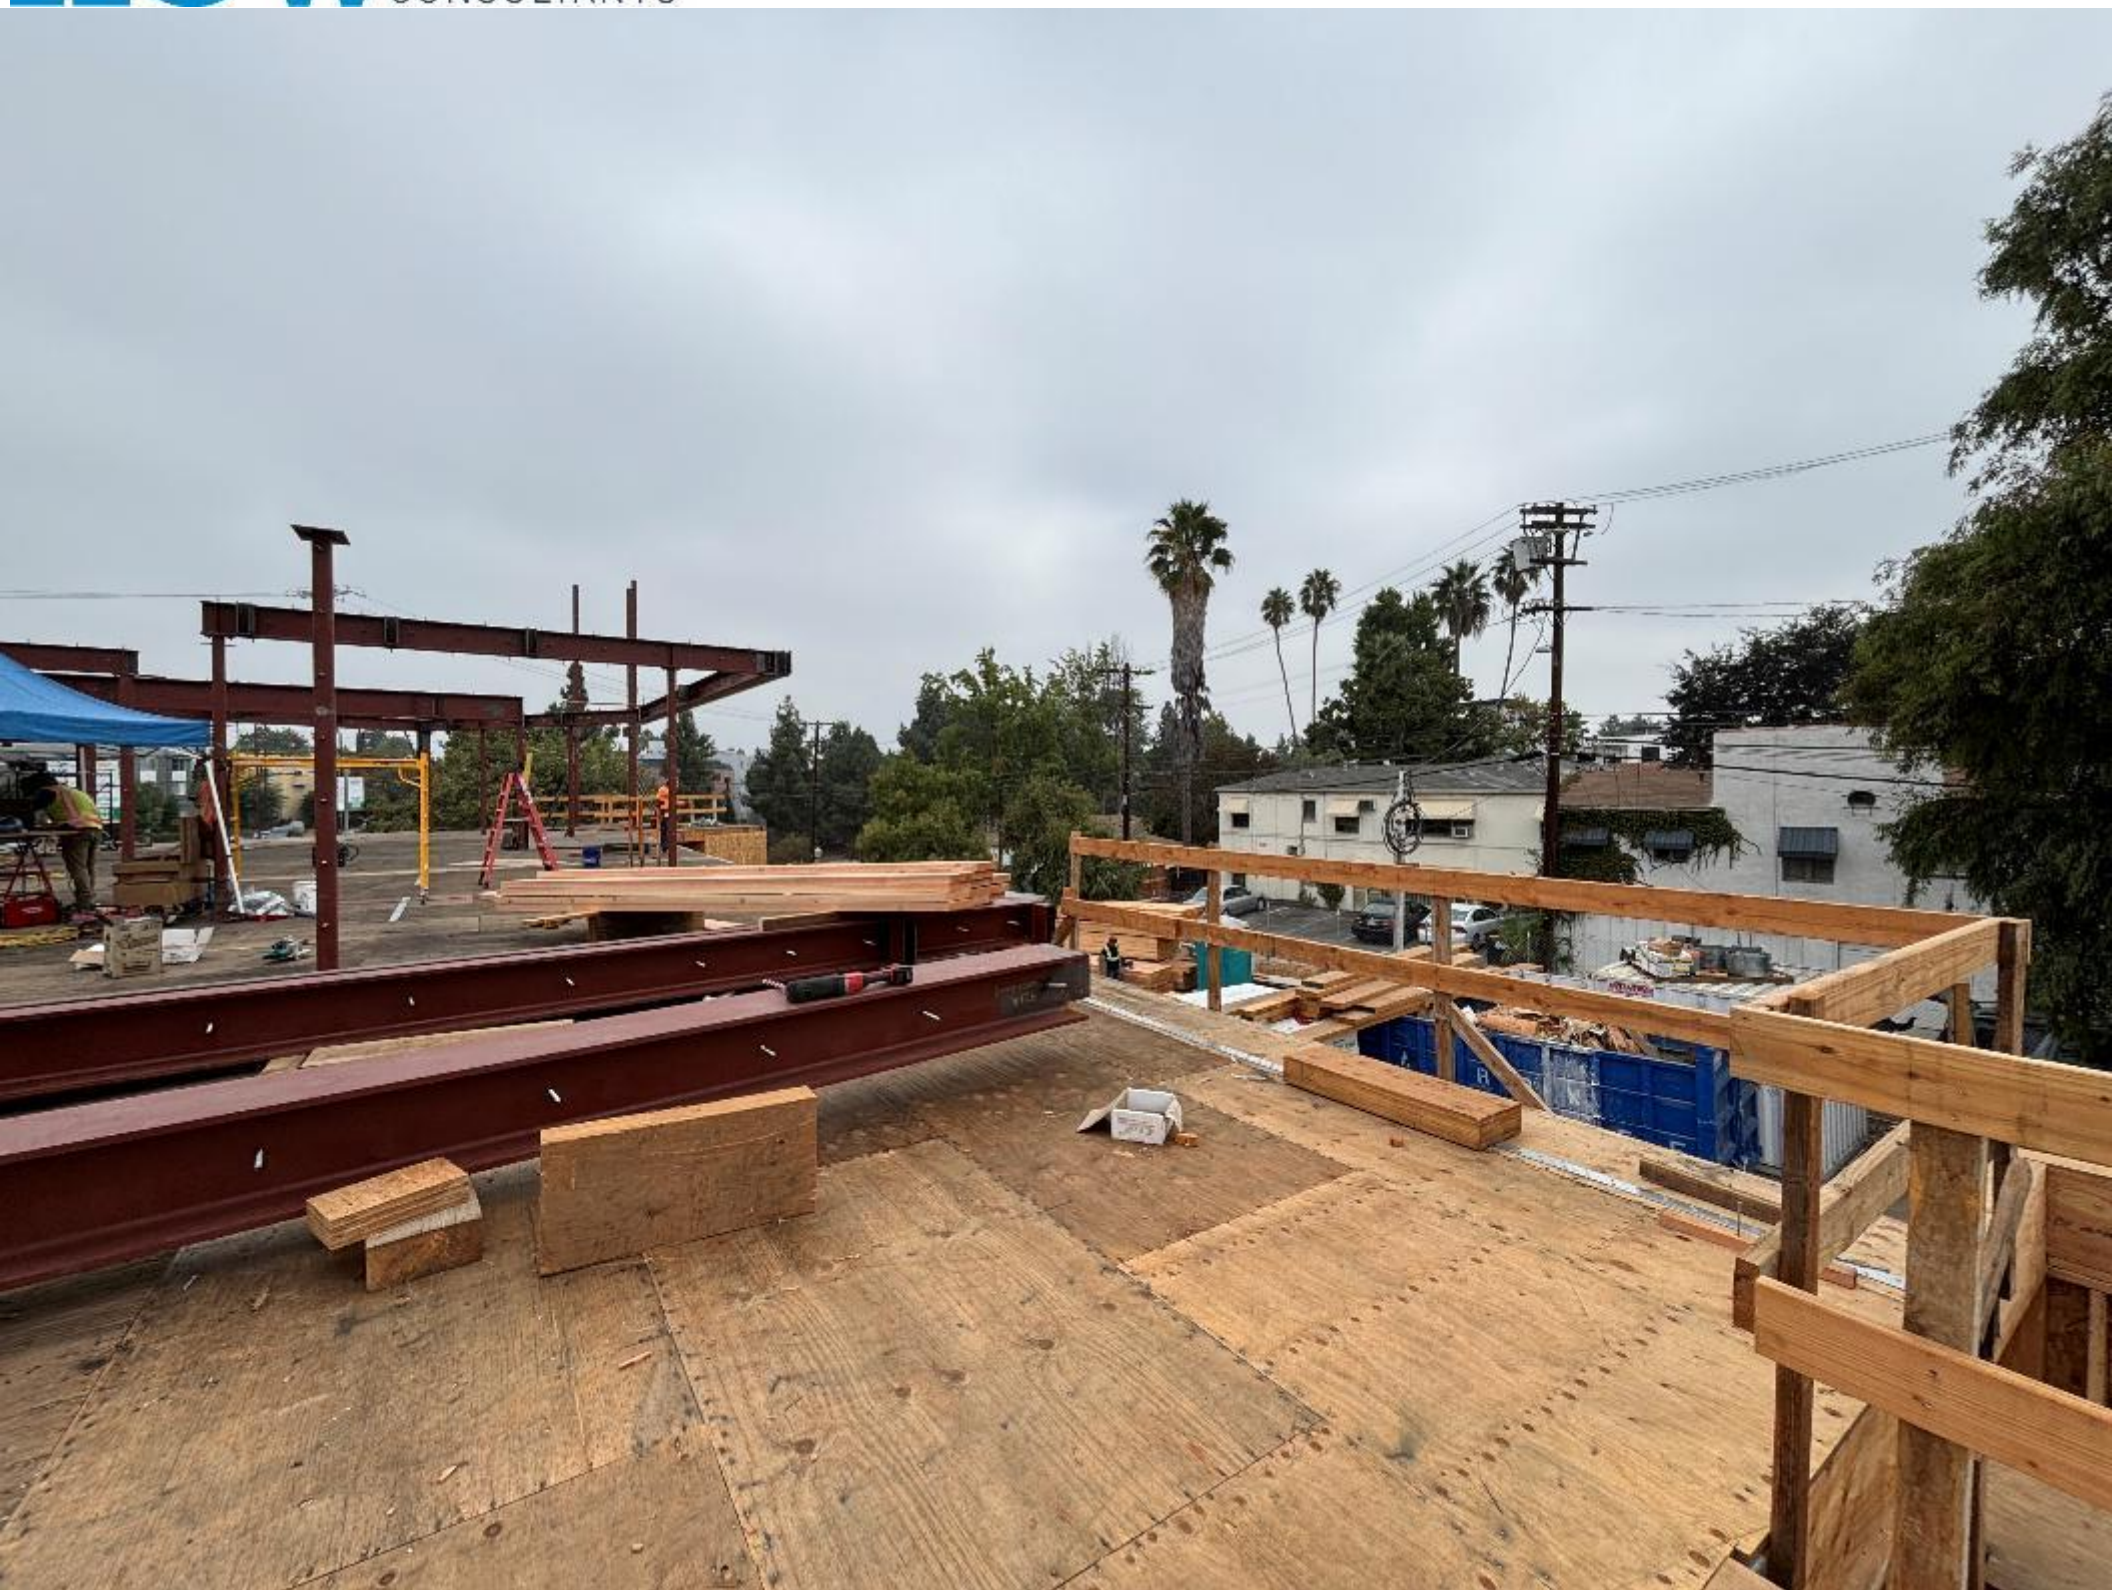
**Photo 25**

Second floor facing north from stairwell 2. Structural steel work ongoing.

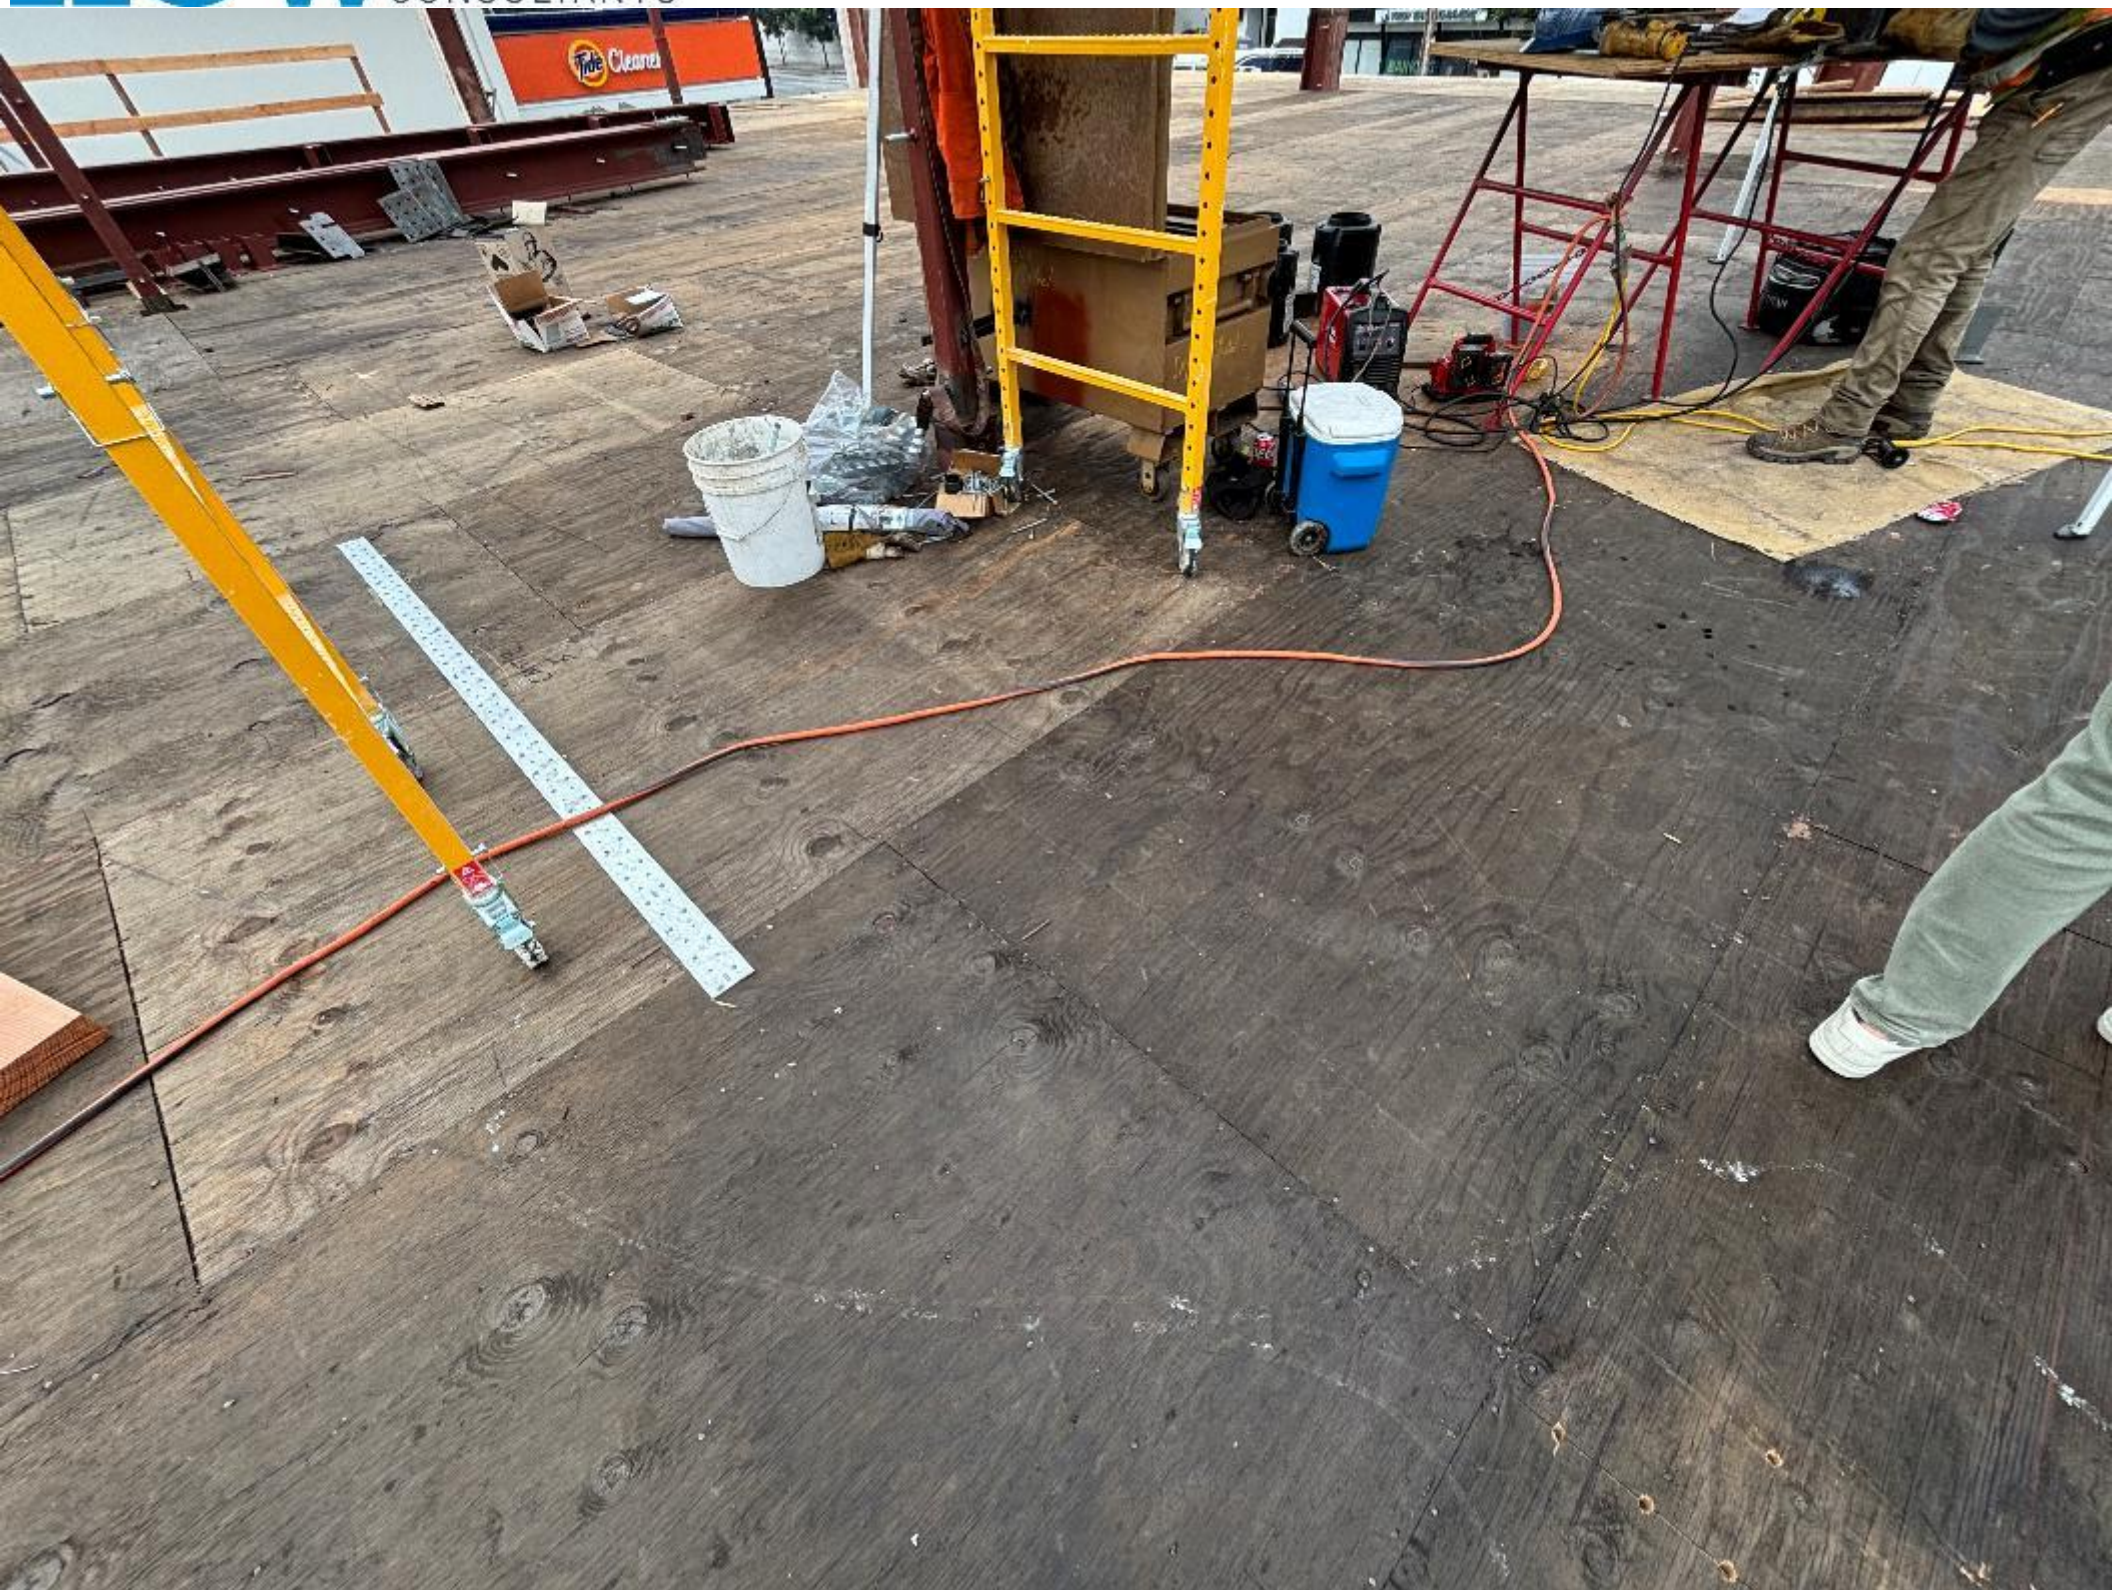
**Photo 28**

Not visible in photo, but second floor restrooms laid out.
