# Budget Review

**Lori Place  
123 Main Street  
Los Angeles, California 91604**

# Budget Review Report

**Project:**  
Lori Place

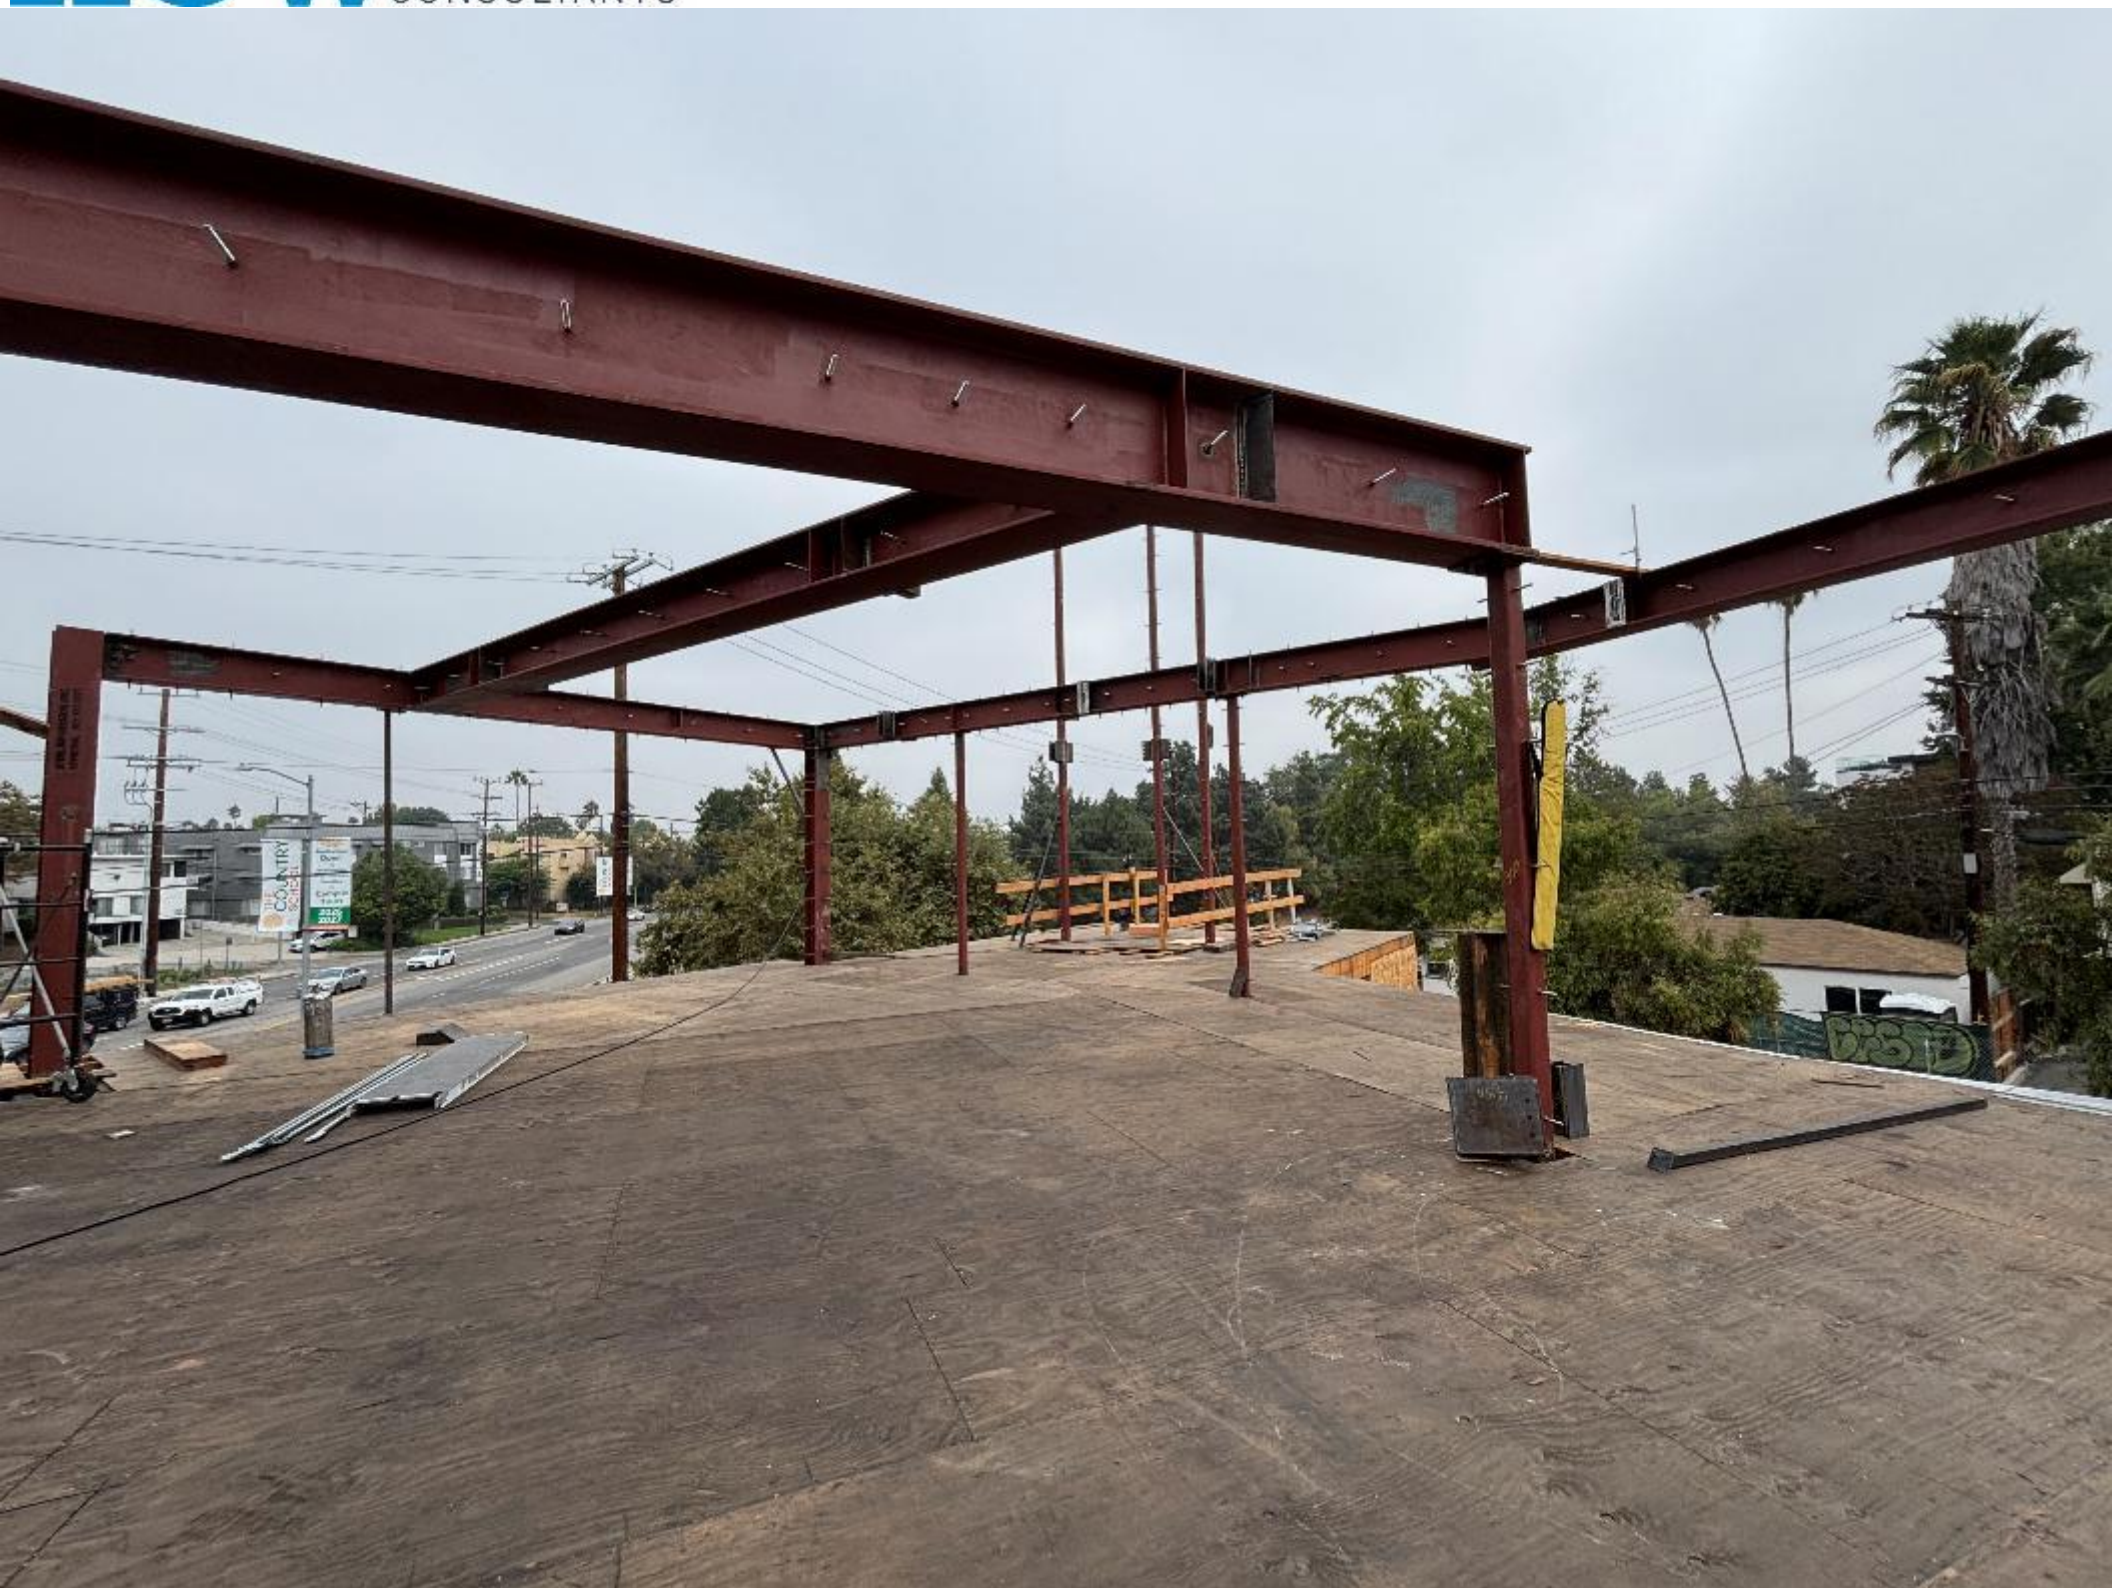
**Photo 29**

Gym #6 and rear hallway areas, with elevator area in the distance.

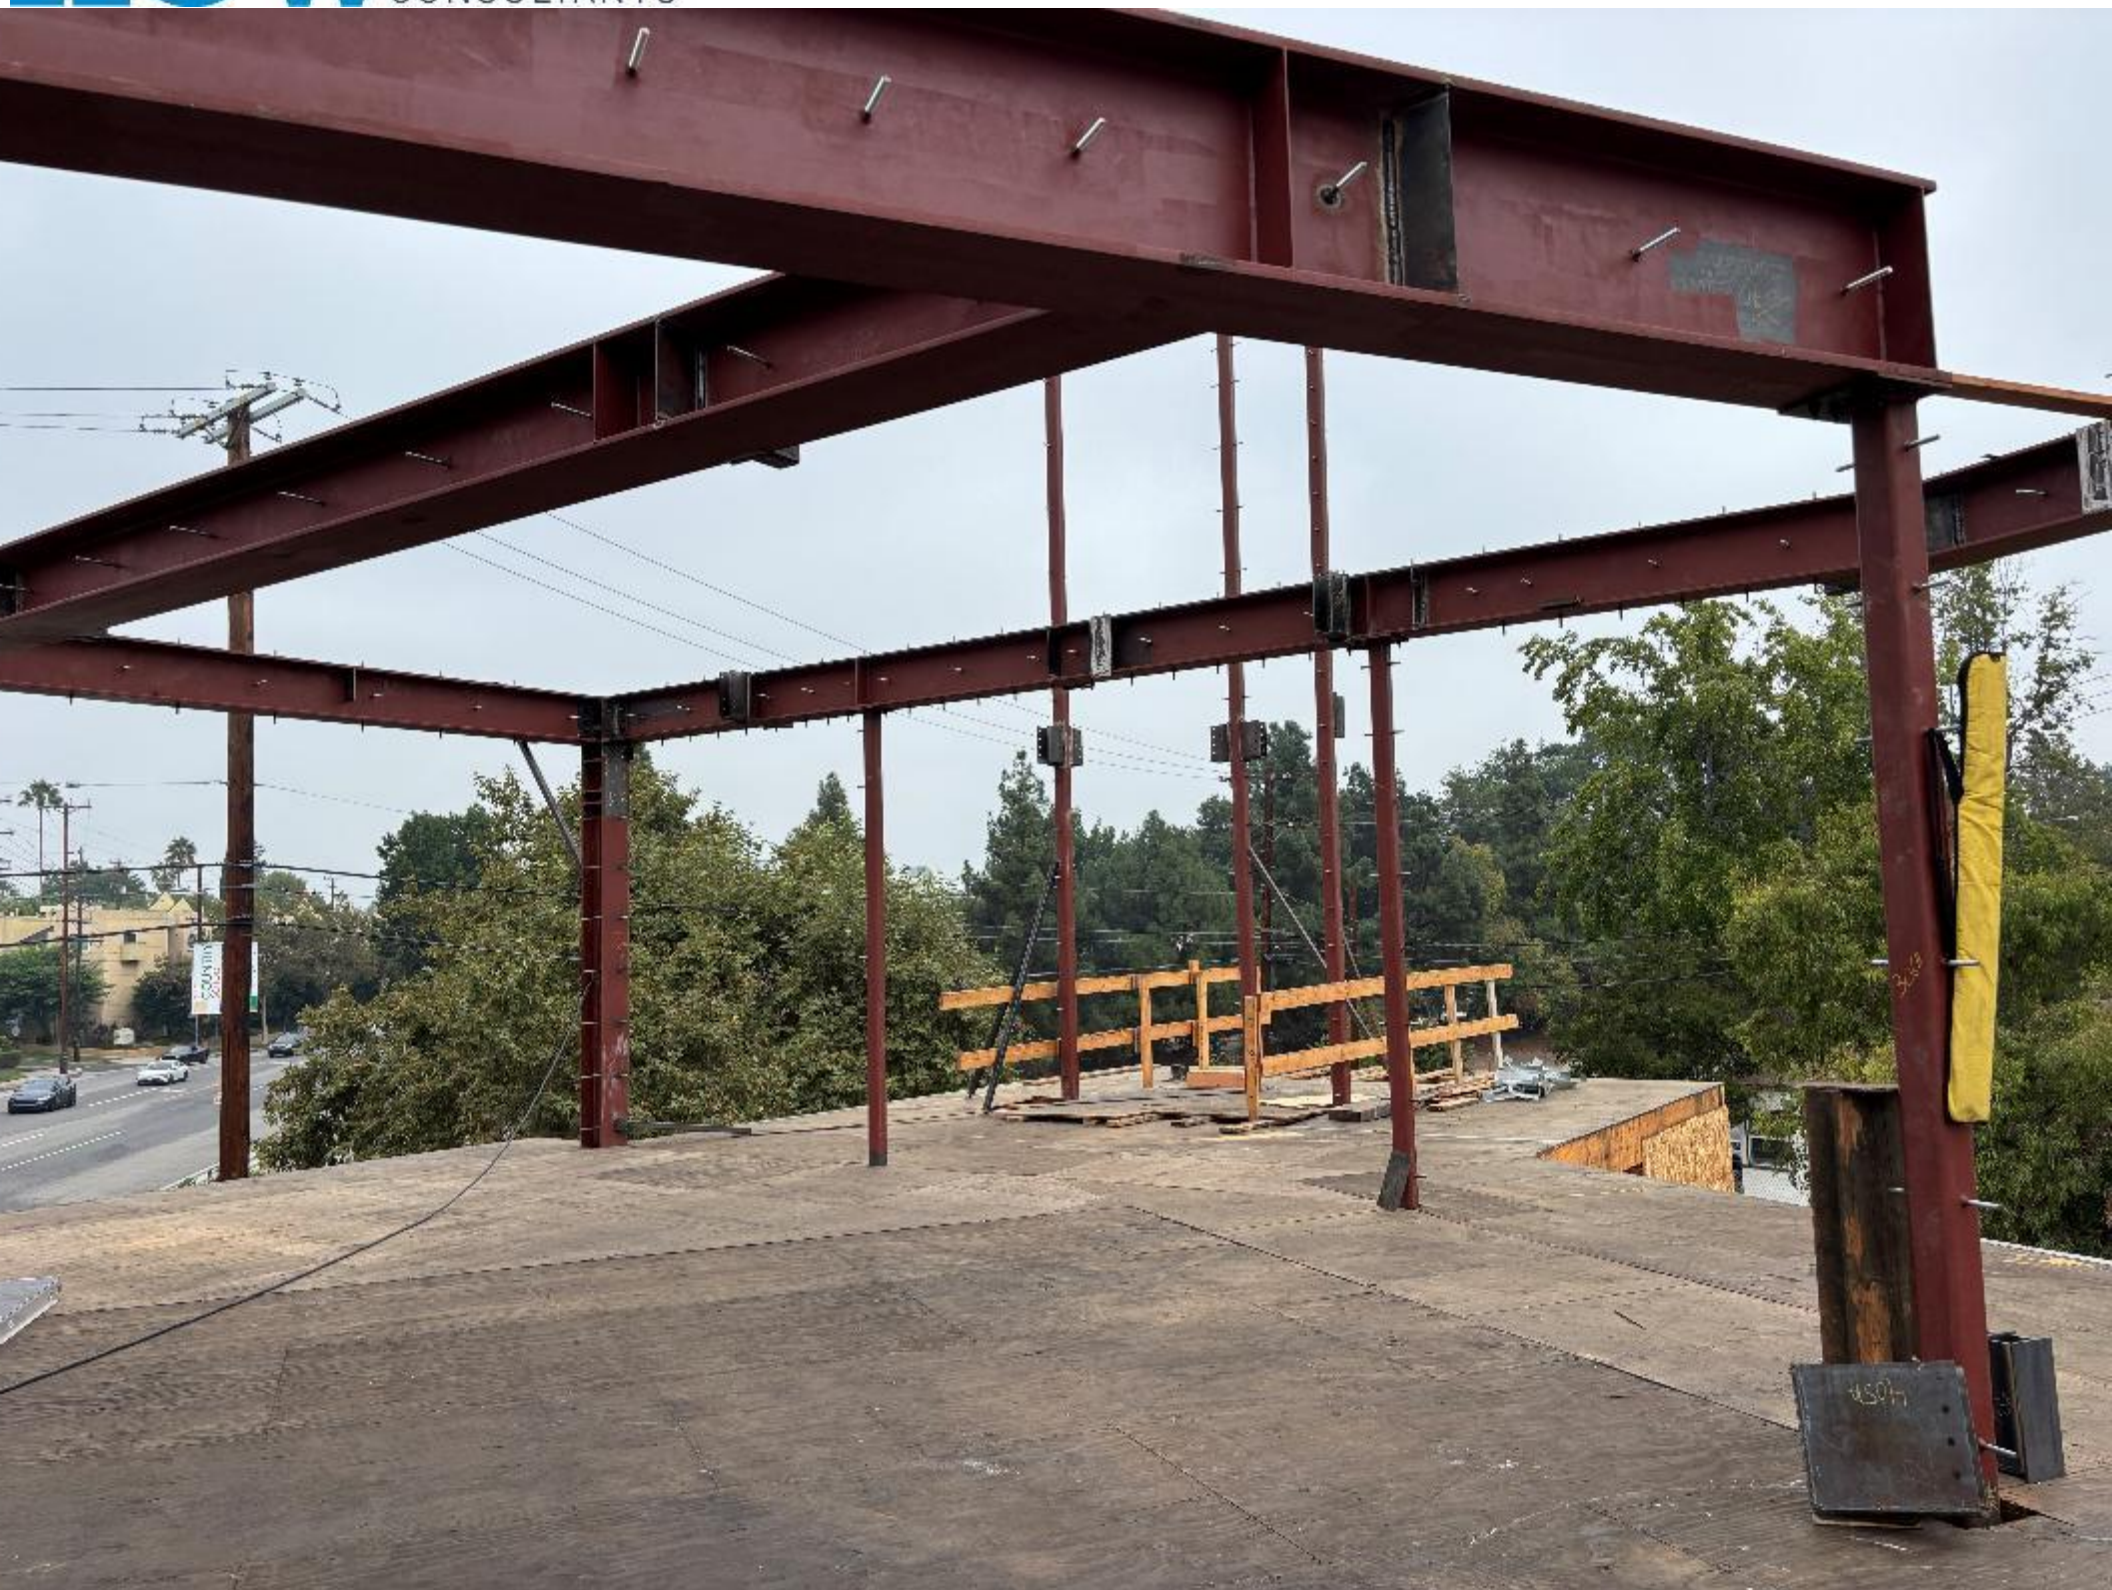
**Photo 30**

Elevator area at the second floor. (Elevator will extend to the third-floor/roof deck)

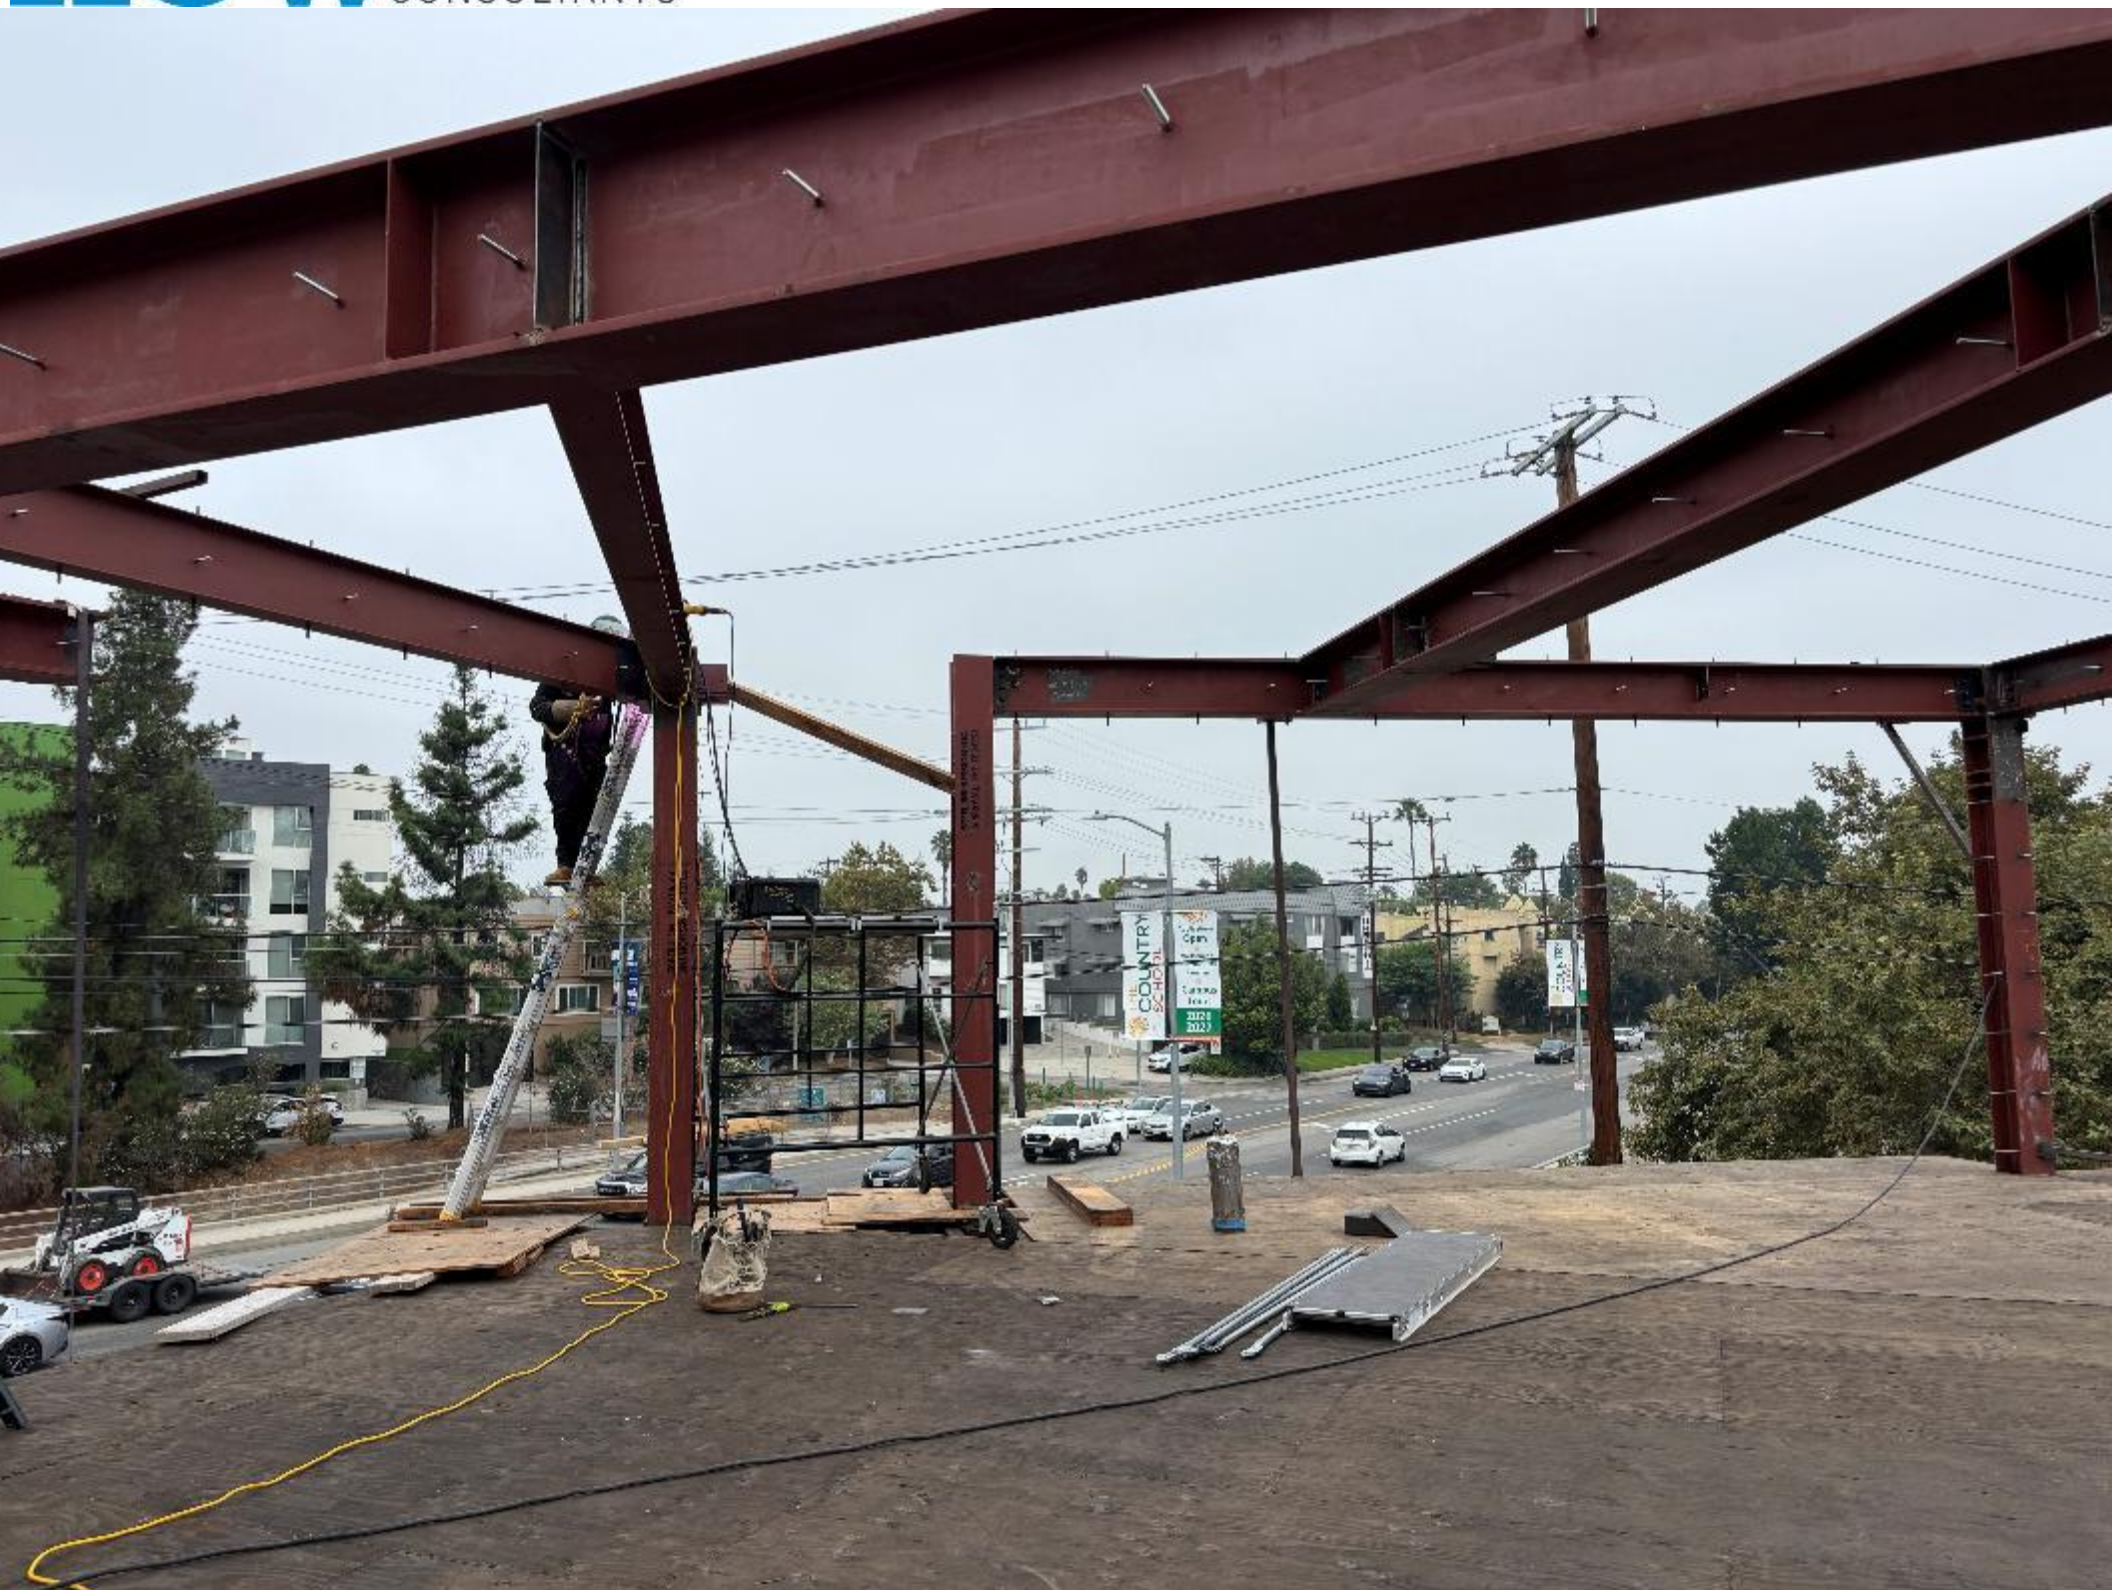
**Photo 31**

Structural steel work ongoing at the rounded exterior wall area of the second floor.

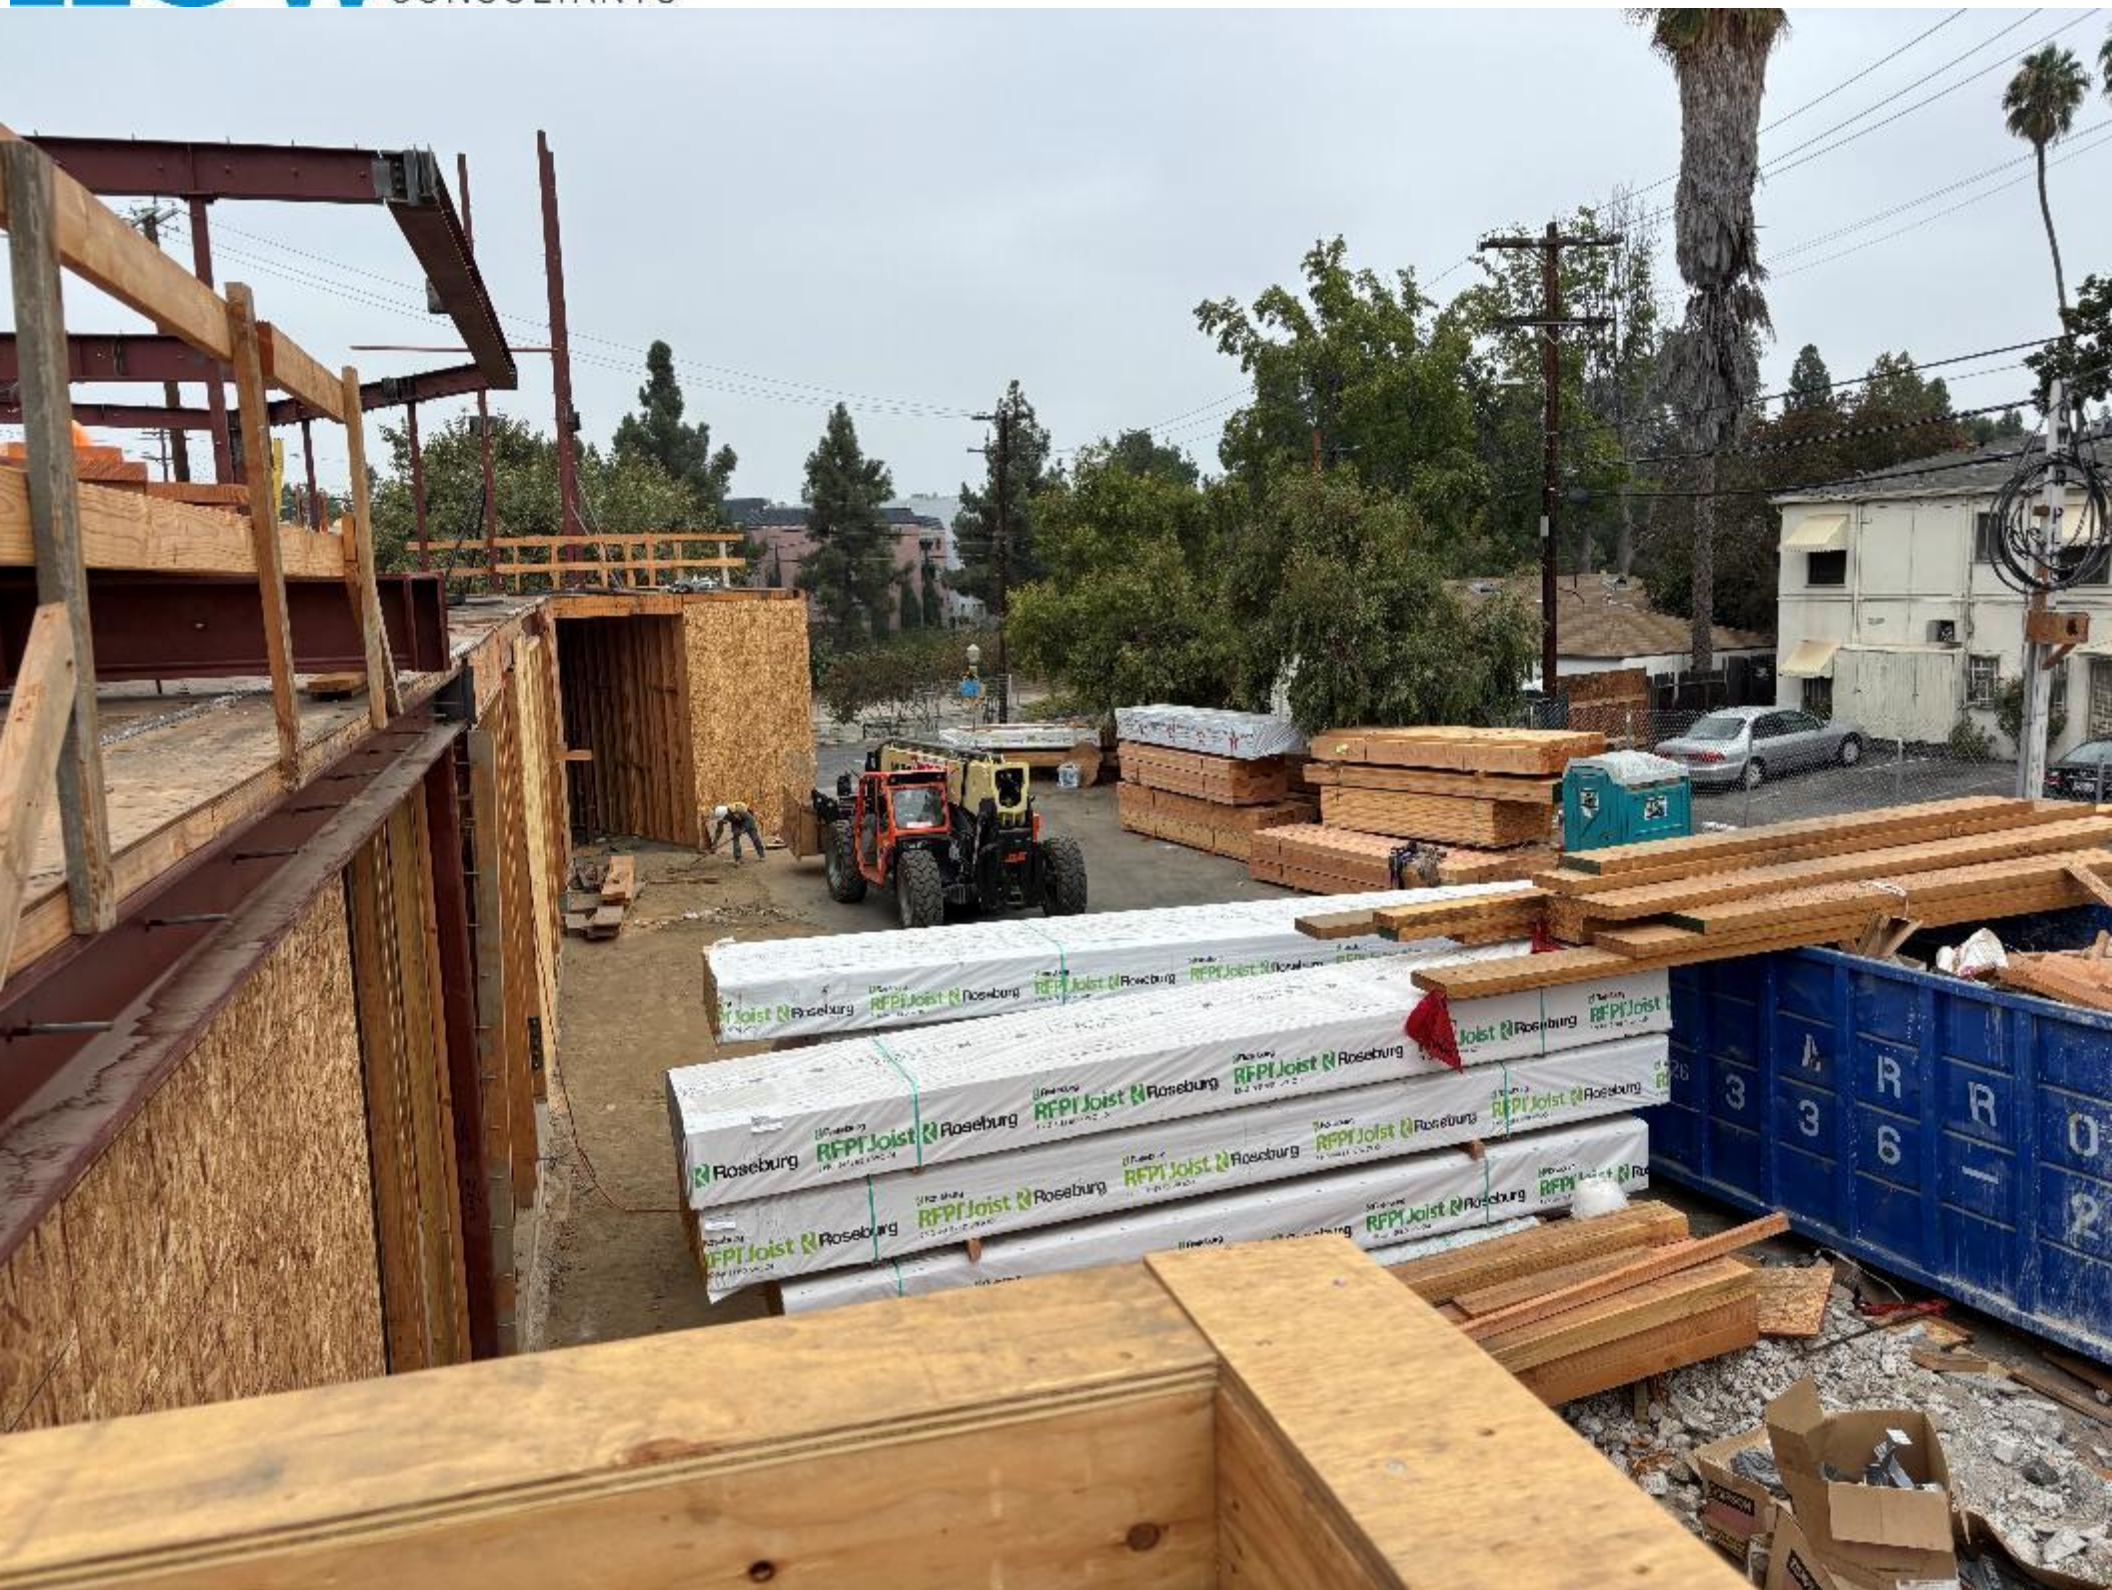
**Photo 32**

Rear parking area from the second floor showing staged materials.
